the **play inspection** company

Annual Inspection

Whitley Parish Council

Inspected: 6-September-2019 - 09:24 by Ross Pringle RPII Annual Inspector

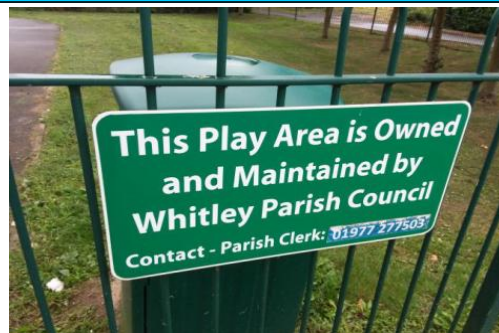
It is recommended that information signs with emergency contact details are installed at each entrance/exit point to the playground - Provide in accordance with the recommendations set out in BS EN 1176

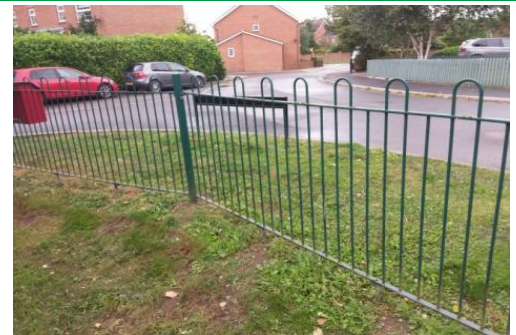
There are a number of loose posts around the fence - Monitor for any further deterioration and reset as required

A number of fixings have worked loose around the fencing - Secure all loose fixings

There is some damage to the fence sections - Monitor for any further deterioration and repair as required

There are a number of fixings missing from the fence - Replace missing fixings

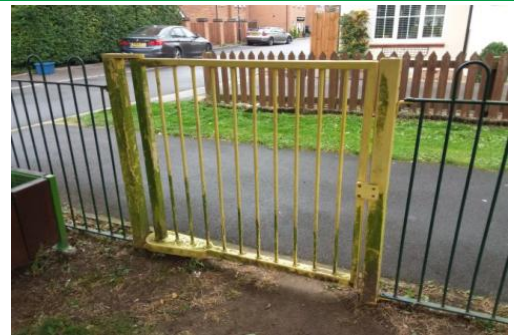
The area under the gate has eroded leaving uneven areas, or the concrete foundations exposed, resulting in trip hazards at the entrance/exit to the playground - Reinstate to level with surrounding surfaces

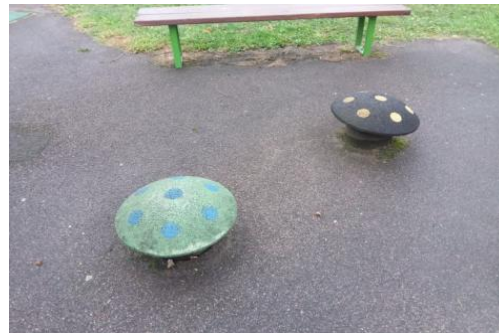
The bench forms a hard object within the falling space of the equipment in contravention of the requirements of BS EN 1176 Part 1 - Monitor - No remedial work recommended

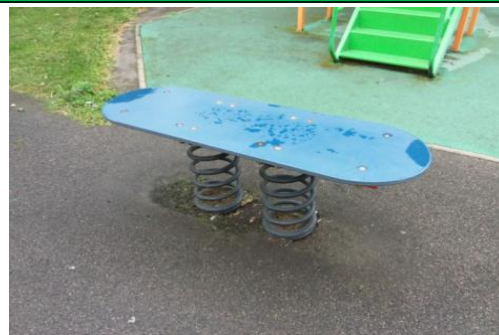
An impact absorbing surface is recommended for this item of equipment - Provide an appropriate impact absorbing surface

The paintwork on the spring has been damaged or worn exposing the metal underneath which is rusting - Treat any rusting components and repaint

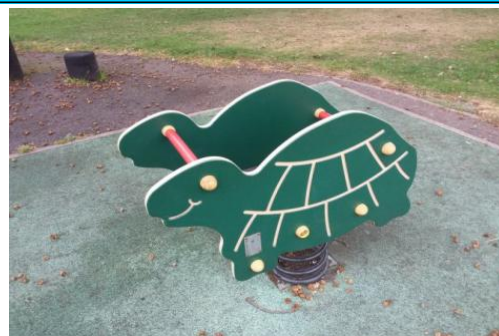
There is/are bolt cap covers missing or damaged on the item - Replace missing or damaged bolt cap covers

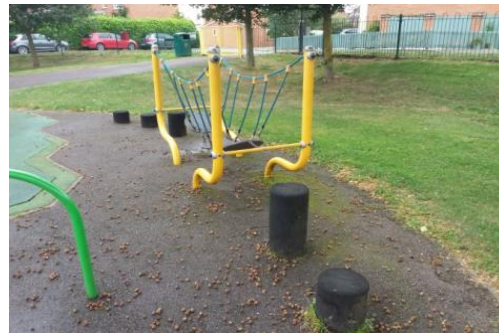
The talk tube forms a hard object within the falling space of the equipment in contravention of the requirements of BS EN 1176 Part 1 - Monitor - No remedial work recommended

A number of fixing(s) have worked loose - Secure all loose fixings

There is some notable evidence of chain wear - Monitor for any further deterioration and replace when 40% worn

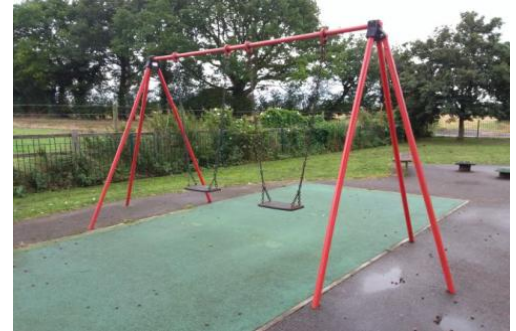
There are gaps opening between the surfacing and the edging surround or between the joints in the surfacing - Monitor for any further deterioration and repair as required

The chain openings are in excess of the 8.6mm as recommended by BS EN 1176 - Monitor - No remedial work recommended

There is some notable evidence of wear to the seat connectors - Monitor for any further deterioration and replace when 40% worn

The bushes are showing signs of wear - Monitor for any further deterioration and replace as required

The surface is lifting at the edges and creating trip points - Repair perimeter of surfacing to remove trip points

There is some notable evidence of chain wear - Monitor for any further deterioration and replace when 40% worn

There is some wear to the shackles. - Monitor for any further deterioration and replace when 40% worn

The shackles are corroding - Consider replacing the corroding shackles

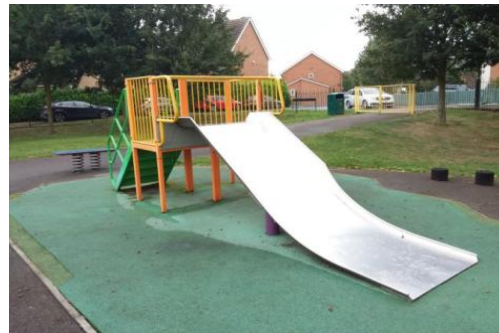
There are gaps opening between the surfacing and the edging surround or between the joints in the surfacing - Monitor for any further deterioration and repair as required

There are a number of dents in the slide surface - Monitor for any further deterioration and repair as required

The surface is lifting at the edges and creating trip points - Repair perimeter of surfacing to remove trip points

There is a split in the slide surface - Repair slide

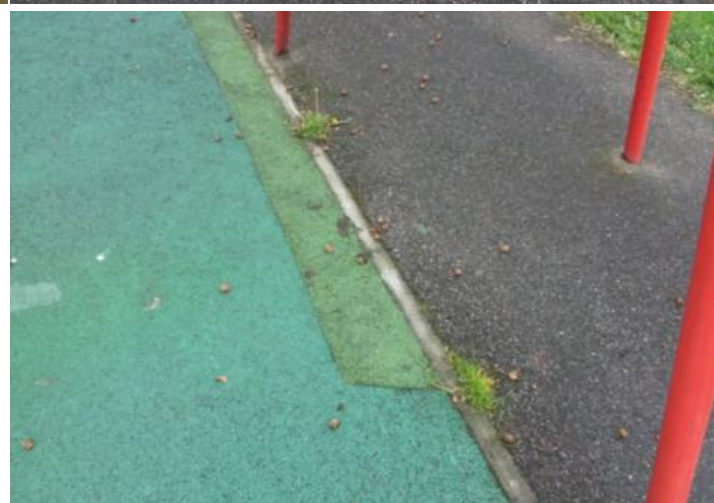
Finding: There are weeds/vegetation growth between or around the edges of the surfacing

Action: Remove weeds/vegetation growth

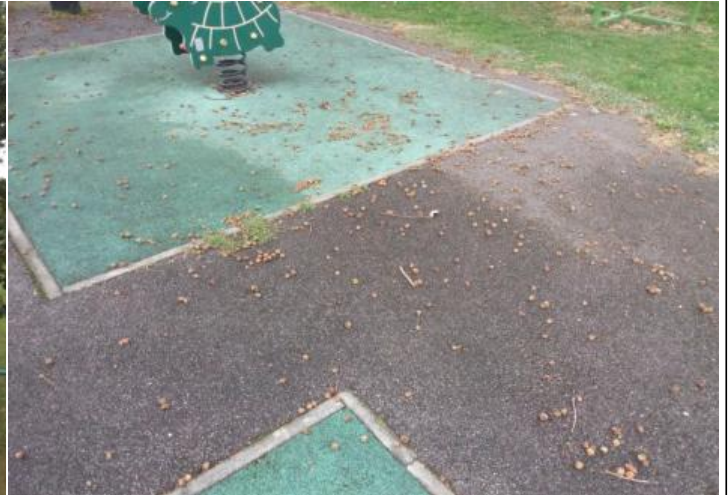
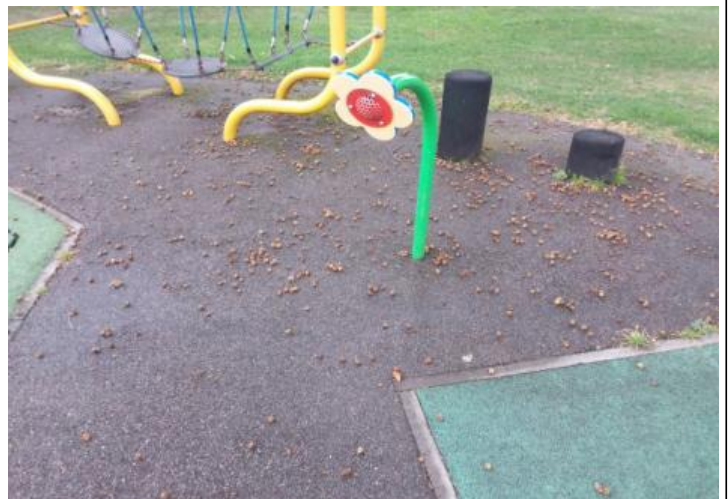
Finding: There is some tree debris on the surfacing

Action: Remove and maintain

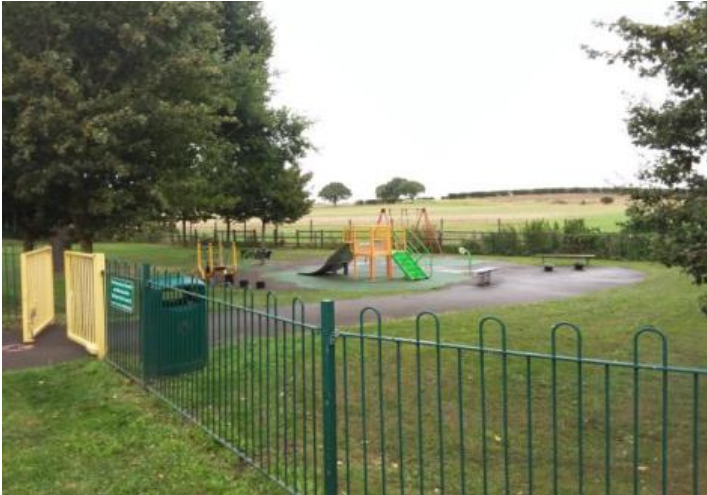
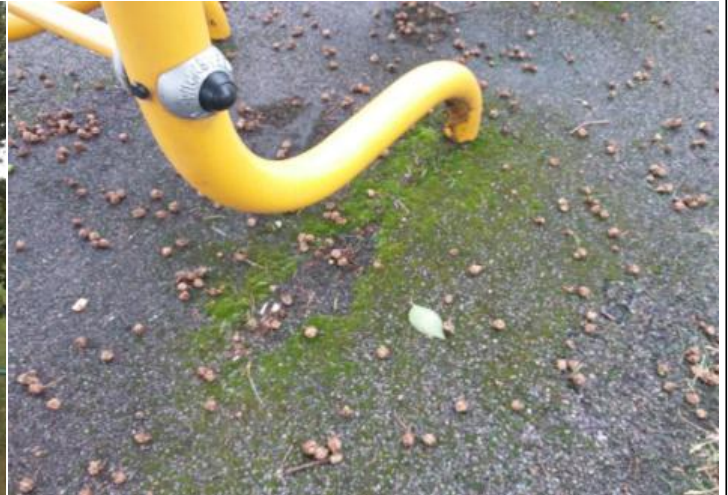
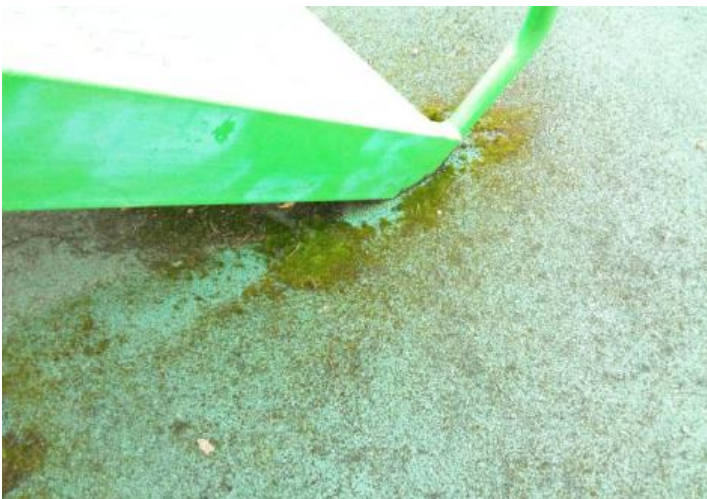
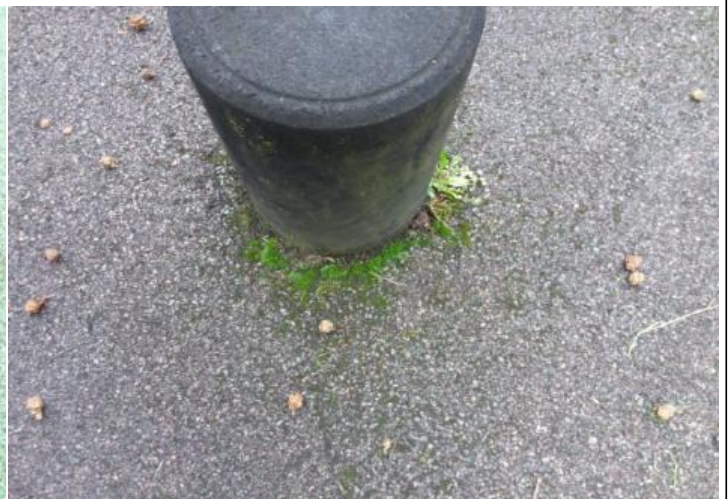
Finding: There is algae or moss growth on the surface resulting in slippery conditions

Action: Clean and treat appropriately

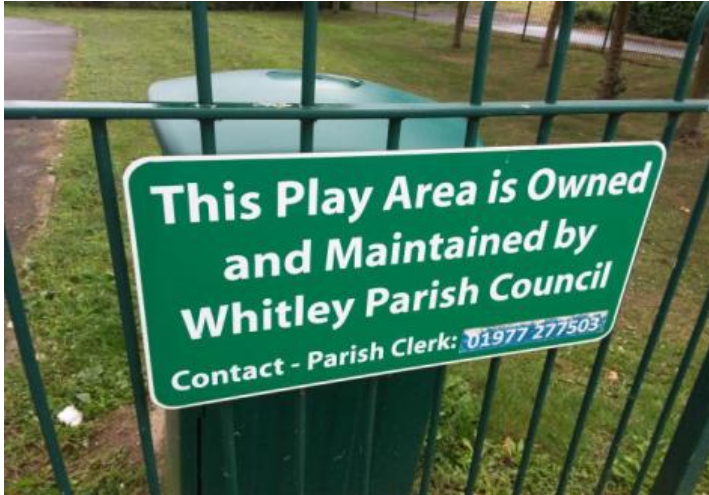
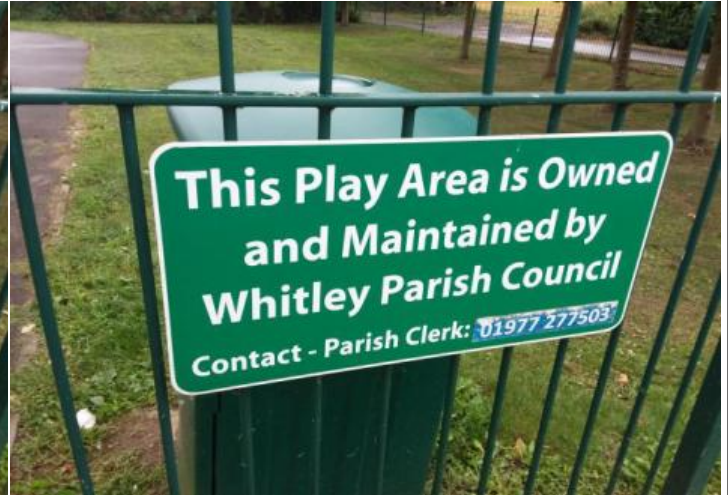
Finding: It is recommended that information signs with emergency contact details are installed at each entrance/exit set out in BS EN 1176 point to the playground

Action: Provide in accordance with the recommendations

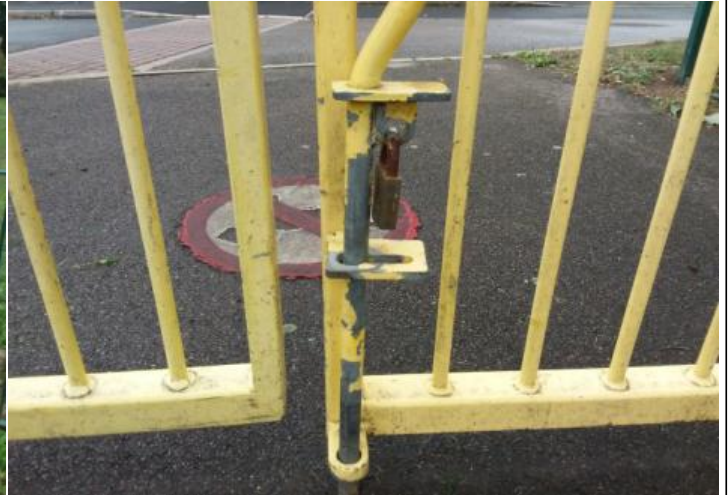
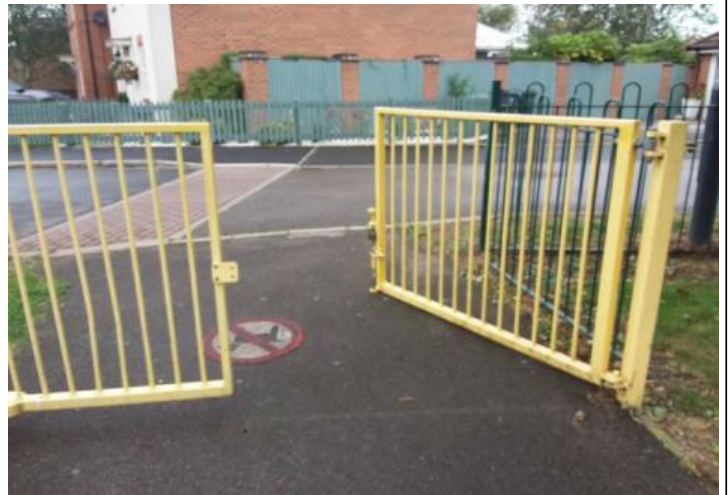
Finding: The padlock on the maintenance gate is not securing it from being opened

Action: Secure the gate

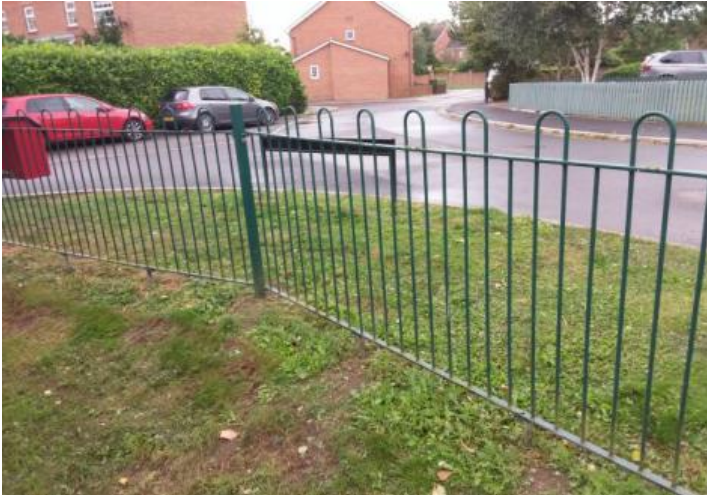
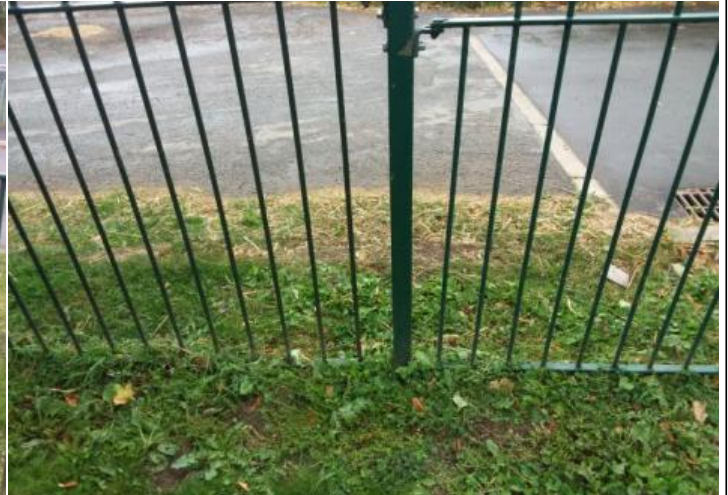
Finding: There are a number of loose posts around the fence

Action: Monitor for any further deterioration and reset as required

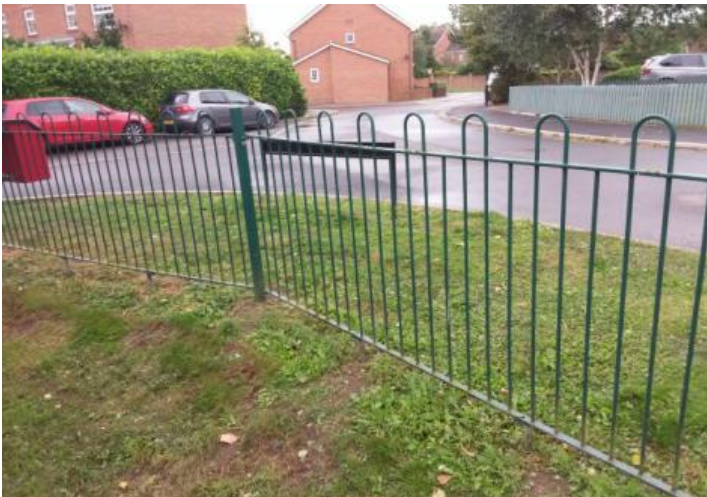
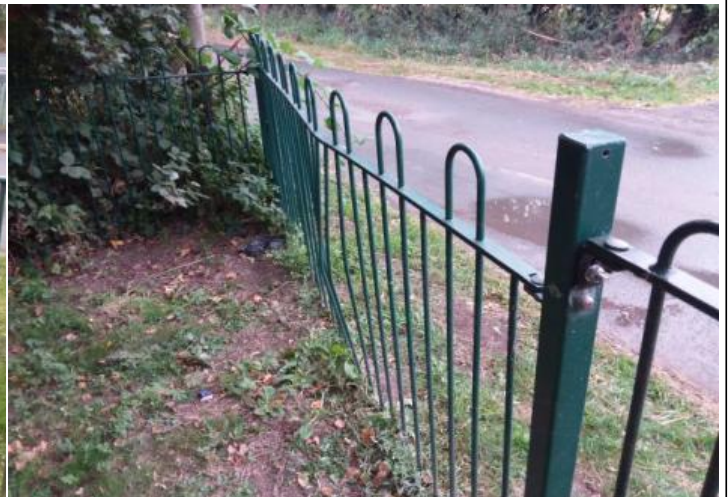
Finding: There is some damage to the fence sections

Action: Monitor for any further deterioration and repair as required

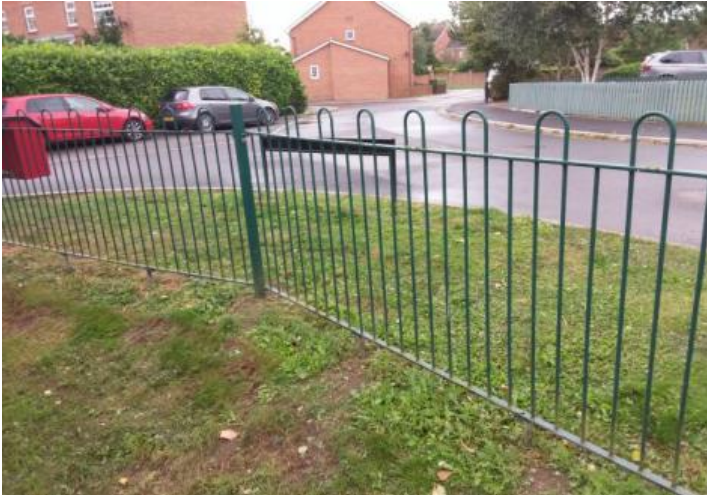
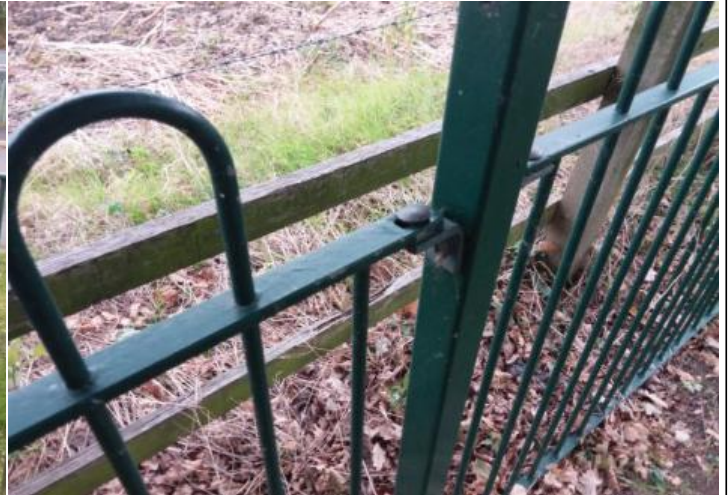
Finding: A number of fixings have worked loose around the fencing
Action: Secure all loose fixings

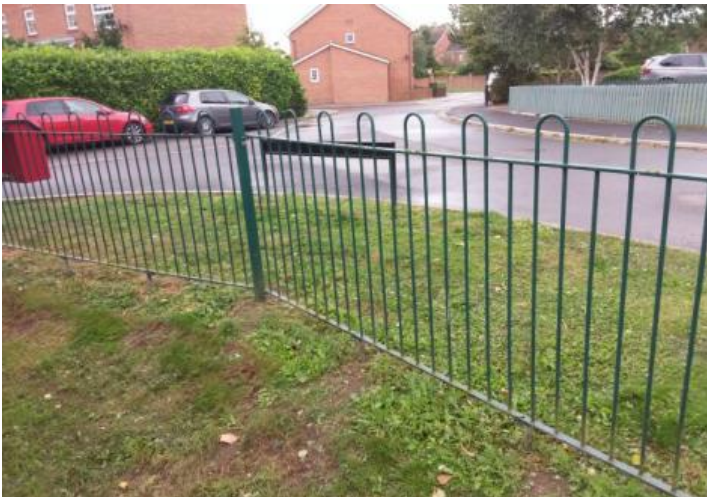
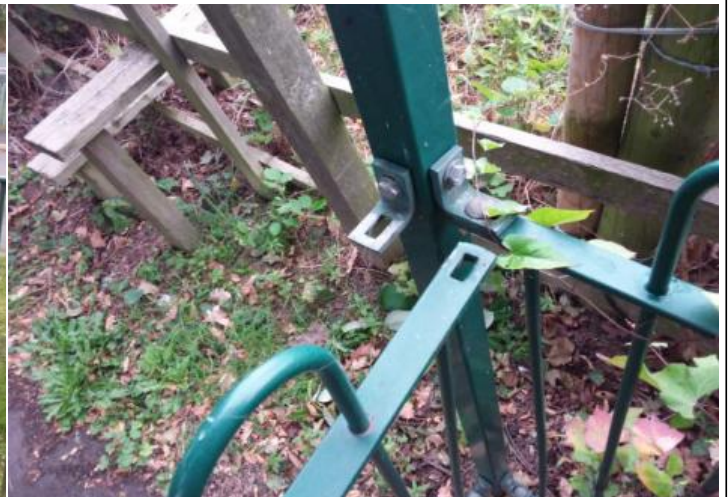
Finding: There are a number of fixings missing from the fence
Action: Replace missing fixings

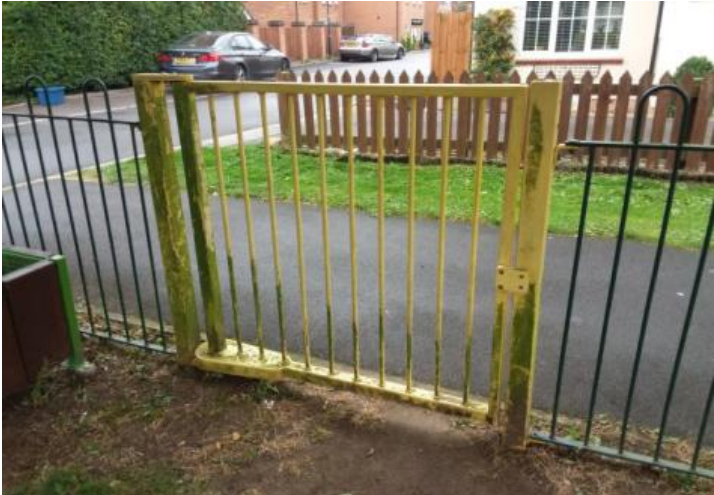
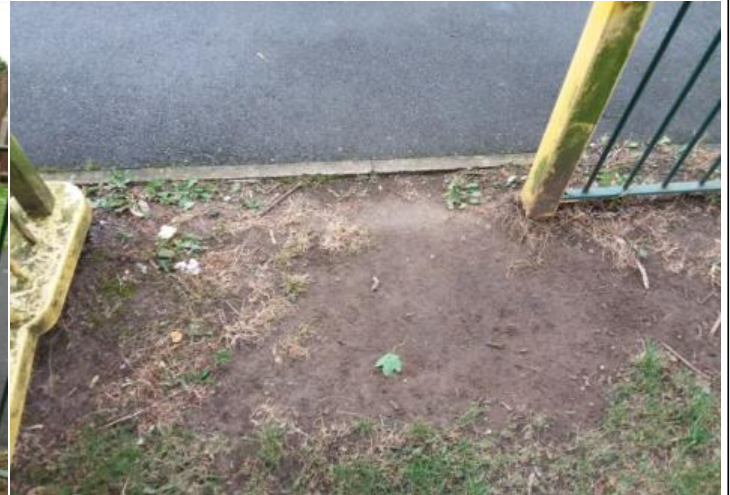
Finding: The area under the gate has eroded leaving uneven areas, or the concrete foundations exposed, resulting in trip hazards at the entrance/exit to the playground

Action: Reinststate to level with surrounding surfaces

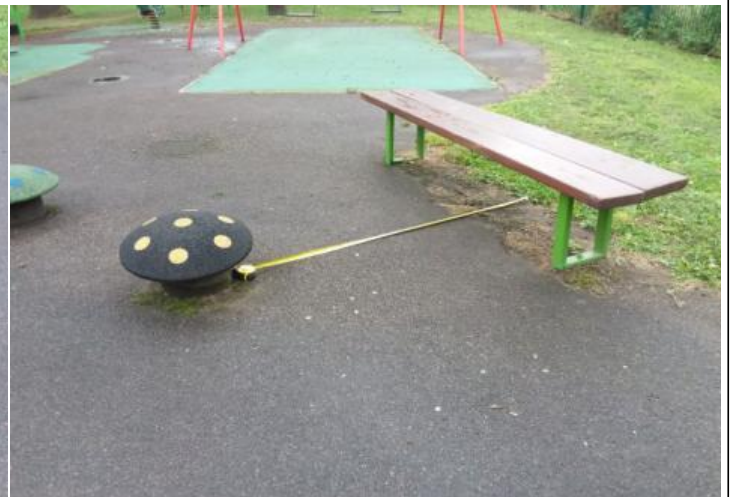
Finding: The bench forms a hard object within the falling space of the equipment in contravention of the requirements of BS EN 1176 Part 1

Action: Monitor - No remedial work recommended

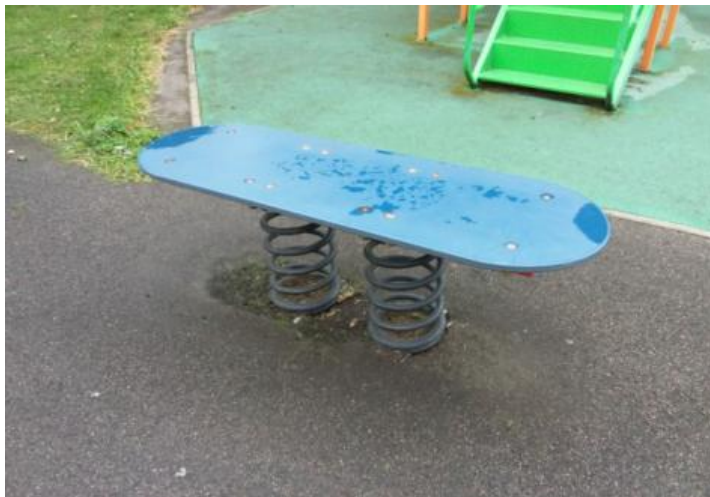
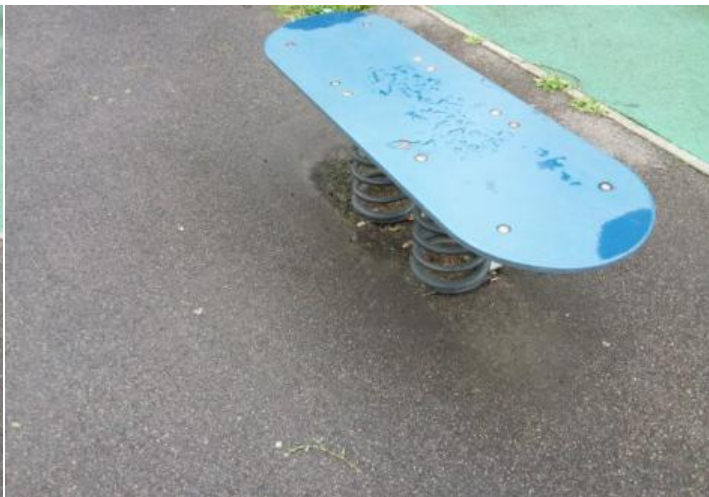
Finding: An impact absorbing surface is recommended for this item of equipment

Action: Provide an appropriate impact absorbing surface

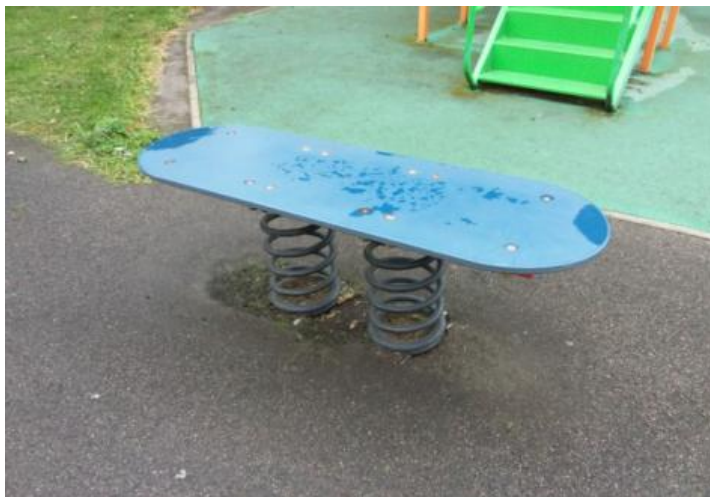
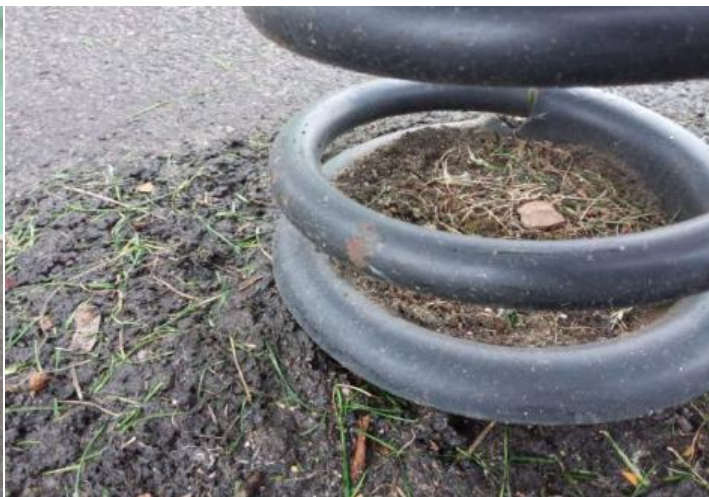
Finding: The paintwork on the spring has been damaged or worn exposing the metal underneath which is rusting

Action: Treat any rusting components and repaint

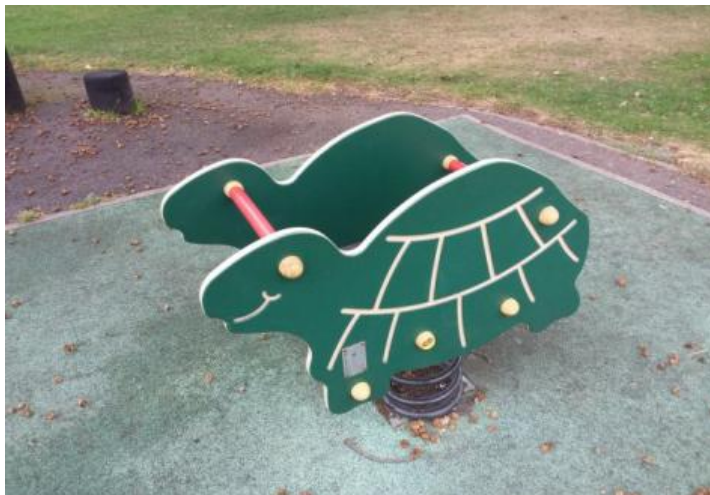
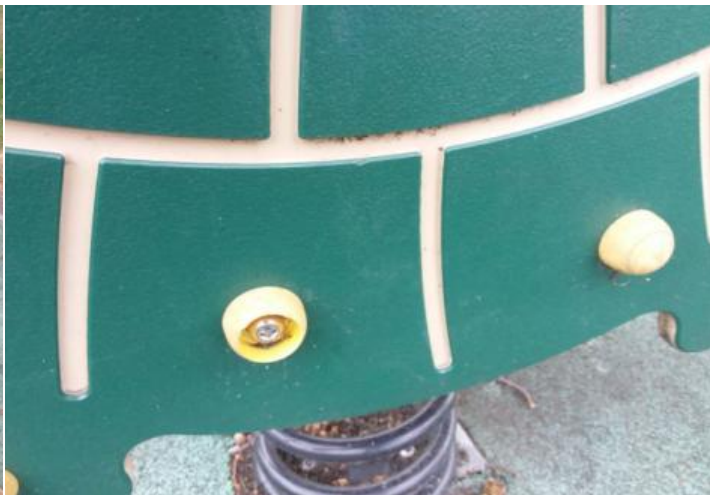
Finding: There is/are bolt cap covers missing or damaged on the item

Action: Replace missing or damaged bolt cap covers

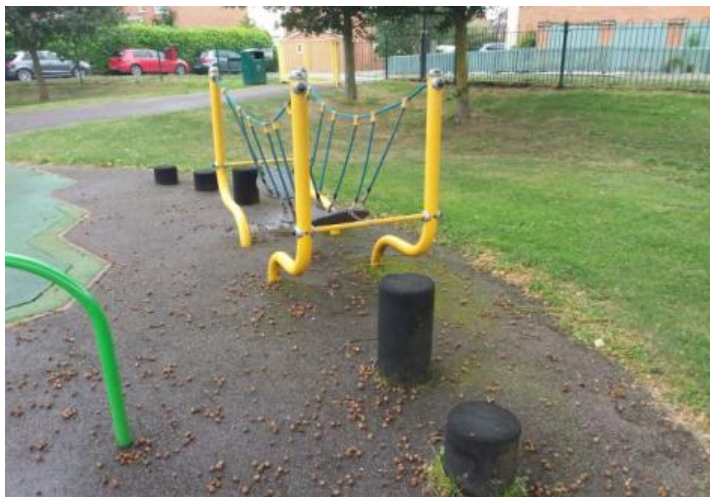
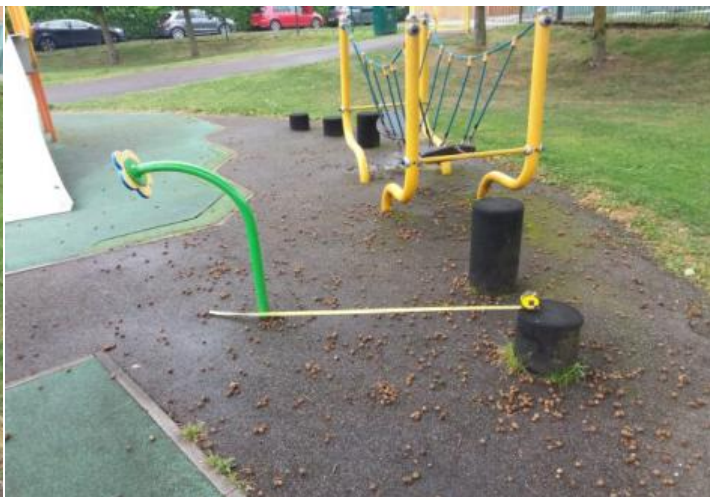
Finding: The talk tube forms a hard object within the falling space of the equipment in contravention of the requirements of BS EN 1176 Part 1

Action: Monitor - No remedial work recommended

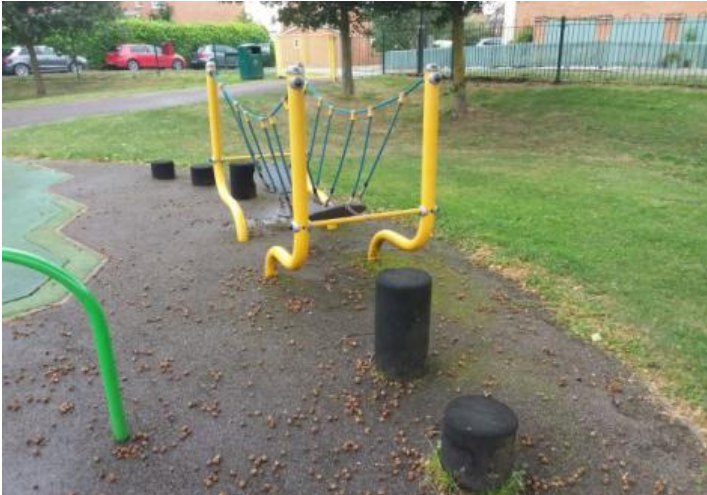
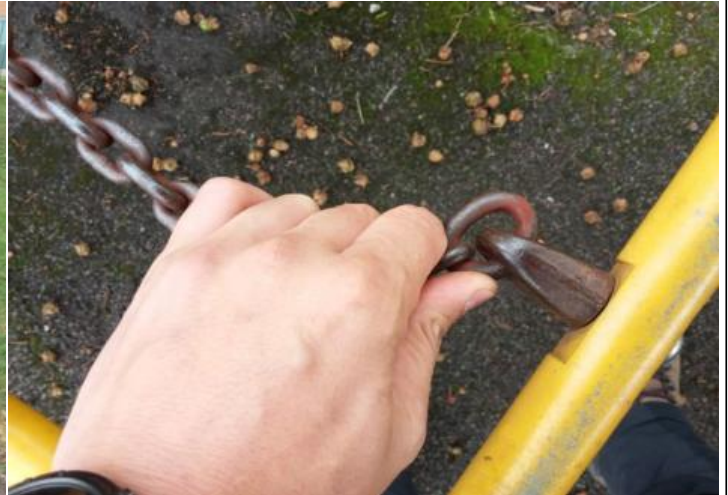
Finding: There is some notable evidence of chain wear

Action: Monitor for any further deterioration and replace when 40% worn

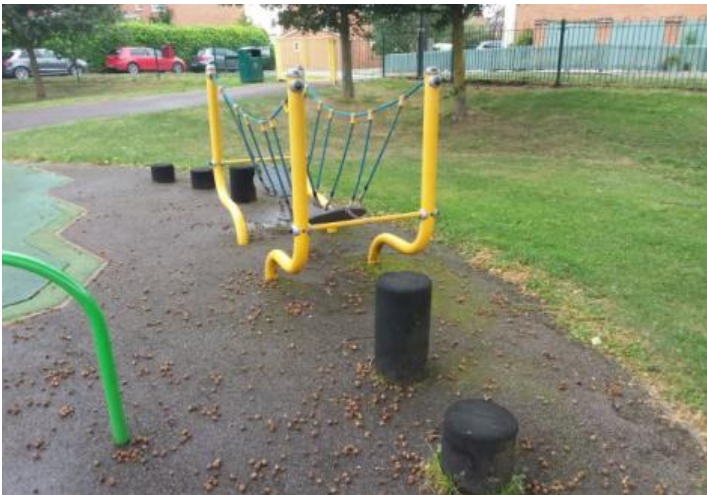
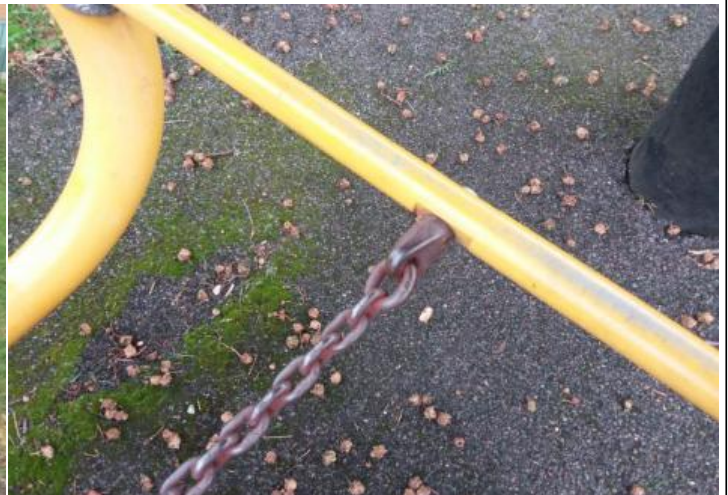
Finding: A number of fixing(s) have worked loose

Action: Secure all loose fixings

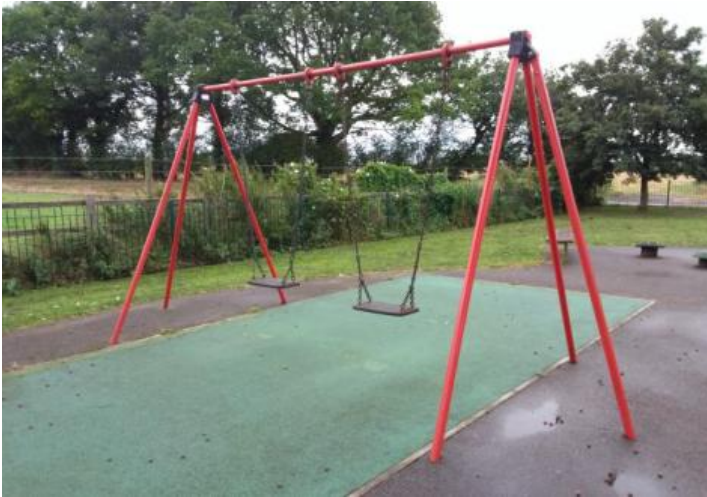
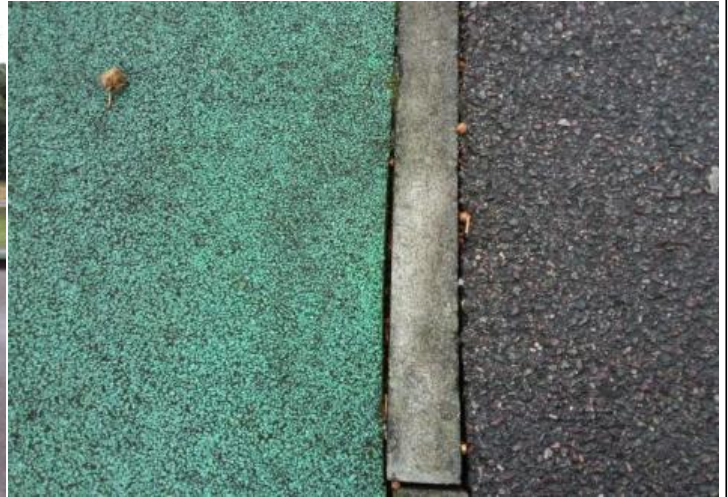
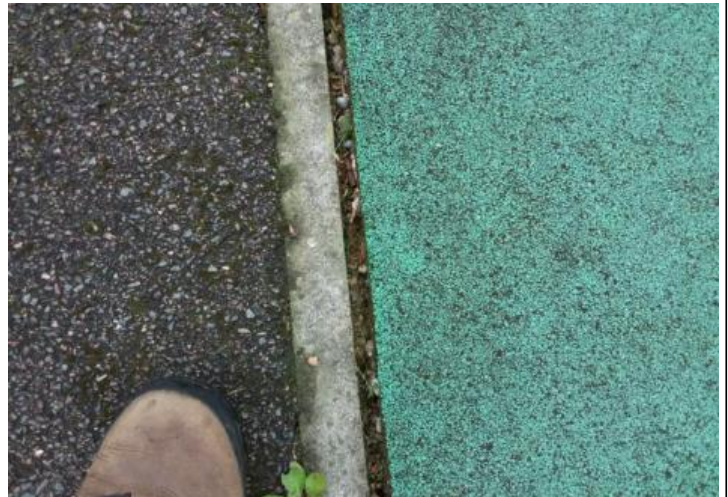
Finding: There are gaps opening between the surfacing and the edging surround or between the joints in the surfacing
Action: Monitor for any further deterioration and repair as required

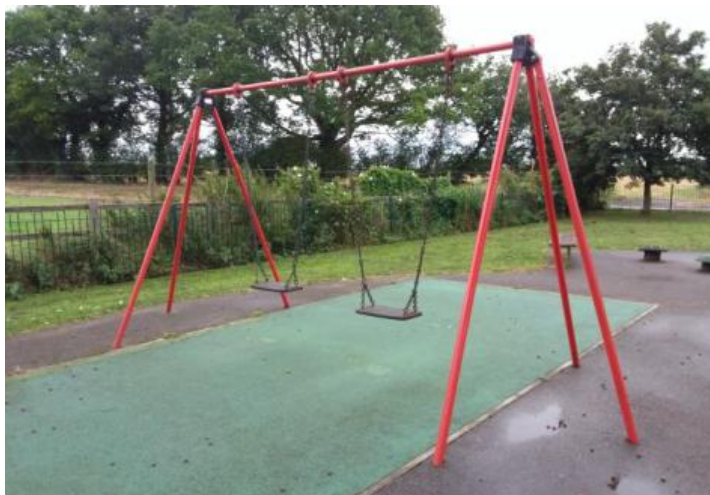
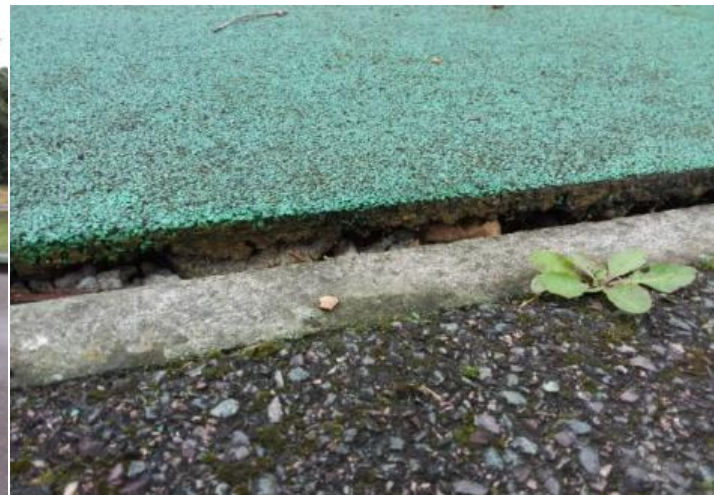
Finding: The surface is lifting at the edges and creating trip points
Action: Repair perimeter of surfacing to remove trip points

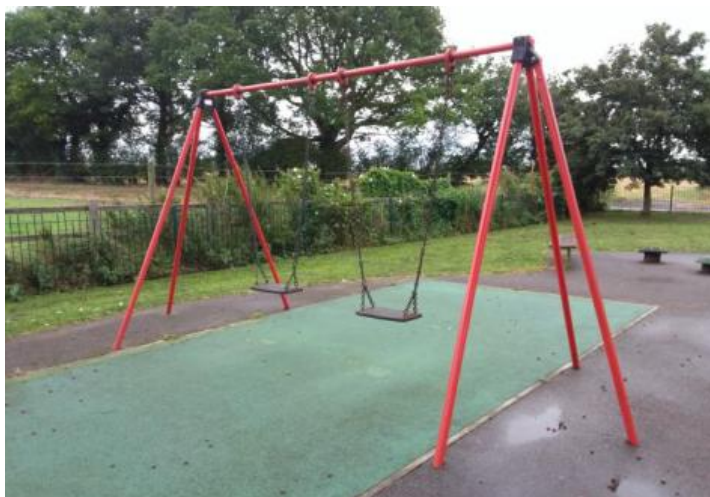
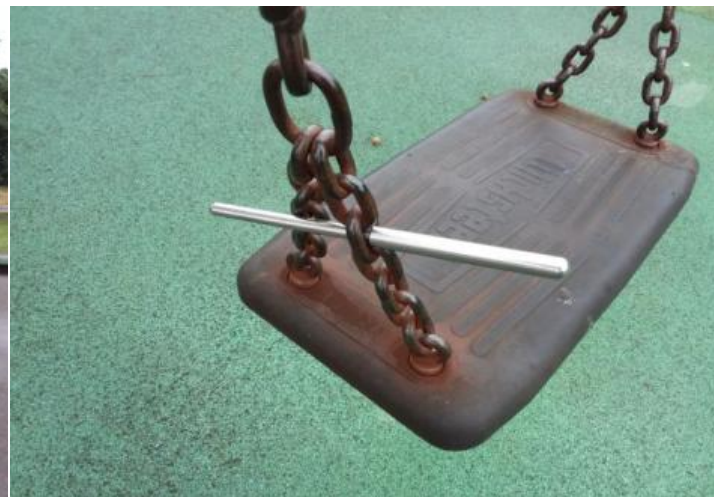
Finding: The chain openings are in excess of the 8.6mm as recommended by BS EN 1176
Action: Monitor - No remedial work recommended

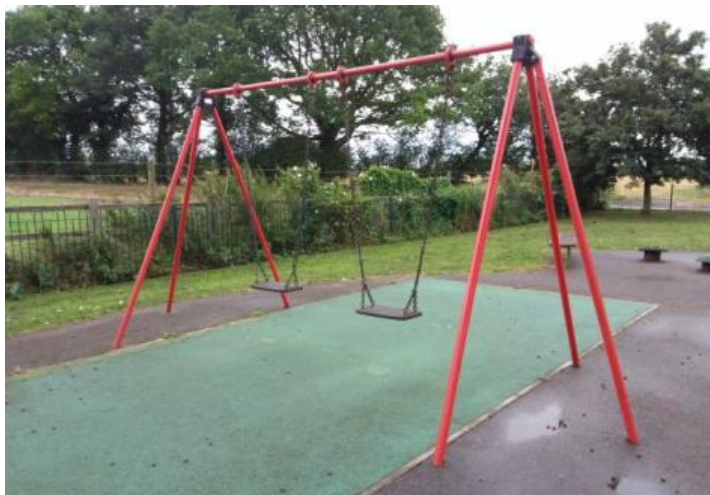
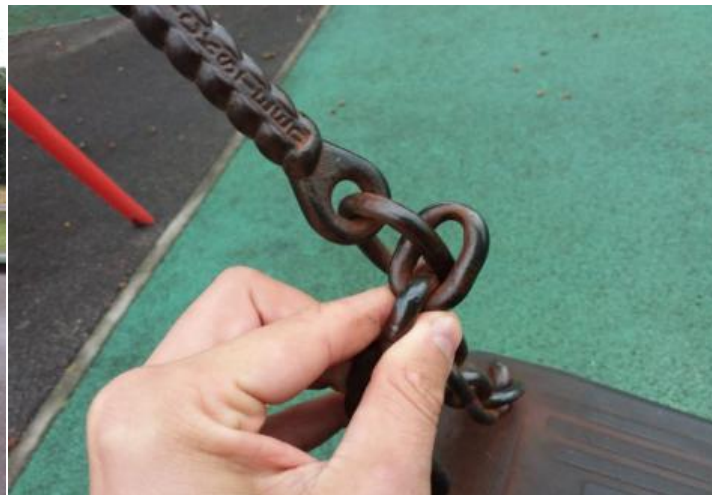
Finding: There is some notable evidence of chain wear

Action: Monitor for any further deterioration and replace when 40% worn

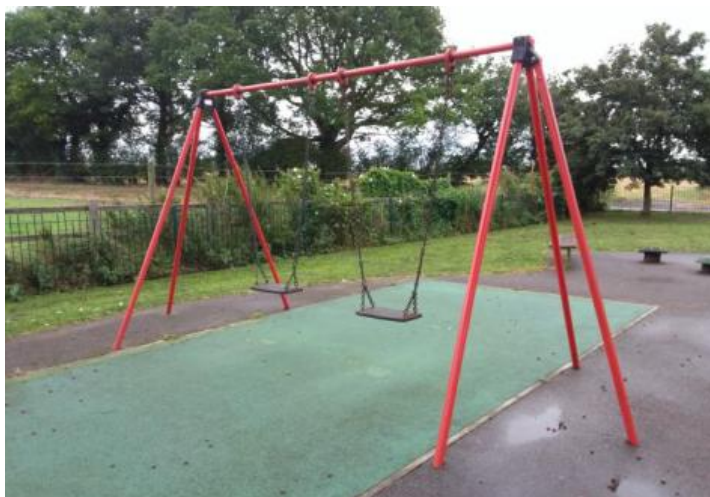
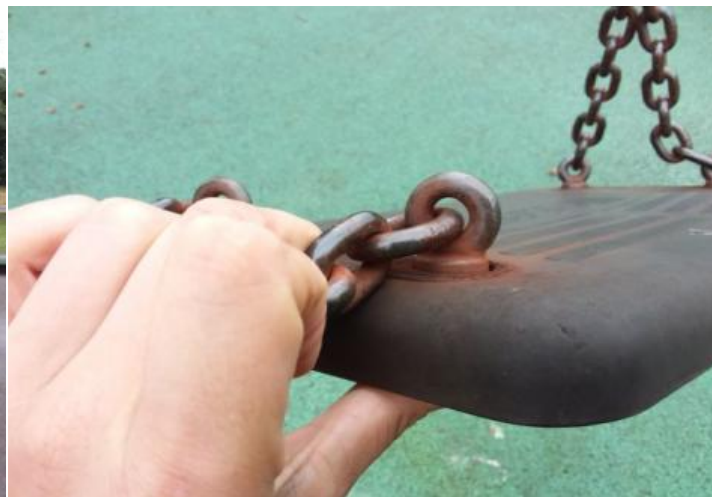
Finding: There is some notable evidence of wear to the seat connectors

Action: Monitor for any further deterioration and replace when 40% worn

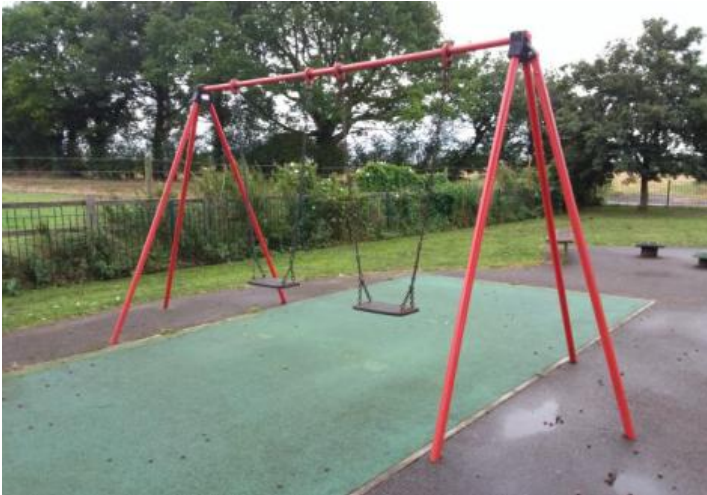
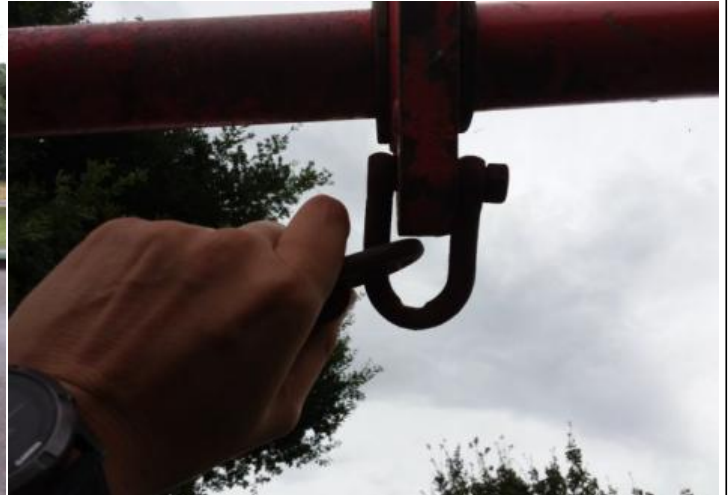
Finding: There is some wear to the shackles.

Action: Monitor for any further deterioration and replace when 40% worn

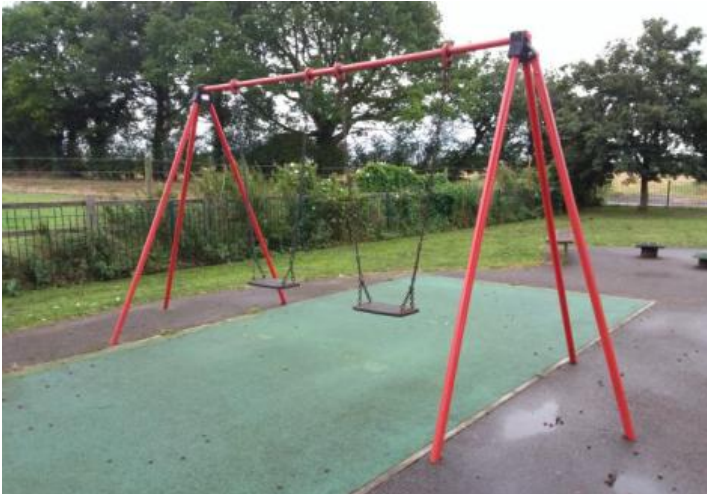
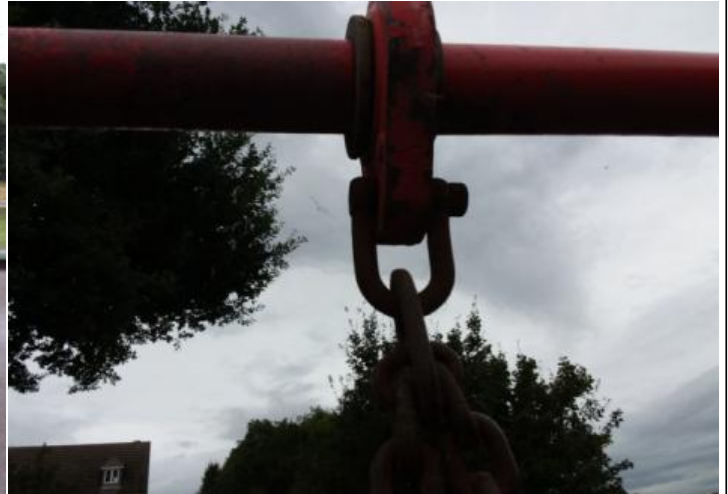
Finding: The bushes are showing signs of wear

Action: Monitor for any further deterioration and replace as required

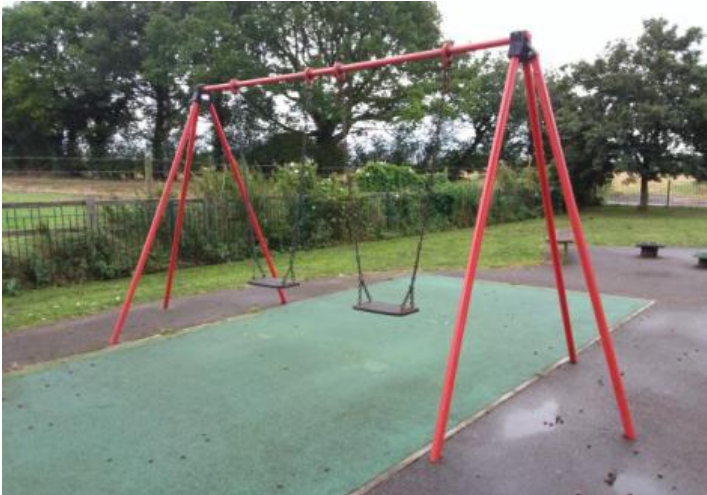
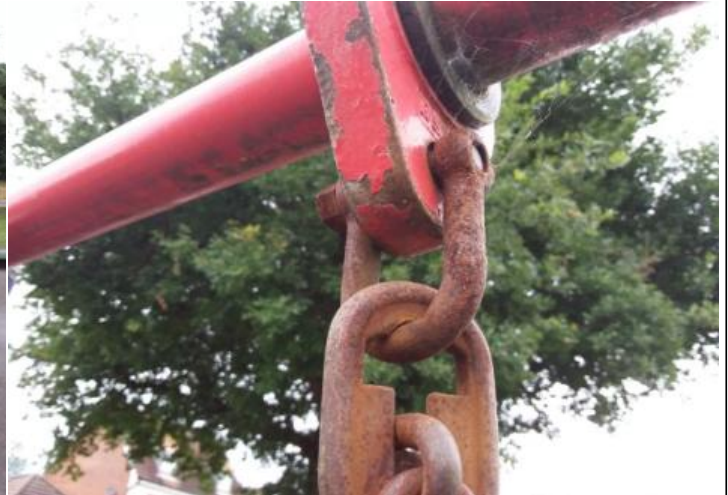
Finding: The shackles are corroding

Action: Consider replacing the corroding shackles

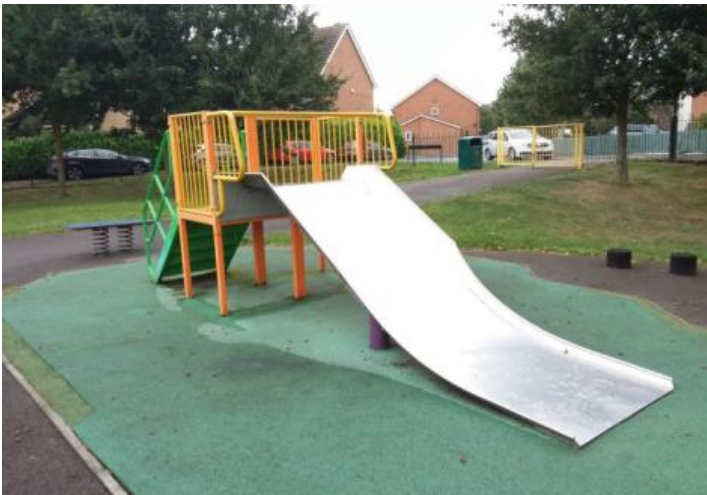
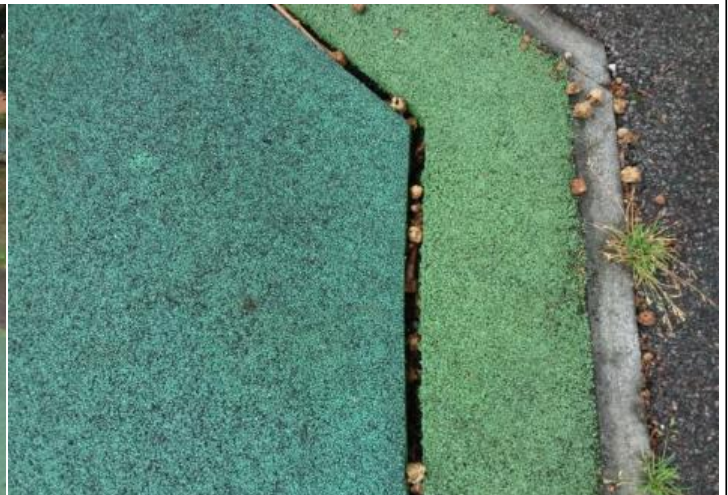
Finding: There are gaps opening between the surfacing and the edging surround or between the joints in the surfacing

Action: Monitor for any further deterioration and repair as required

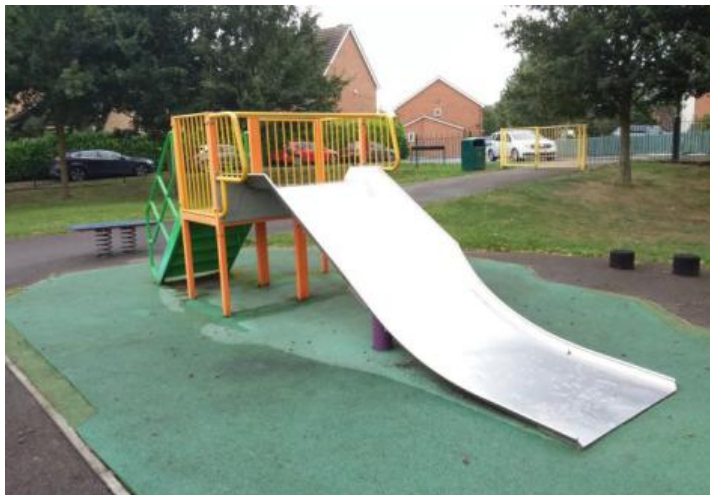
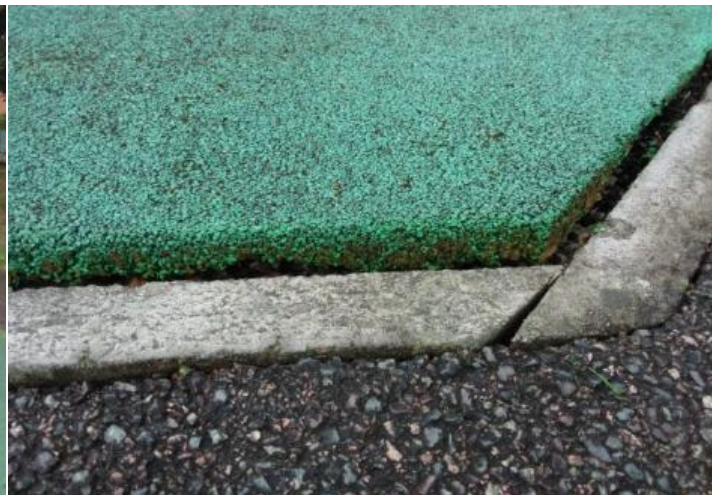
Finding: The surface is lifting at the edges and creating trip points
Action: Repair perimeter of surfacing to remove trip points
