the **play inspection** company

Annual Inspection

Whitley Parish Council

Inspected: 6-September-2019 - 09:24 by Ross Pringle RPII Annual Inspector

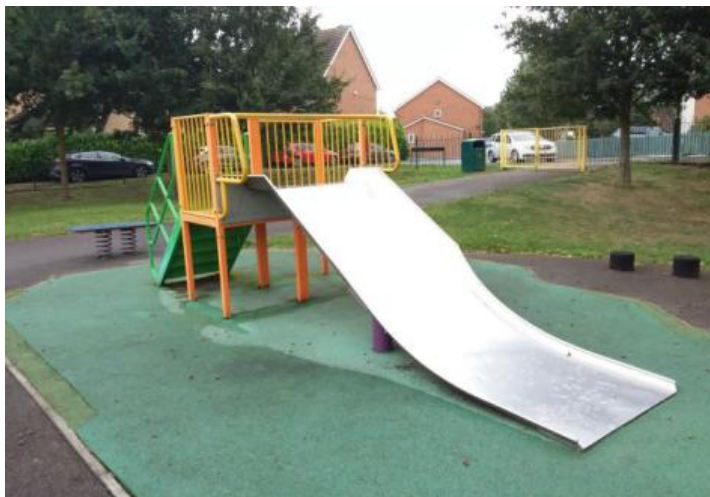
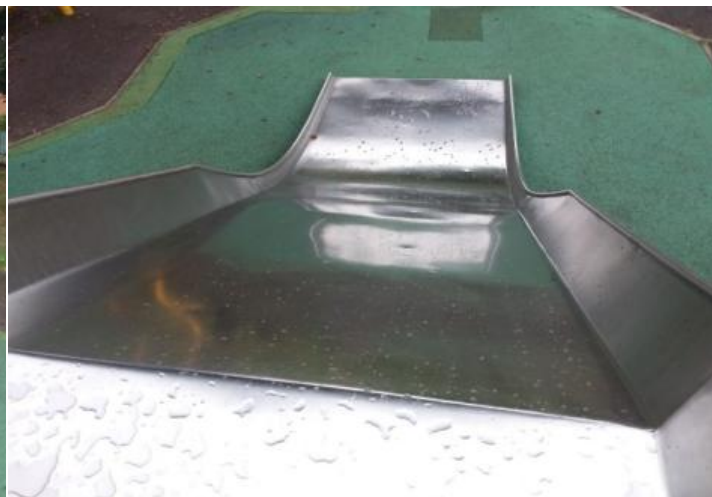
Finding: There are a number of dents in the slide surface
Action: Monitor for any further deterioration and repair as required

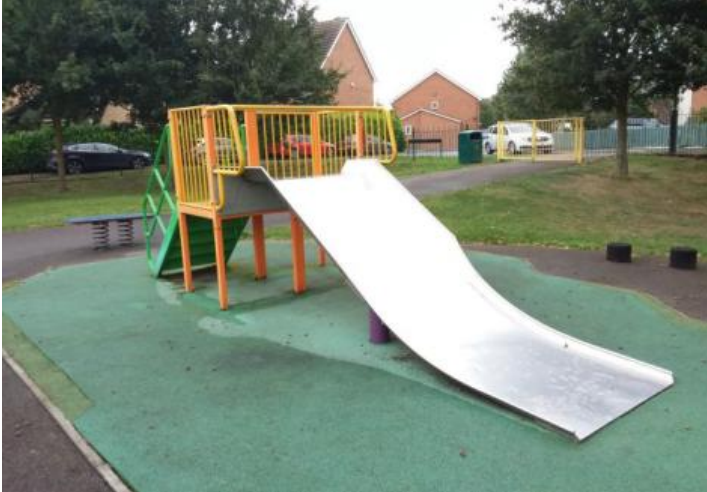
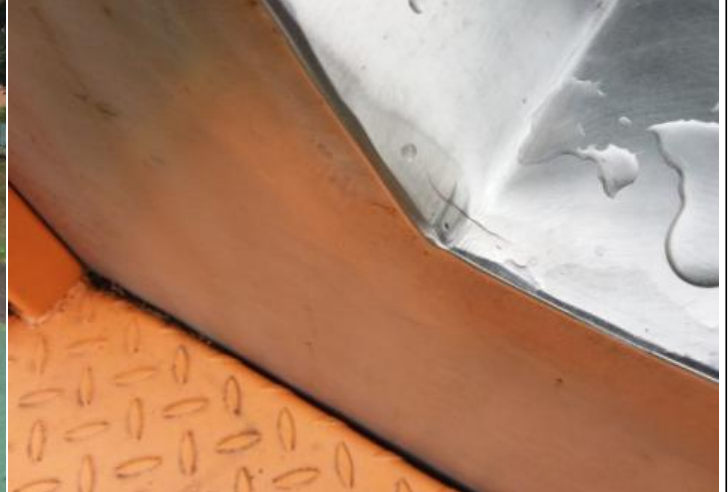
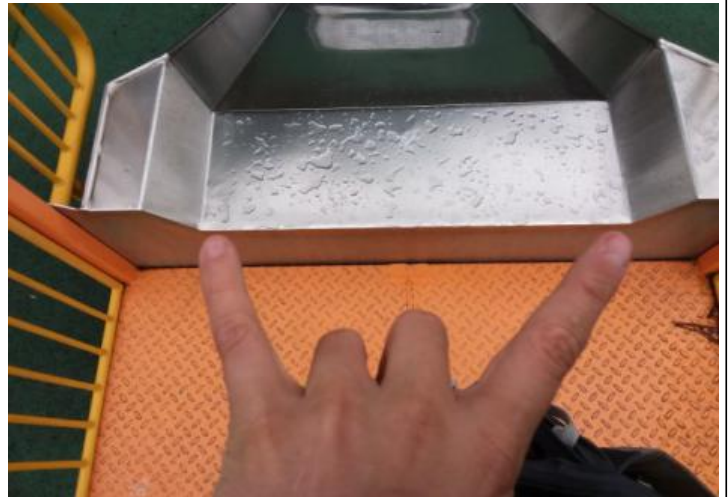
Finding: There is a split in the slide surface

Action: Repair slide
