Annual Inspection

Whitley Parish Council

Daffodil Field

Whitley Farm Close , DN14 0GL

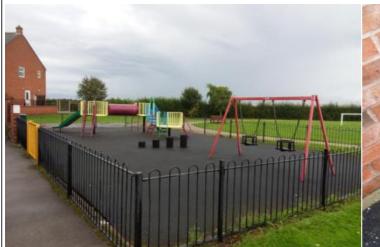
8 - Low Risk (Finding 2)

Finding: There is algae or moss growth on the surface resulting in slippery conditions

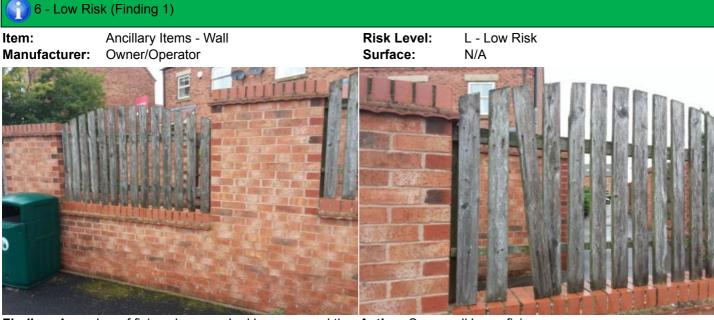
Finding: A number of fixings have worked loose around the **Action:** Secure all loose fixings fencing

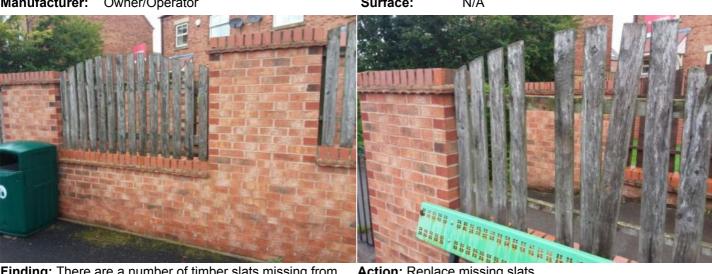
6 - Low Risk (Finding 3)

Finding: There are a number of timber slats missing from the fence

Action: Replace missing slats

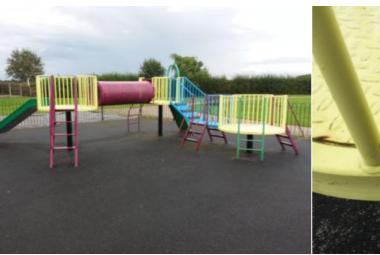
6 - Low Risk (Finding 1)

Finding: The paintwork on this item has been damaged or worn exposing the metal underneath which is rusting

Action: Treat any rusting components and repaint

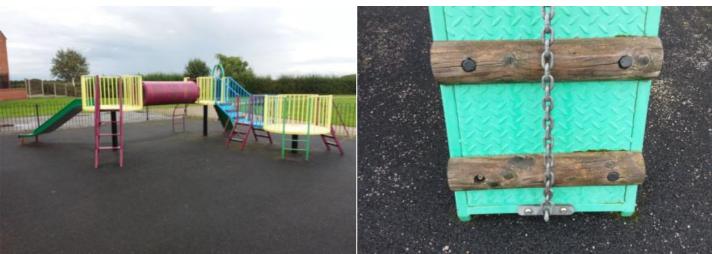
Finding: There is/are bolt cap covers missing or damaged on the item

Action: Replace missing or damaged bolt cap covers

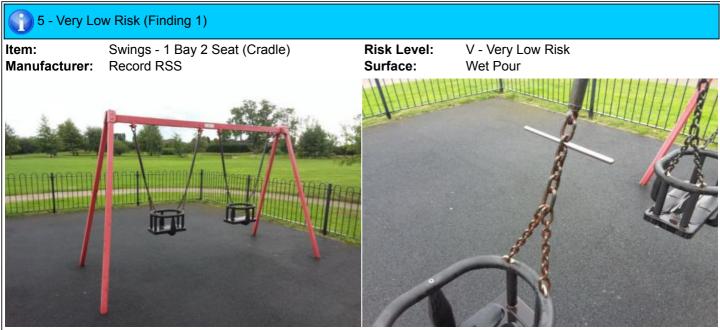
Finding: The chain openings are in excess of the 8.6mm as **Action:** Monitor - No remedial work recommended recommended by BS EN 1176

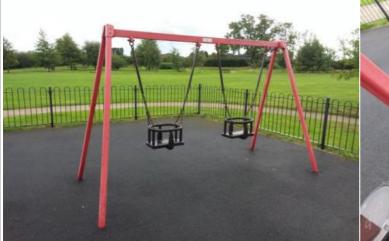
6 - Low Risk (Finding 2)

Finding: There is some notable evidence of chain wear

Action: Monitor for any further deterioration and replace when 40% worn

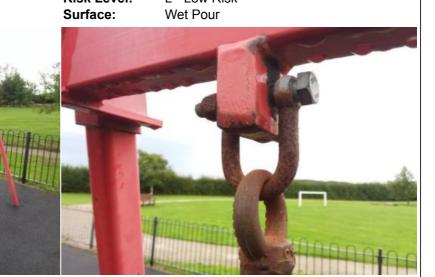
Finding: The shackles are corroding

Action: Consider replacing the corroding shackles

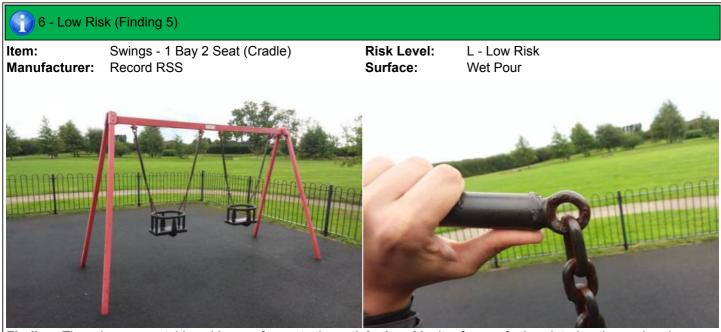
Finding: There is some notable evidence of wear to the anti Action: Monitor for any further deterioration and replace wrap bars when 40% worn

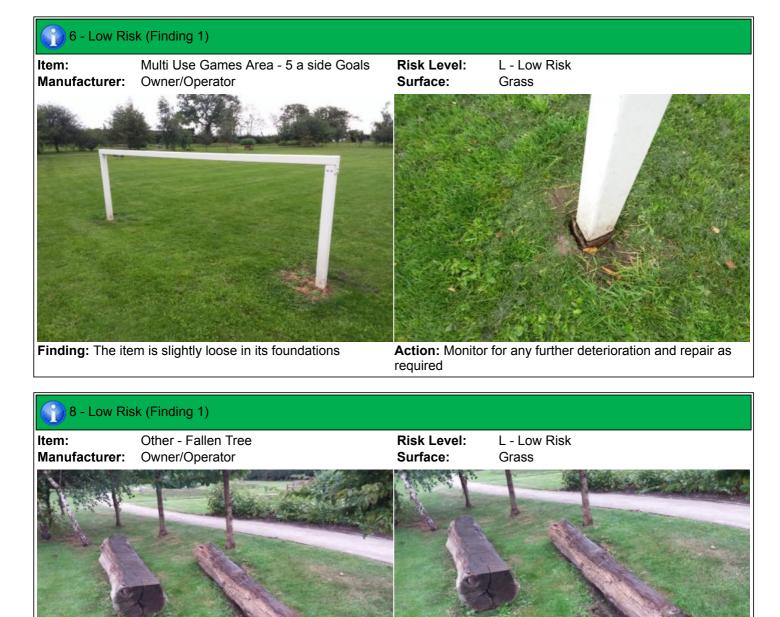
Finding: The item is not securely fixed to the surface and there is some possibility of the item rolling over

Action: Secure the item to the ground

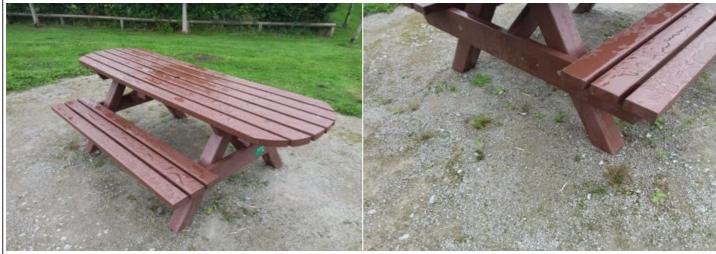
6 - Low Risk (Finding 2)

Finding: There are weeds/vegetation growth around the surfacing

Action: Remove weeds/vegetation growth

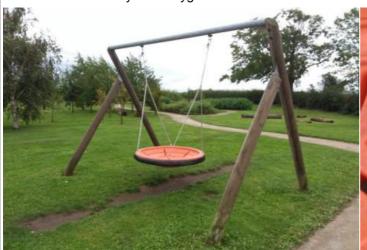
5 - Very Low Risk (Finding 3)

Finding: The connecting links are in excess of 8.6mm and less than 12mm and fail the requirements of BS EN 1176 Part 1; clause 4.2.13, Chains

Action: Monitor use and replace with compliant links at the next maintenance cycle

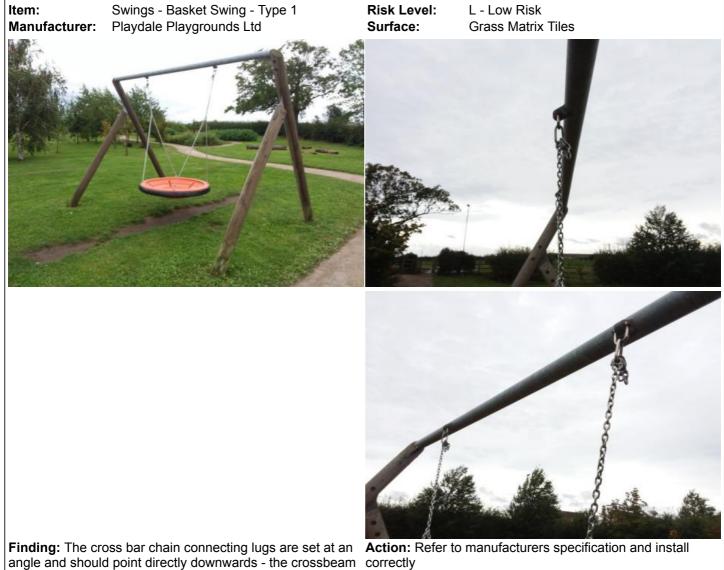
8 - Low Risk (Finding 6)

has been installed incorrectly

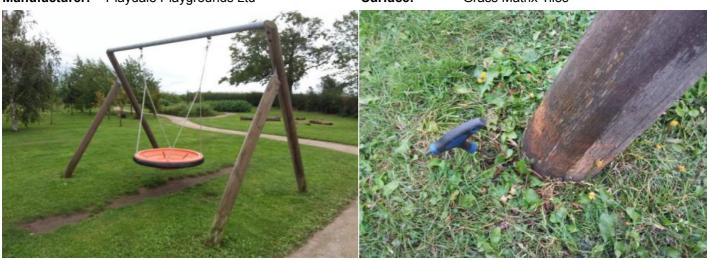
6 - Low Risk (Finding 7)

Finding: There is some evidence of rot in the timber

Action: Monitor for any further deterioration and replace as required
