Annual Inspection

Whitley Parish Council

Daffodil Field

Inspection Ref: 1703918 Site Ref: 79236 Customer Order: 1259819 / 418792

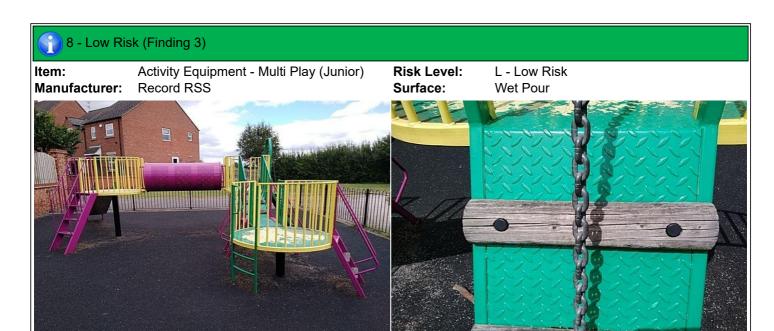
The timber has a number of splits/shakes or air cracks and this may affect the stability or allow water ingress which will accelerate the rotting process - Monitor and replace the slats as required

Finding: The timber has a number of splits/shakes or air cracks and this may affect the stability or allow water ingress which will accelerate the rotting process

Action: Monitor and replace the slats as required

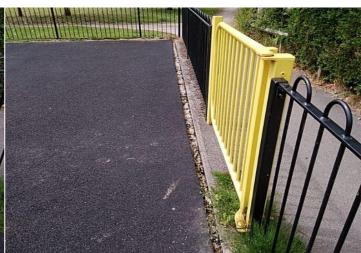
9 - Low Risk (Finding 1)

There are significant gaps (over 30mm) between the surface and the edging or between the joints in the surface; edges of the surfacing - Remove weeds/vegetation growth these are large enough for a small foot to enter - Repair surfacing

Finding: There are significant gaps (over 30mm) between the surface and the edging or between the joints in the surface; these are large enough for a small foot to enter

Action: Repair surfacing

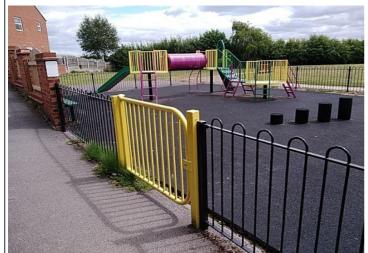
5 - Very Low Risk (Finding 1)

Finding: It is recommended that signage, with information including the site address, contact information for maintenance issues and emergency contact details are provided for the facility

Action: Provide in accordance with the recommendations

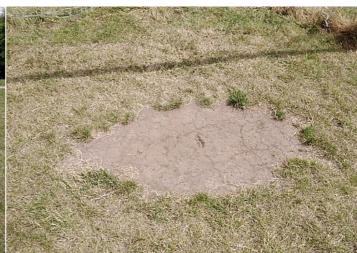
Item:Goal Posts (Soccer/Football) - PostsRisk Level:L - Low RiskManufacturer:UnknownSurface:Grass

Ground erosion - Grounds maintenance as required

Finding: Ground erosion Action: Grounds maintenance as required

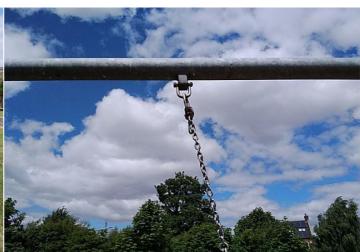
8 - Low Risk (Finding 1)

Swings of this design should have a secondary safety device fitted to prevent collapse of the seat in the event of a joint failure to meet the requirements of BS EN 1176 Part 2 - Consider providing a secondary safety device where possible

Finding: Swings of this design should have a secondary safety device fitted to prevent collapse of the seat in the event of a joint failure to meet the requirements of BS EN 1176 Part 2

Action: Consider providing a secondary safety device where possible
