Annual Inspection

Whitley Parish Council

Daffodil Field

Inspection Ref: 2236754

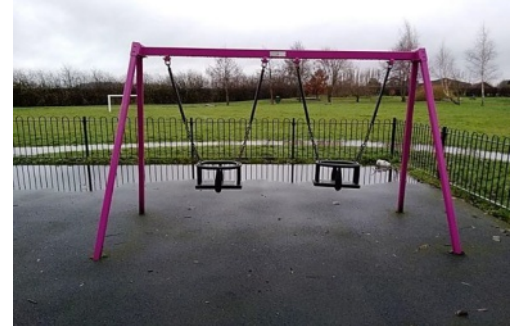
Item: 1 Bay 2 Seat (Cradle)
Manufacturer: Record RSS
Surface Type: Wet Pour
Item Part Number: RP162 2006
Item Quantity: 1
Equipment Compliance: Yes
Surface Area Compliance: Yes
Total Findings: 1

This item is satisfactory - no work required -

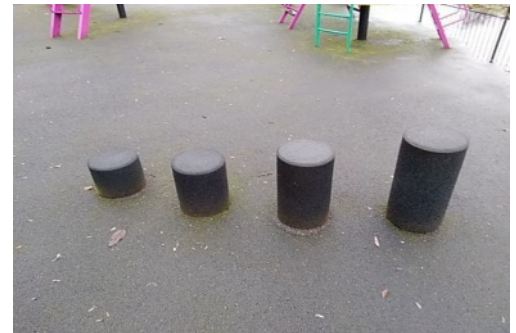
Item: Toadstools
Manufacturer: Unknown
Surface Type: Wet Pour
Item Quantity: 4
Equipment Compliance: N/A
Surface Area Compliance: N/A

This item is satisfactory - no work required -

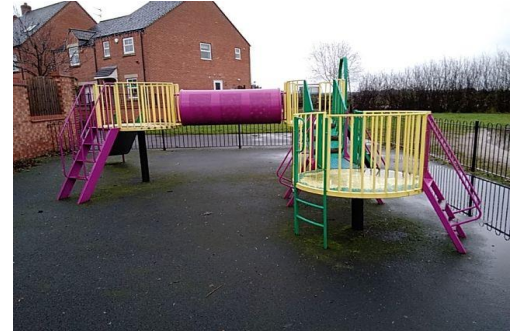
Item: Multi Play (Junior)
Manufacturer: Record RSS
Surface Type: Wet Pour
Item Part Number: RP693 2006
Item Quantity: 1
Equipment Compliance: Yes
Surface Area Compliance: Yes
Total Findings: 4

Step treads loose - Tighten the fixings - security bit required

The paint is flaking off the metalwork - Rub down and re-paint

The timber has a number of splits/shakes or air cracks and this may affect the stability or allow water ingress which will accelerate the rotting process - Monitor and replace the slats as required

There is/are bolt cap covers missing or damaged on the item - Replace missing or damaged bolt cap covers

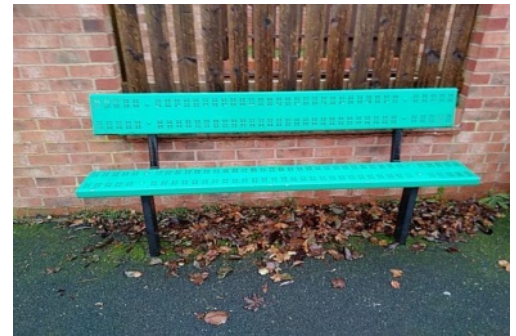
Item: Seat
Manufacturer: Record RSS
Surface Type: Wet Pour
Item Quantity: 1
Equipment Compliance: N/A
Surface Area Compliance: N/A
Total Findings: 1

This item is satisfactory - no work required -

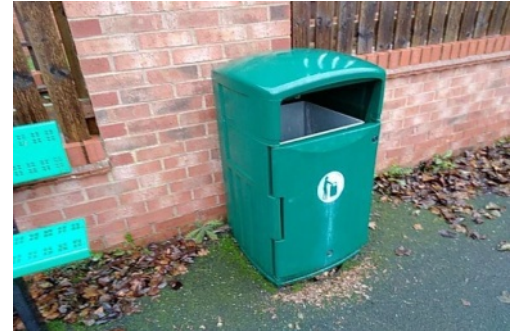
Item: Litter Bin
Manufacturer: Glasdon
Surface Type: Wet Pour
Item Quantity: 1
Equipment Compliance: N/A
Surface Area Compliance: N/A

This item is satisfactory - no work required -

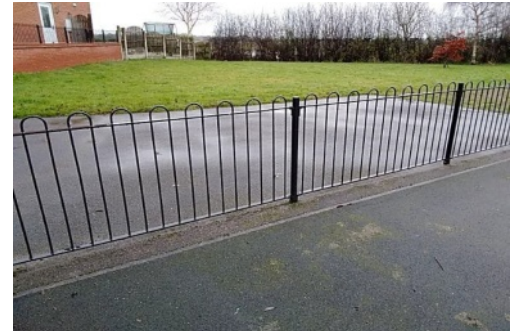
Item: Fence - Bow Top
Manufacturer: Unknown
Surface Type: Tarmac
Item Quantity: 1
Equipment Compliance: N/A
Surface Area Compliance: N/A

This item is satisfactory - no work required -

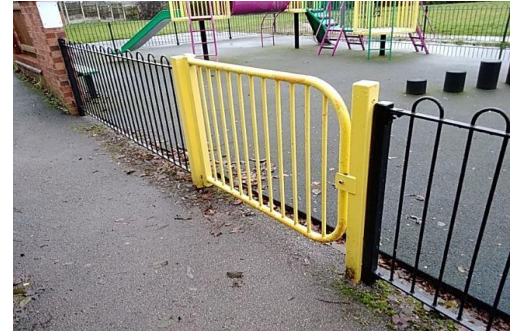
Item: Gate - Self Closing
Manufacturer: Unknown
Surface Type: Tarmac
Item Quantity: 1
Equipment Compliance: N/A
Surface Area Compliance: N/A

There are significant gaps (over 30mm) between the surface and the edging or between the joints in the surface; these are large enough for a small foot to enter - Repair surfacing

There are weeds/vegetation growth between or around the edges of the surfacing - Remove weeds/vegetation growth

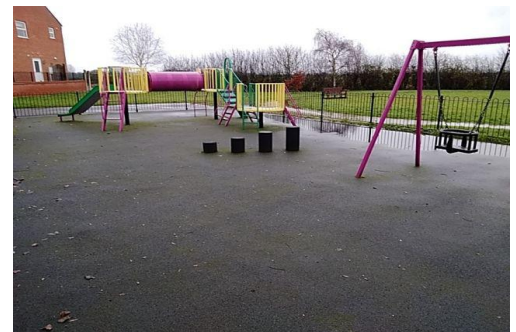
Item: Site General
Manufacturer: Unknown
Surface Type: Wet Pour
Item Quantity: 1
Equipment Compliance: N/A
Surface Area Compliance: N/A

It is recommended that signage, with information including the site address, contact information for maintenance issues and emergency contact details are provided for the facility - Provide in accordance with the recommendations

Parts of the playing surface were waterlogged at the time of the inspection - Monitor

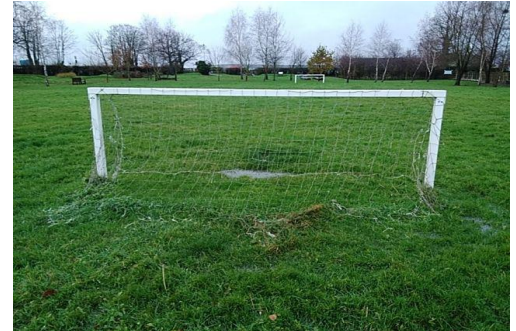
Item: Posts
Manufacturer: Unknown
Surface Type: Grass
Item Quantity: 2
Equipment Compliance: N/A
Surface Area Compliance: N/A

Ground erosion / waterlogged - Grounds maintenance as required

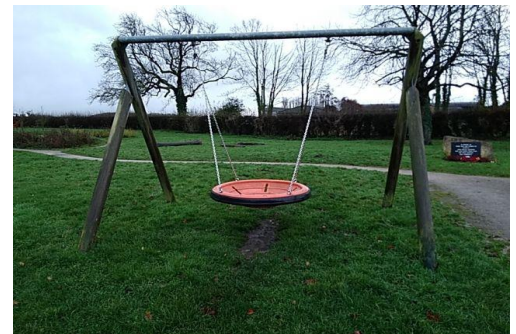
Item: Basket Swing - Type 1
Manufacturer: Playdale Playgrounds Ltd
Surface Type: Grass Matrix Tiles
Item Quantity: 1
Equipment Compliance: No
Surface Area Compliance: Yes

Swings of this design should have a secondary safety device fitted to prevent collapse of the seat in the event of a joint failure to meet the requirements of BS EN 1176 Part 2 - Consider providing a secondary safety device where possible

The timber has a number of splits/shakes or air cracks and this may affect the stability or allow water ingress which will accelerate the rotting process - Monitor to ensure the splits do not cross through fixing points of the structure and/or cause any instability

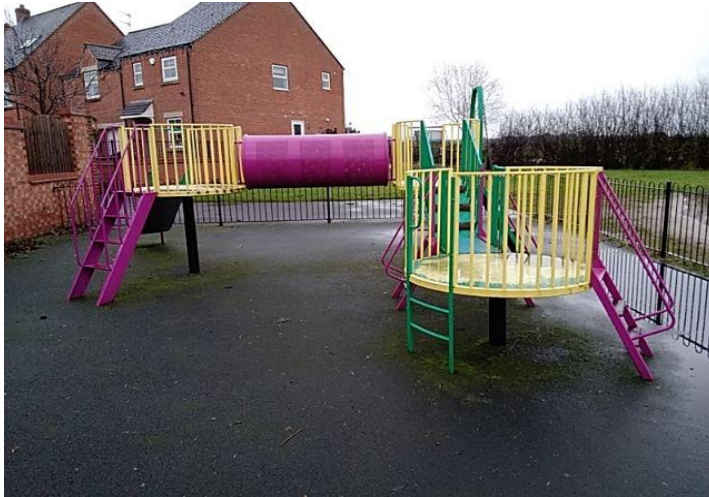
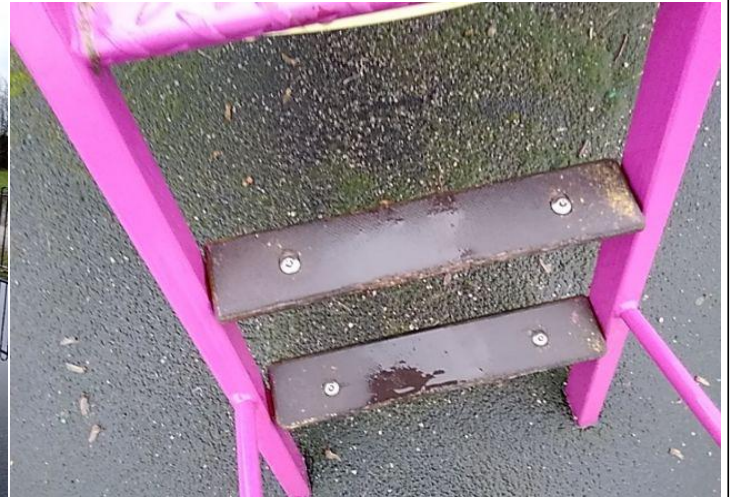
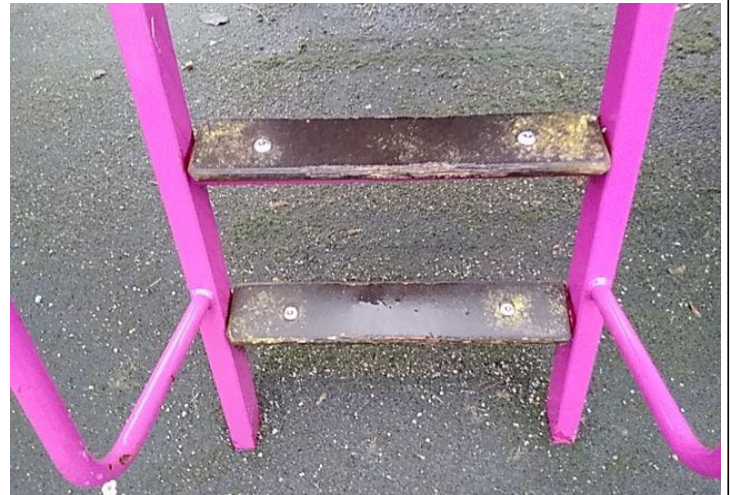
9 - Low Risk (Finding 1)

Finding: Step treads loose

Action: Tighten the fixings - security bit required

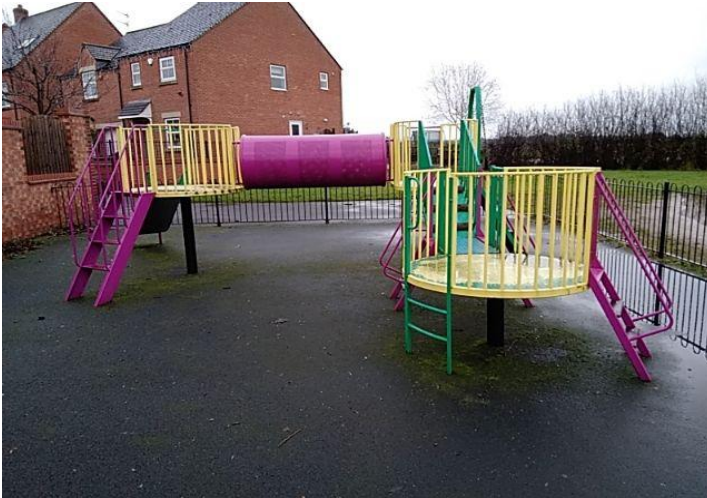
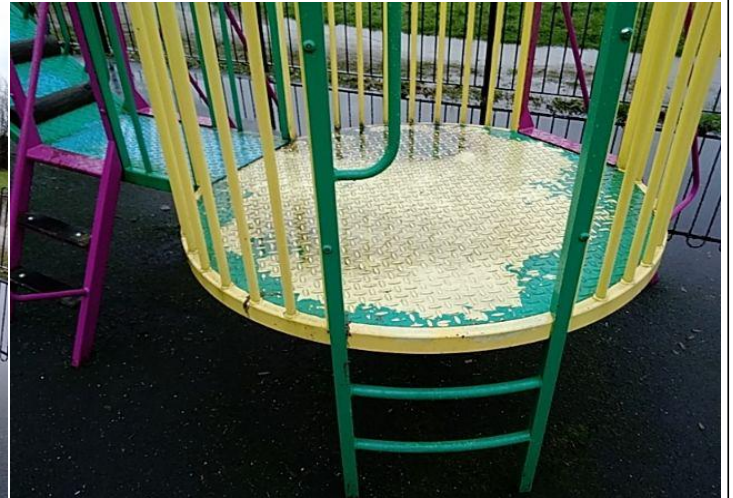
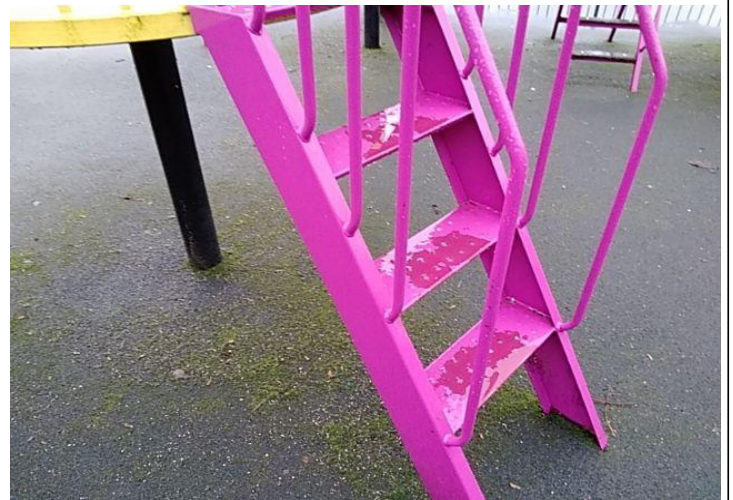
6 - Low Risk (Finding 2)

Finding: The paint is flaking off the metalwork

Action: Rub down and re-paint

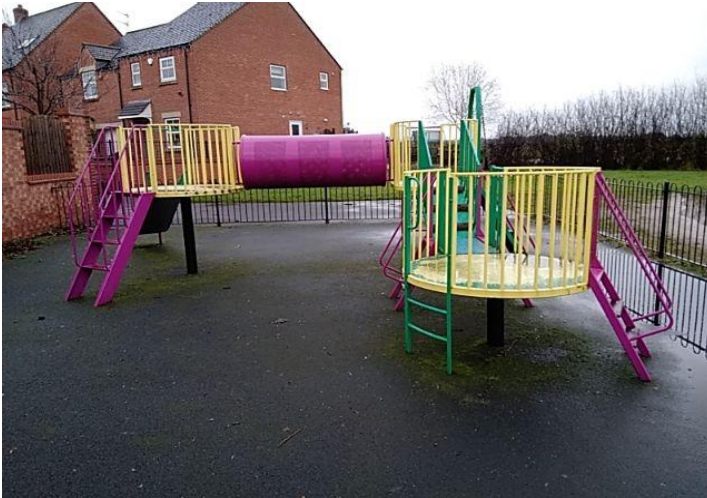
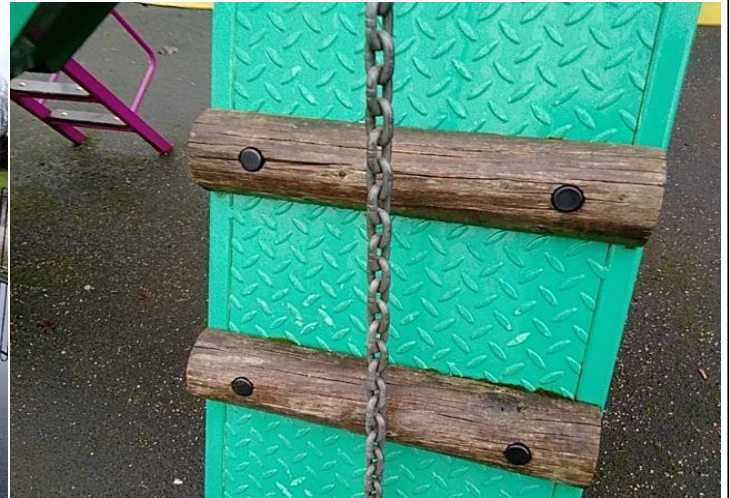
8 - Low Risk (Finding 3)

Finding: The timber has a number of splits/shakes or air cracks and this may affect the stability or allow water ingress which will accelerate the rotting process

Action: Monitor and replace the slats as required

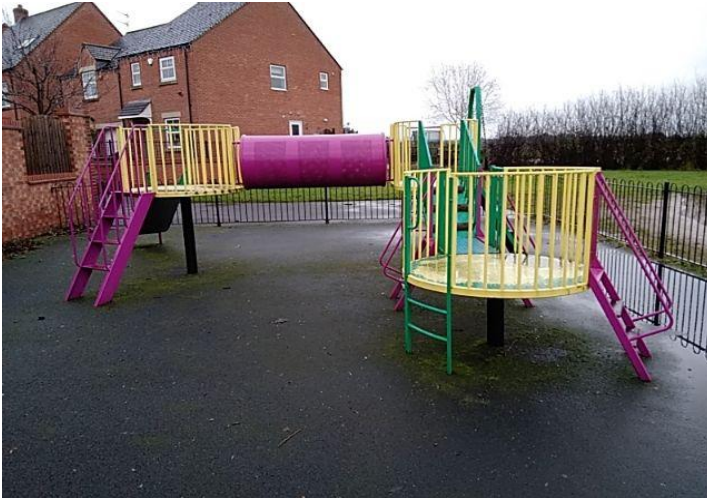
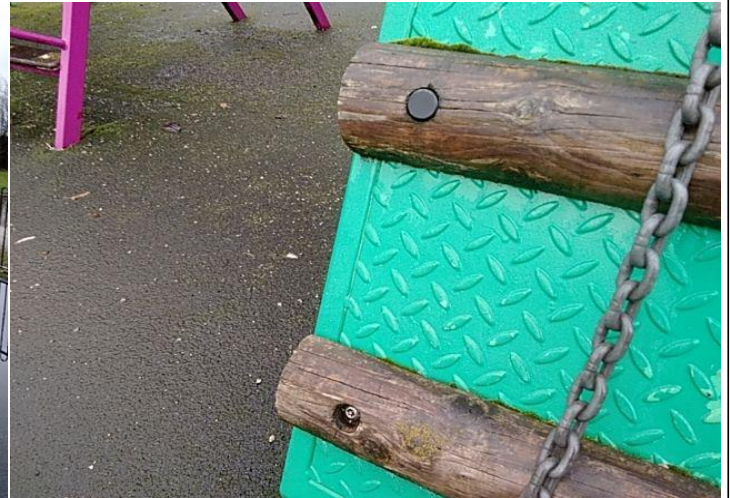
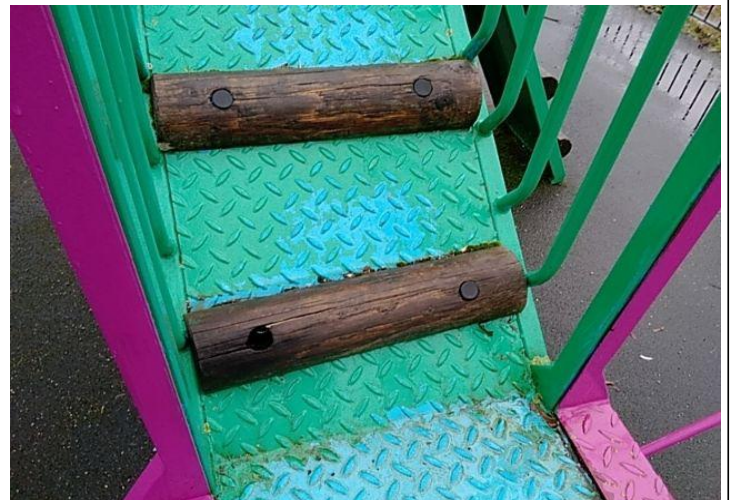
i 4 - Very Low Risk (Finding 4)

Finding: There is/are bolt cap covers missing or damaged on the item

Action: Replace missing or damaged bolt cap covers

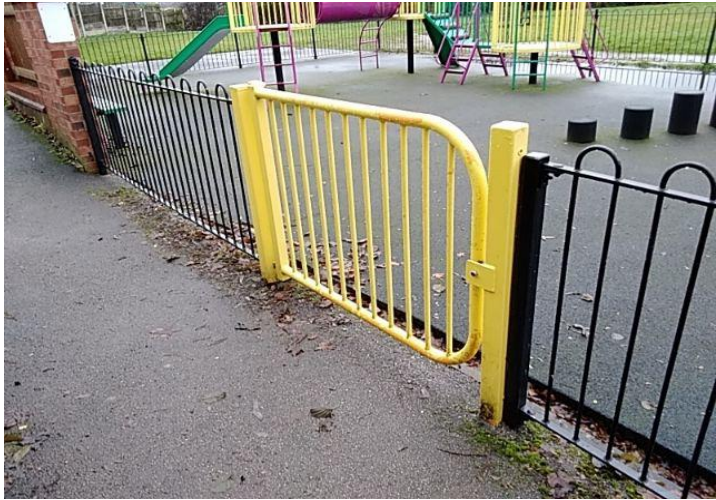
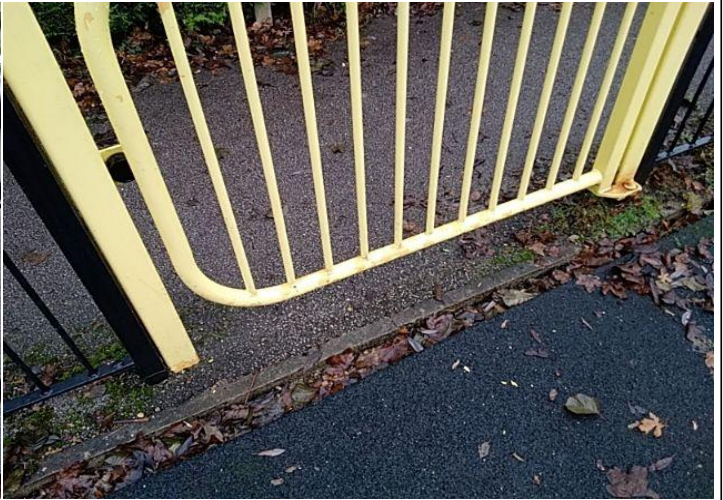
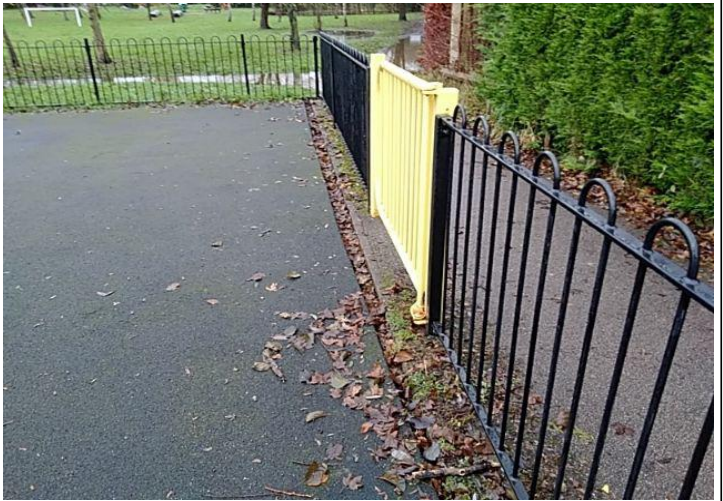
i 9 - Low Risk (Finding 1)

Finding: There are significant gaps (over 30mm) between the surface and the edging or between the joints in the surface; these are large enough for a small foot to enter

Action: Repair surfacing

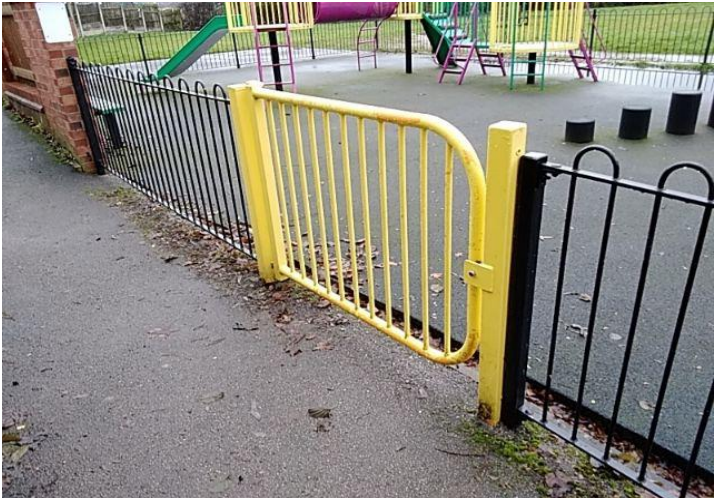
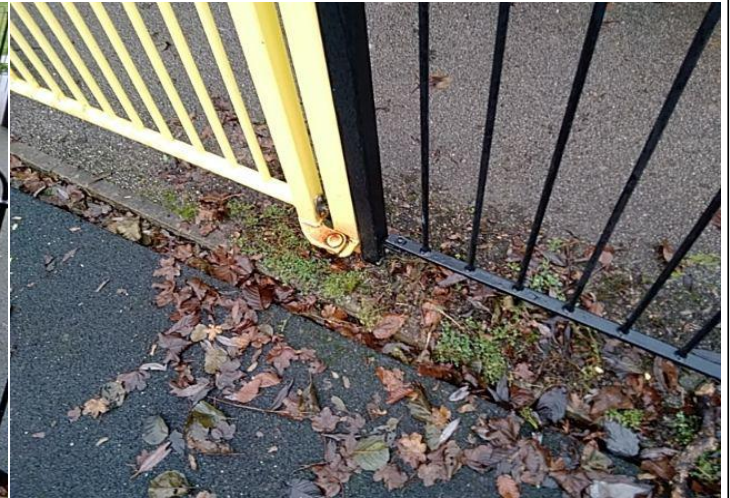
6 - Low Risk (Finding 2)

Finding: There are weeds/vegetation growth between or around the edges of the surfacing

Action: Remove weeds/vegetation growth

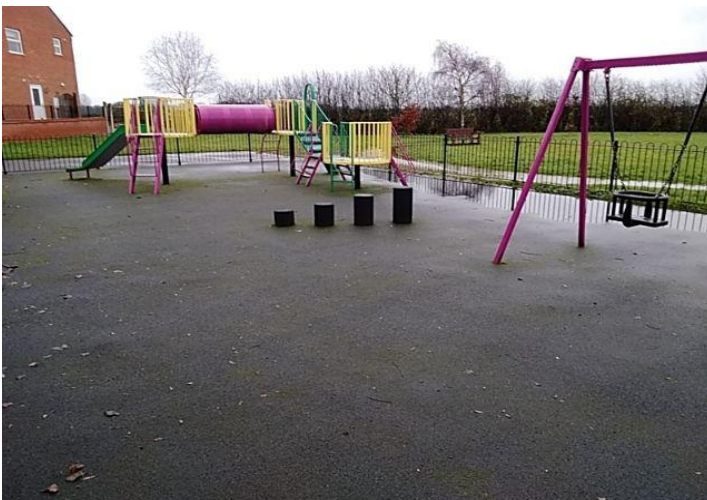
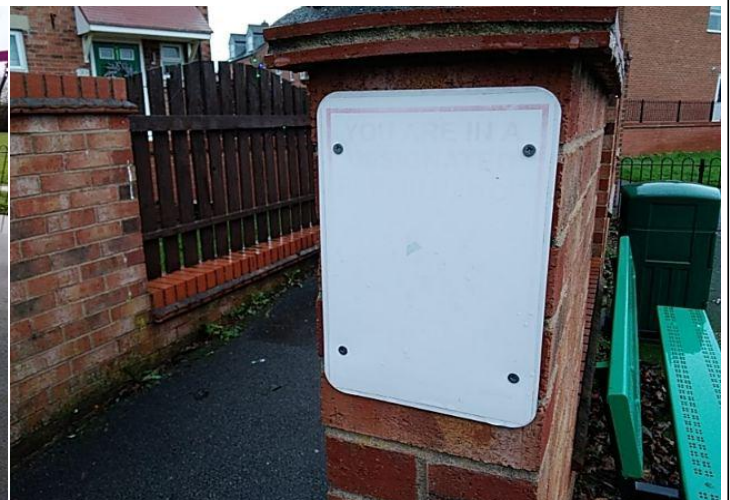
5 - Very Low Risk (Finding 1)

Finding: It is recommended that signage, with information including the site address, contact information for maintenance issues and emergency contact details are provided for the facility

Action: Provide in accordance with the recommendations

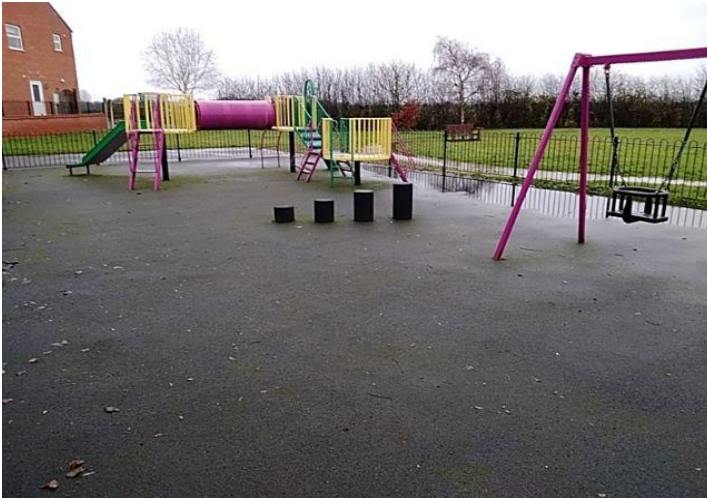
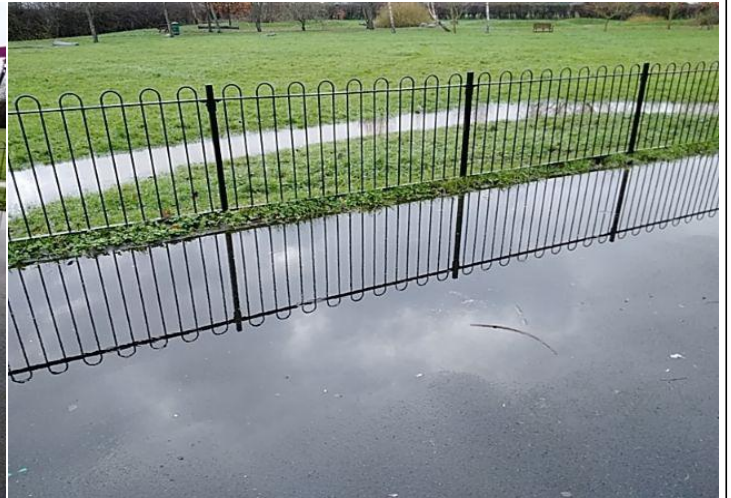
i 6 - Low Risk (Finding 2)

Finding: Parts of the playing surface were waterlogged at the time of the inspection

Action: Monitor

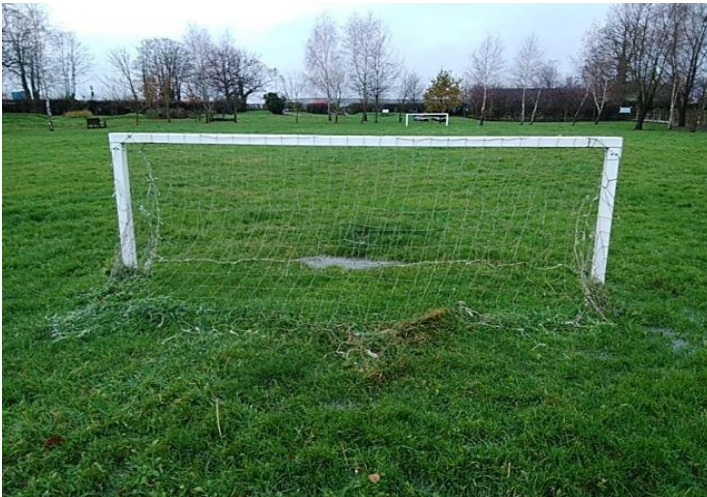
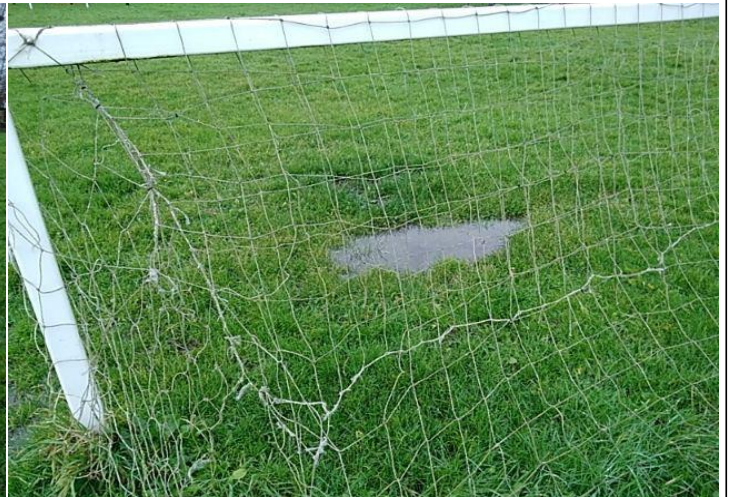
i 6 - Low Risk (Finding 1)

Finding: Ground erosion / waterlogged

Action: Grounds maintenance as required

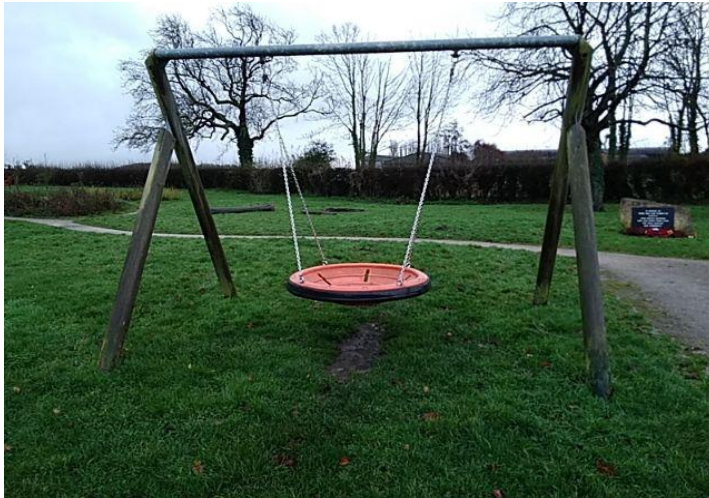
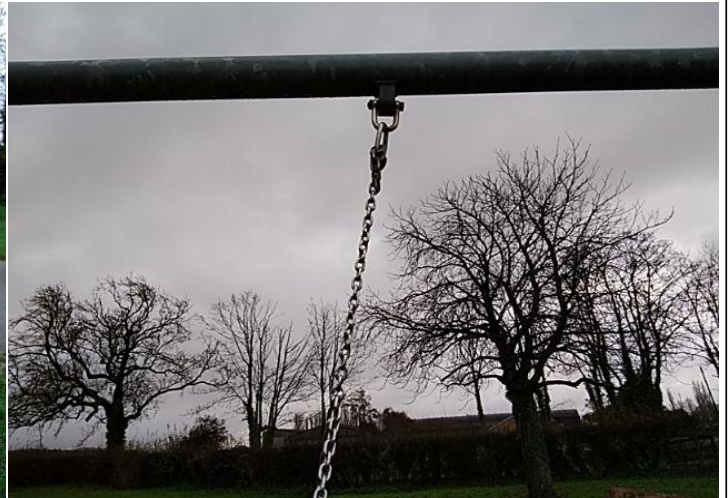
i 8 - Low Risk (Finding 1)

Finding: Swings of this design should have a secondary safety device fitted to prevent collapse of the seat in the event of a joint failure to meet the requirements of BS EN 1176 Part 2

Action: Consider providing a secondary safety device where possible

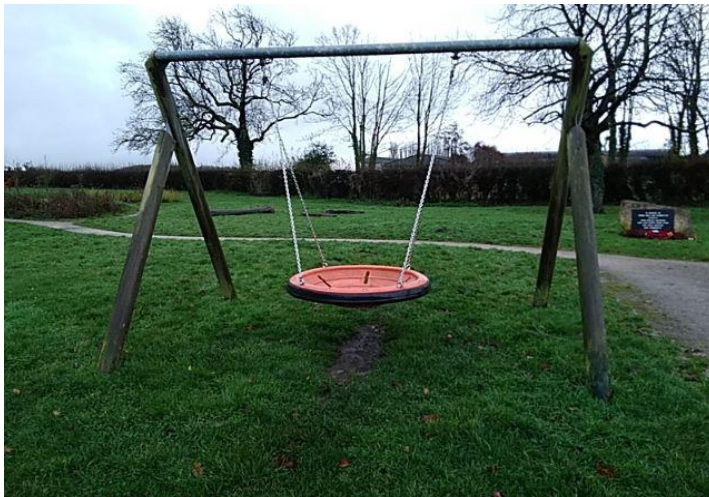
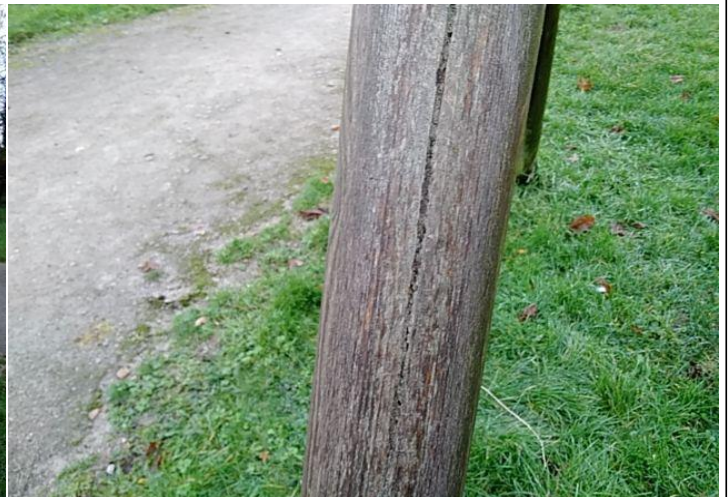
i 6 - Low Risk (Finding 2)

Finding: The timber has a number of splits/shakes or air cracks and this may affect the stability or allow water ingress which will accelerate the rotting process

Action: Monitor to ensure the splits do not cross through fixing points of the structure and/or cause any instability
