Annual Inspection

Whitley Parish Council

Lee View

Inspection Ref: 2236752

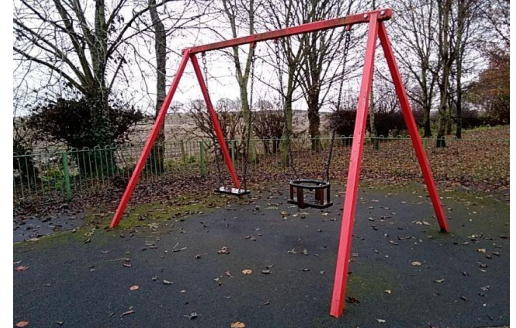
Item: 1 Bay 2 Seat Swing
Manufacturer: Unknown
Surface Type: Wet Pour
Item Quantity: 1
Equipment Compliance: Yes
Surface Area Compliance: Yes

There is algae or moss growth on the surface resulting in slippery conditions - Clean and treat appropriately

There are gaps opening between the surfacing and the edging surround or between the joints in the surfacing - Monitor for any further deterioration and repair as required

There is no identification label affixed to the equipment - Provide an identification label

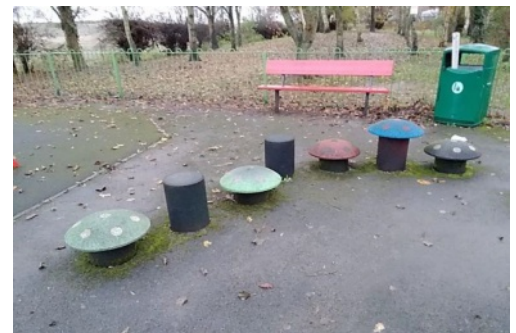
Item: Activity Trail
Manufacturer: Unknown
Surface Type: Tarmac
Item Quantity: 1
Equipment Compliance: N/A
Surface Area Compliance: N/A

This item is satisfactory - no work required -

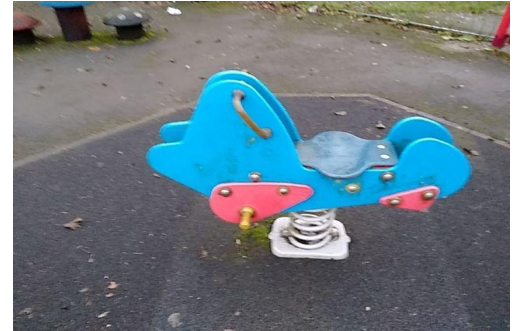
Item: Spring Aeroplane
Manufacturer: Ledon
Surface Type: Wet Pour
Item Quantity: 1
Equipment Compliance: No
Surface Area Compliance: Yes

The end of footrests have a cross section of less than 15cm² and fail to meet the requirements of BS EN 1176 Part 6 - Monitor - No remedial work recommended

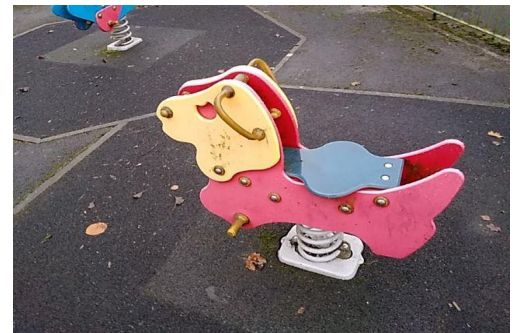
Item: Spring Dog
Manufacturer: Ledon
Surface Type: Wet Pour
Item Quantity: 1
Equipment Compliance: No
Surface Area Compliance: Yes

The item has been damaged - Monitor for any further deterioration and replace as required

The end of footrests have a cross section of less than 15cm² and fail to meet the requirements of BS EN 1176 Part 6 - Monitor - No remedial work recommended

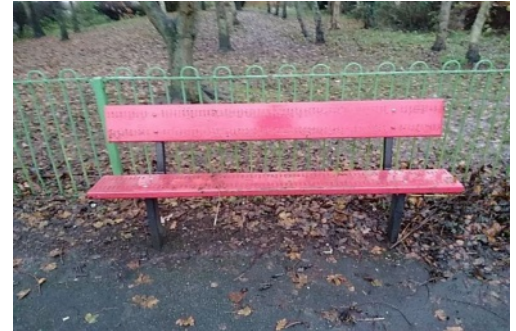
Item: Seat
Manufacturer: Record RSS
Surface Type: Tarmac
Item Quantity: 1
Equipment Compliance: N/A
Surface Area Compliance: N/A

This item is satisfactory - no work required -

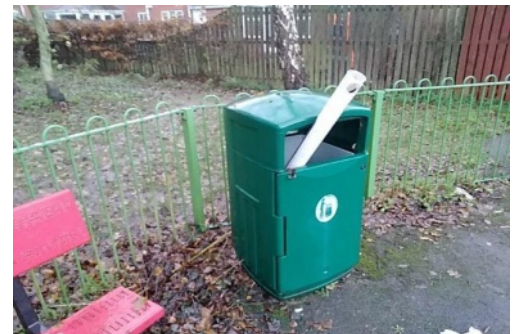
Item: Litter Bin
Manufacturer: Glasdon
Surface Type: Tarmac
Item Quantity: 1
Equipment Compliance: N/A
Surface Area Compliance: N/A

This item is satisfactory - no work required -

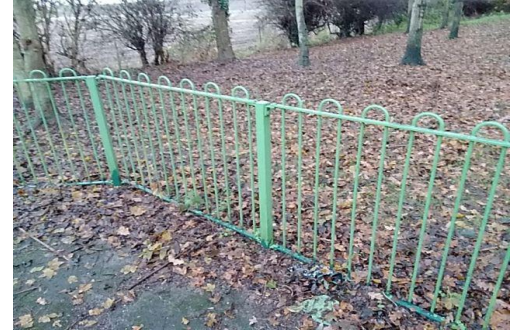
Item: Fence - Bow Top
Manufacturer: Unknown
Surface Type: Tarmac
Item Quantity: 1
Equipment Compliance: Yes
Surface Area Compliance: N/A

The item has been damaged - Monitor for any further deterioration and replace as required

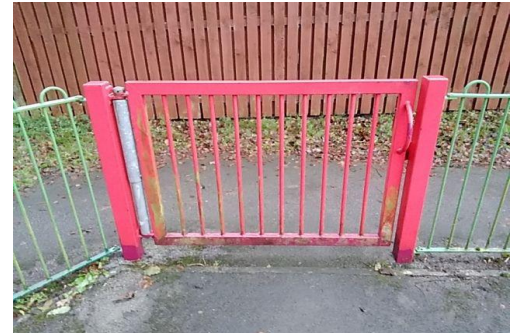
Item: Gate - Pedestrian
Manufacturer: Unknown
Surface Type: Tarmac
Item Quantity: 1
Equipment Compliance: N/A
Surface Area Compliance: N/A

The gate is not self closing - Adjust if possible

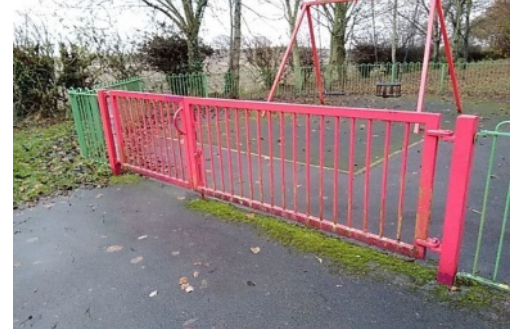
Item: Gate - Combination
Manufacturer: Unknown
Surface Type: Tarmac
Item Quantity: 1
Equipment Compliance: Yes
Surface Area Compliance: N/A

This item is satisfactory - no work required -

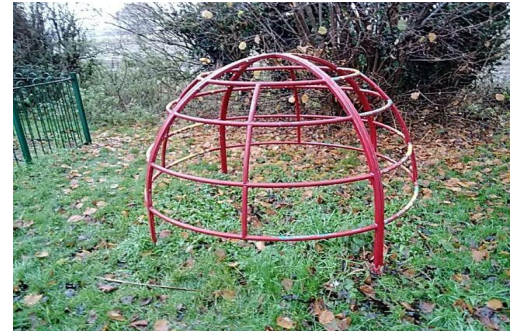
Item: Climbing Frame
Manufacturer: Unknown
Surface Type: Grass Matrix Tiles
Item Quantity: 1
Equipment Compliance: Yes
Surface Area Compliance: Yes

There is no identification label affixed to the equipment - Provide an identification label

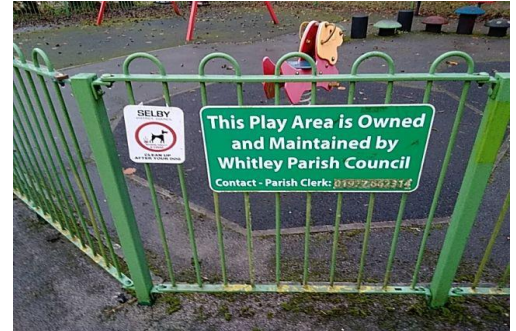
Item: Sign
Manufacturer: Unknown
Surface Type: N/A
Item Quantity: 1
Equipment Compliance: No
Surface Area Compliance: N/A

BS EN 1176 Part 7 recommends that signage shall include emergency contact details and contact details of owner / operator for reporting maintenance issues - Provide additional information

BS EN 1176 Part 7 recommends that signage shall include the site name / address - Provide additional information

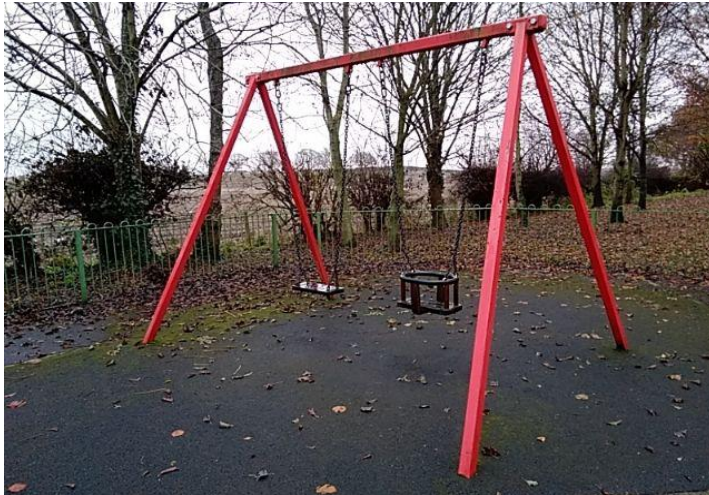
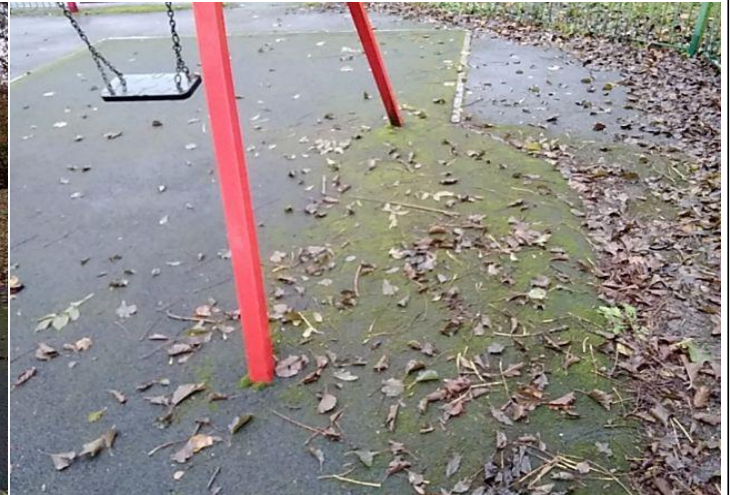
i 8 - Low Risk (Finding 1)

Item: Swings - 1 Bay 2 Seat Swing
Manufacturer: Unknown

Finding: There is algae or moss growth on the surface resulting in slippery conditions

Action: Clean and treat appropriately

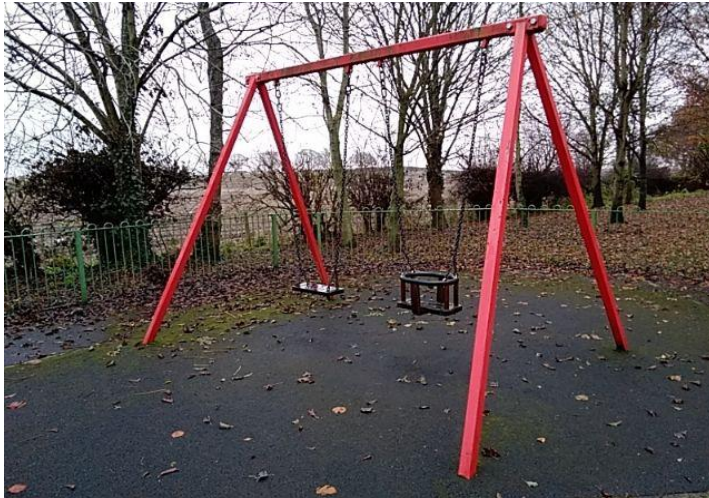
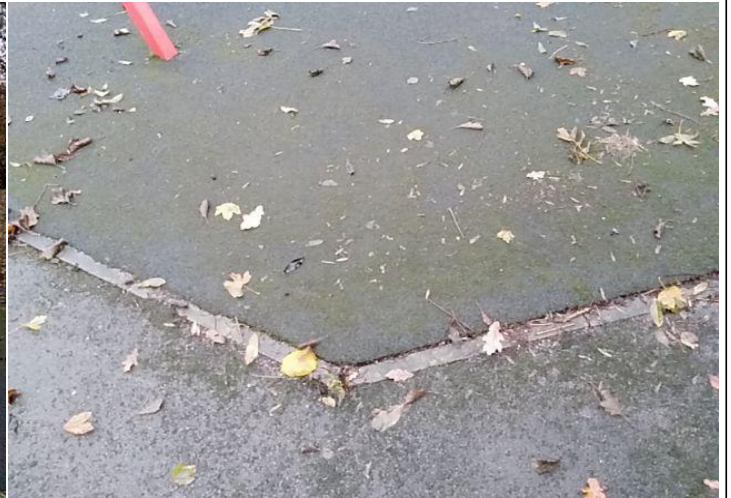
i 6 - Low Risk (Finding 2)

Item: Swings - 1 Bay 2 Seat Swing
Manufacturer: Unknown

Finding: There are gaps opening between the surfacing and the edging surround or between the joints in the surfacing
Action: Monitor for any further deterioration and repair as required

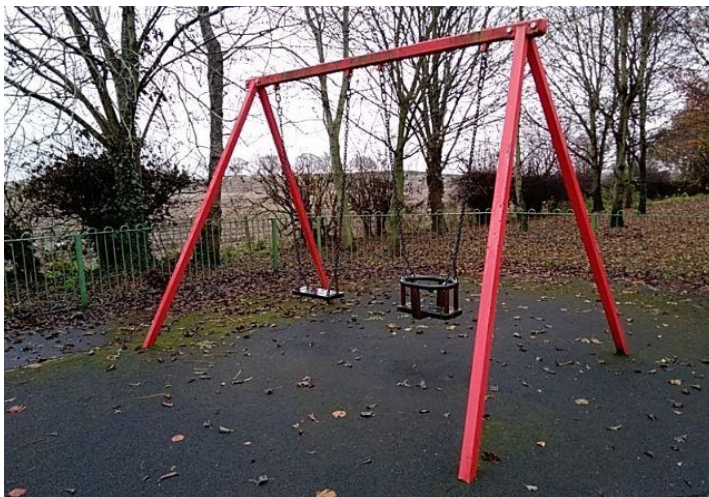
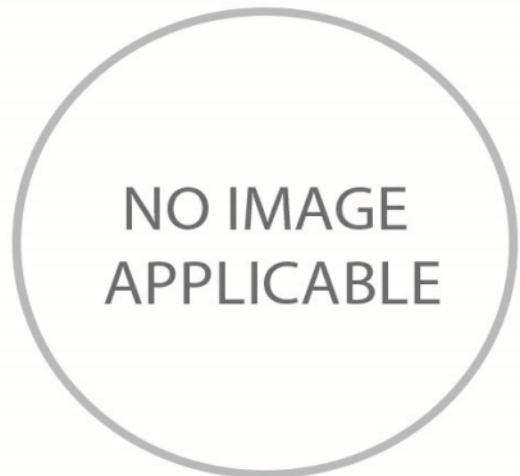
Item: Swings - 1 Bay 2 Seat Swing
Manufacturer: Unknown

Finding: There is no identification label affixed to the equipment

Action: Provide an identification label

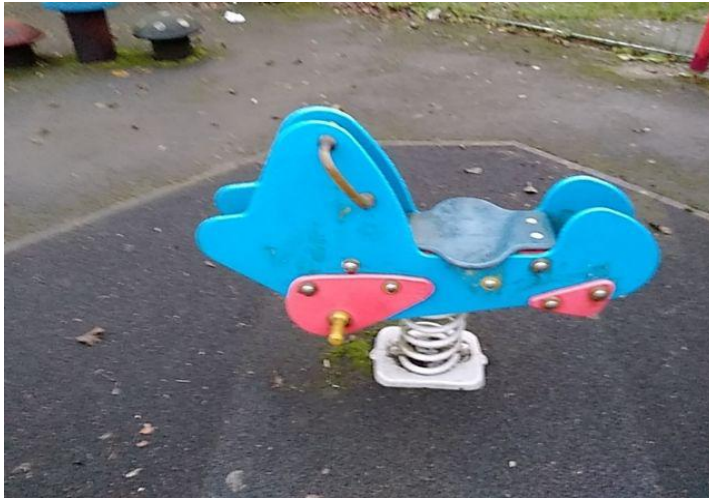
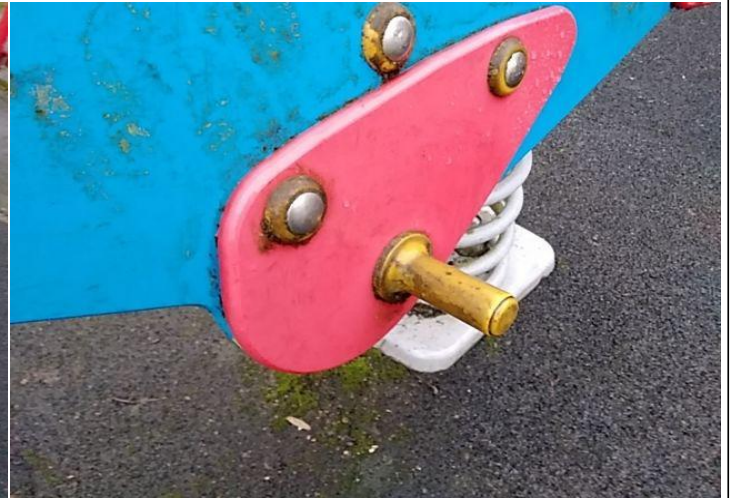
Item: Rocking Equipment - Spring Aeroplane
Manufacturer: Ledon

Finding: The end of footrests have a cross section of less than 15cm² and fail to meet the requirements of BS EN 1176 Part 6

Action: Monitor - No remedial work recommended

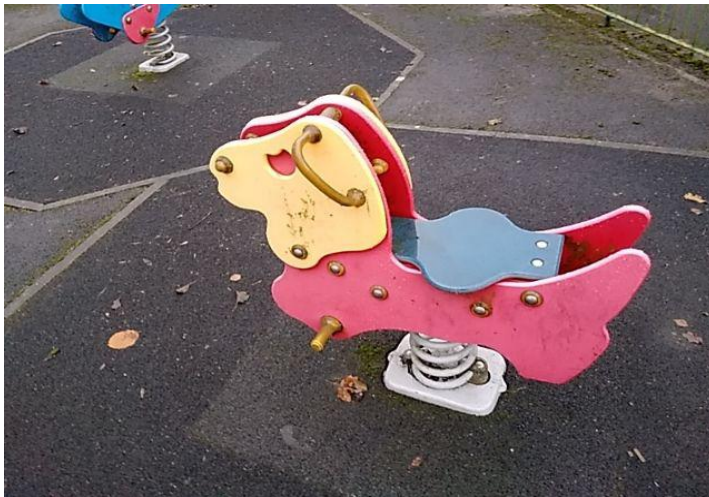
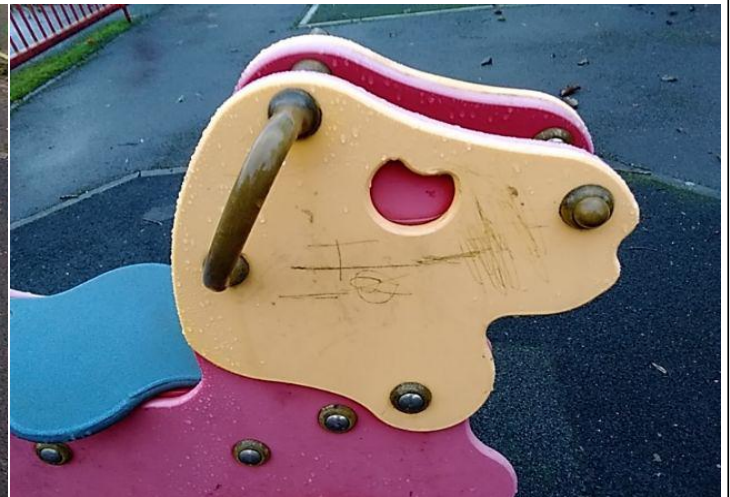
Item: Rocking Equipment - Spring Dog
Manufacturer: Ledon

Finding: The item has been damaged

Action: Monitor for any further deterioration and replace as required

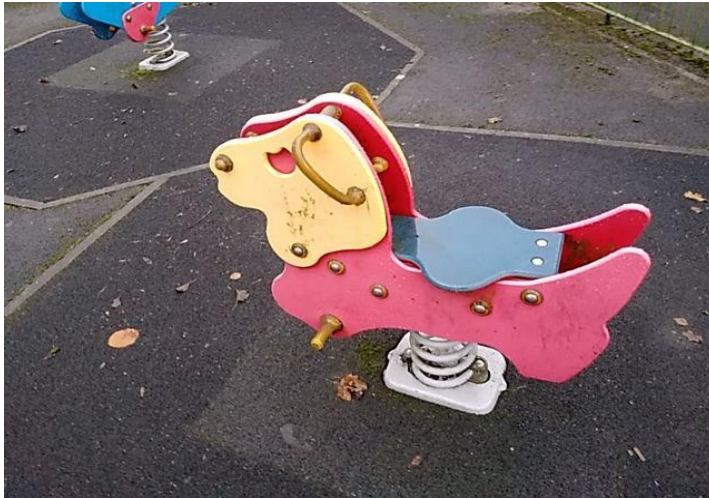
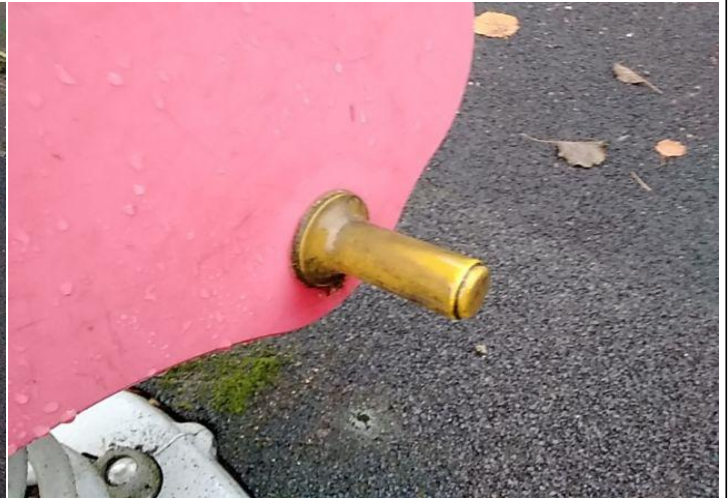
Item: Rocking Equipment - Spring Dog
Manufacturer: Ledon

Finding: The end of footrests have a cross section of less than 15cm² and fail to meet the requirements of BS EN 1176 Part 6

Action: Monitor - No remedial work recommended

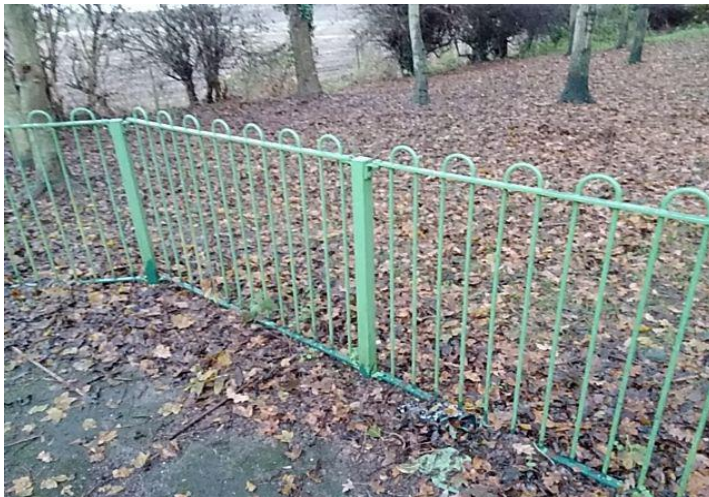
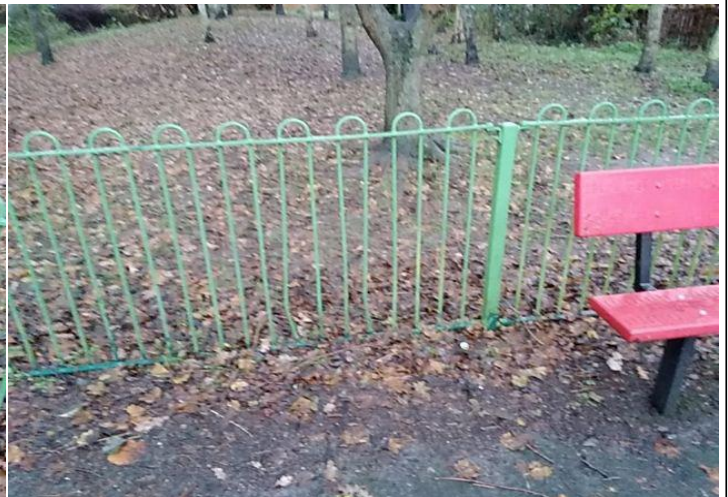
Item: Fences - Fence - Bow Top
Manufacturer: Unknown

Finding: The item has been damaged

Action: Monitor for any further deterioration and replace as required

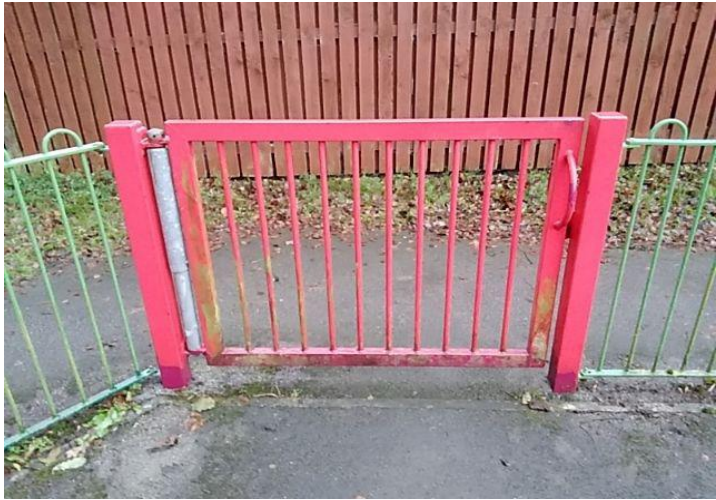
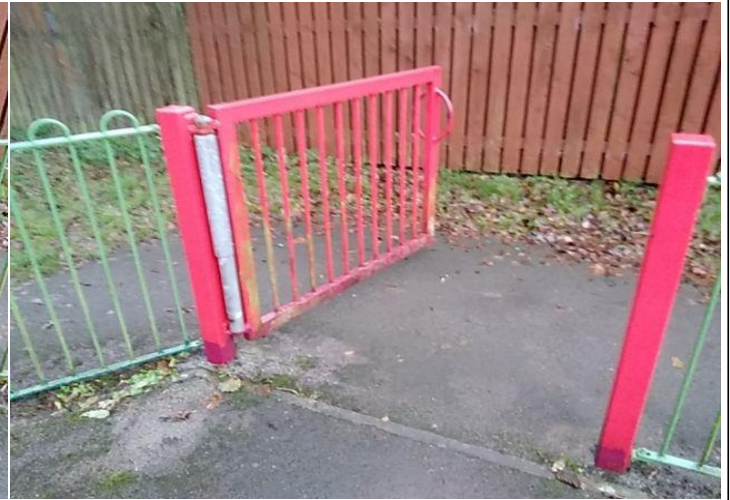
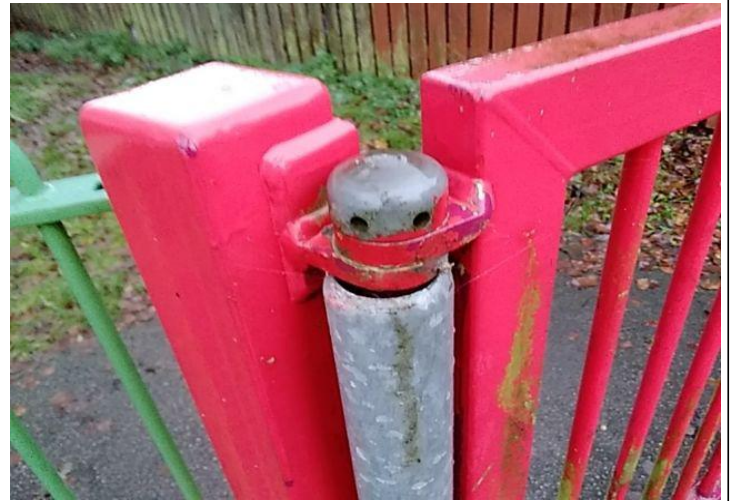
Item: Gates - Gate - Pedestrian
Manufacturer: Unknown

Finding: The gate is not self closing

Action: Adjust if possible

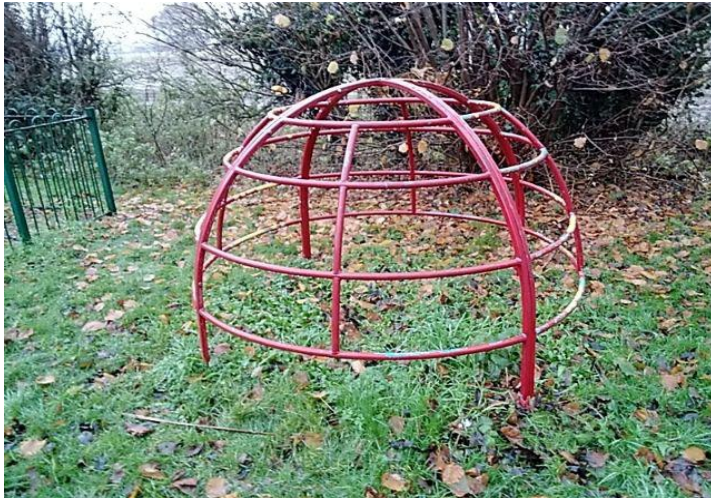
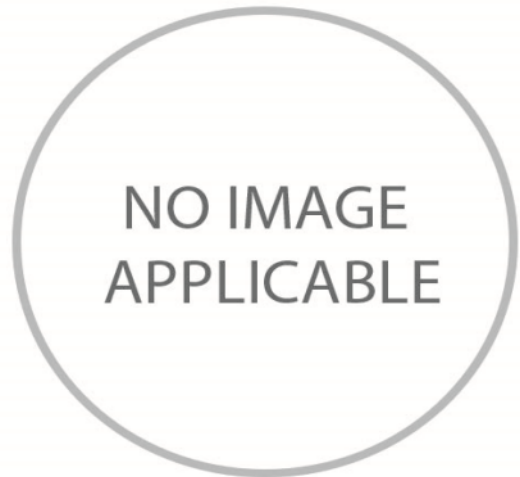
Item: Activity Equipment - Climbing Frame
Manufacturer: Unknown

Finding: There is no identification label affixed to the equipment

Action: Provide an identification label

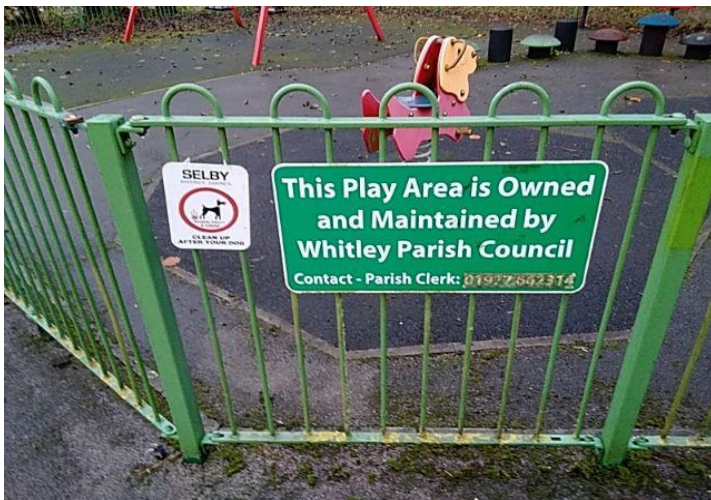
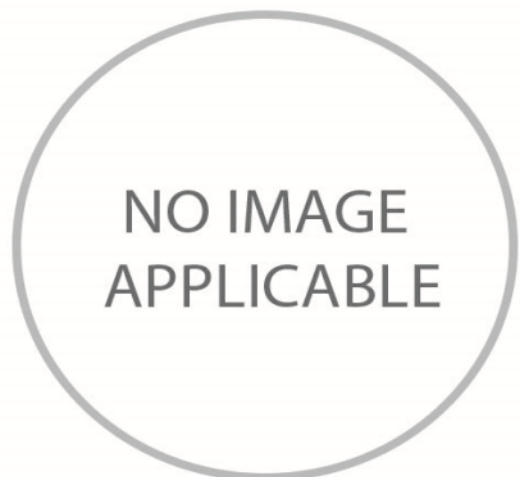
Item: Ancillary Items - Sign
Manufacturer: Unknown

Finding: BS EN 1176 Part 7 recommends that signage shall include emergency contact details and contact details of owner / operator for reporting maintenance issues

Action: Provide additional information

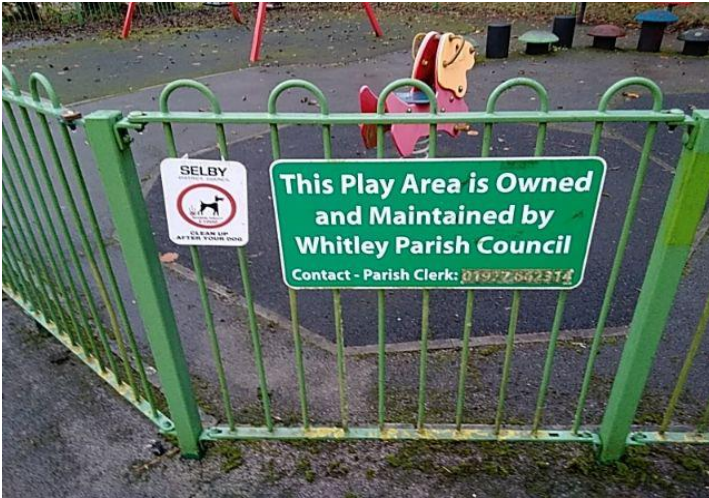
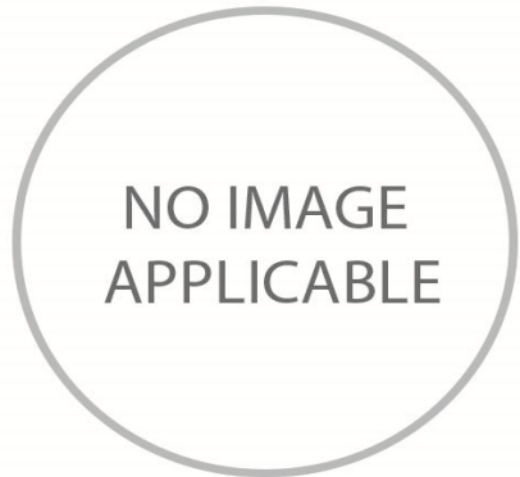
Item: Ancillary Items - Sign
Manufacturer: Unknown

Finding: BS EN 1176 Part 7 recommends that signage shall include the site name / address **Action:** Provide additional information
