PLAY AREA SAFETY ANNUAL INSPECTION REPORT

For Whitley Parish Council

On 18th March 2016

Play Area, Whitley Farm Close, Whitley, Yorkshire

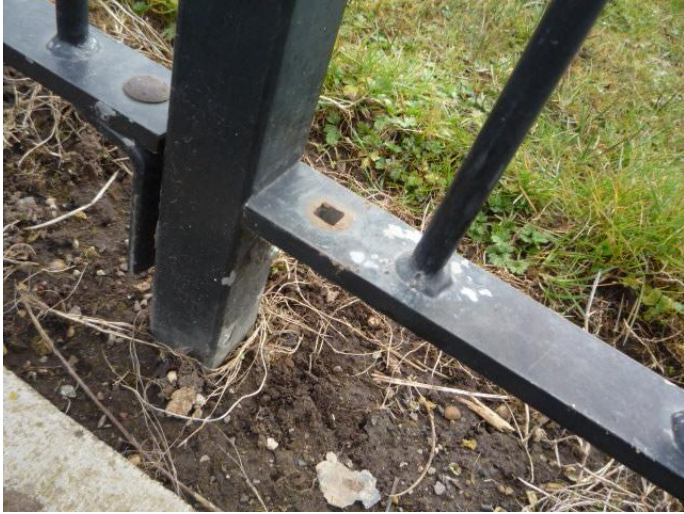
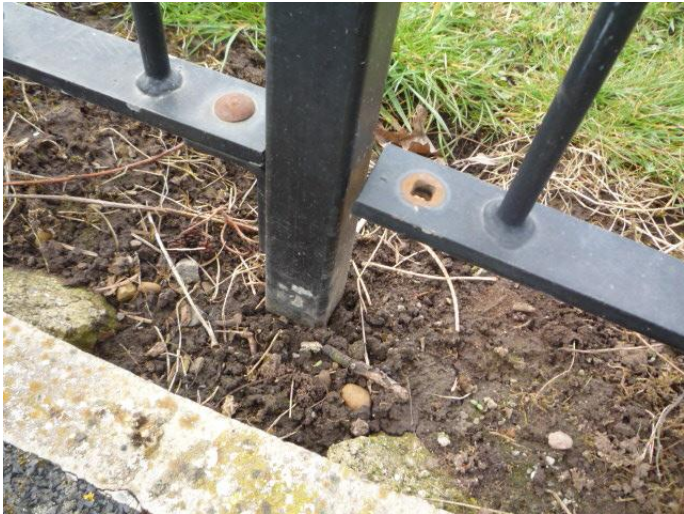
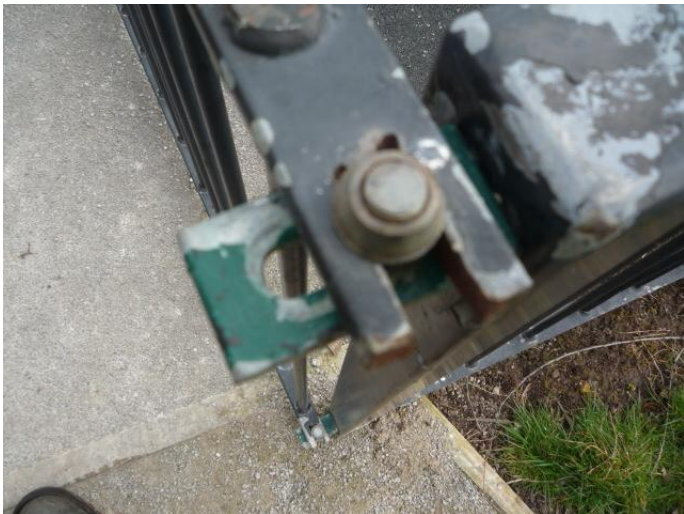
Bow-top Fence (1000mm) – Recommend replace missing bolts x 2, tighten loose bolts x 2, Replace missing bracket x 2. One bracket has no hole for bolt –Low to Medium Risk.

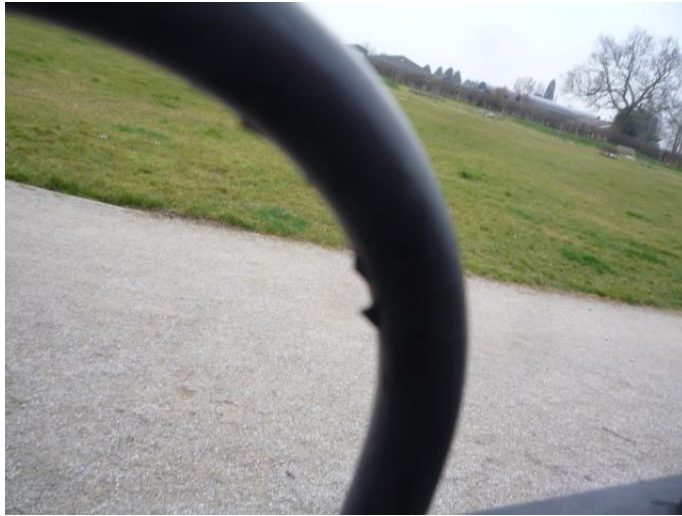
Recommend file off metal burrs found under some of the 'bow tops' – Low to Medium risk.

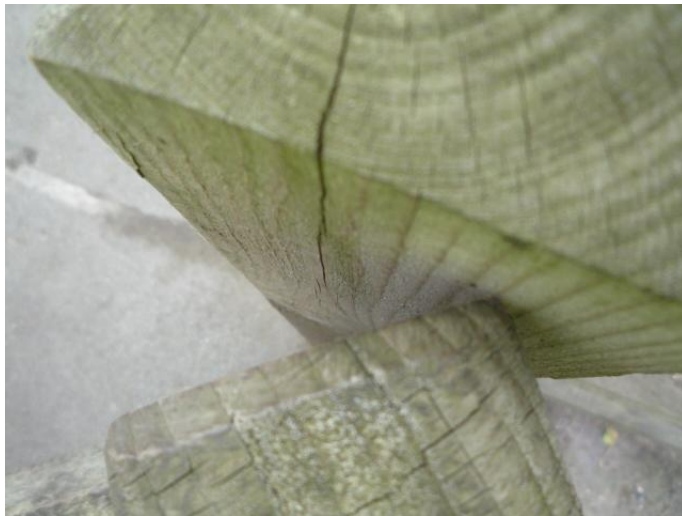
Kissing Gate x 1 – To eliminated possible entrapment when gate and posts meet –Recommend to add rubber buffers (door stops) on posts –Low risk

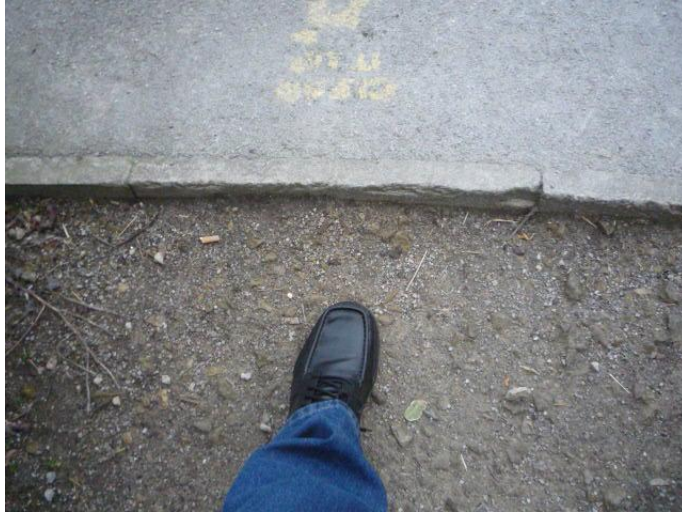
Access –Recommend build up edge of roadside path to eliminate trip hazard – Low to Medium risk.

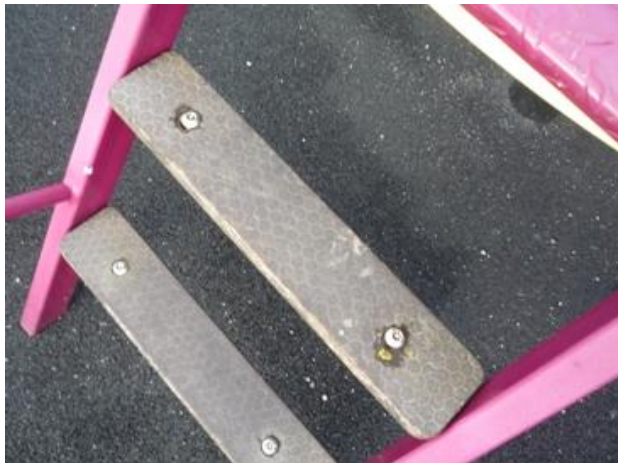
Recommend repair loose steps x 2 – Tighten and add washers –Low Risk.

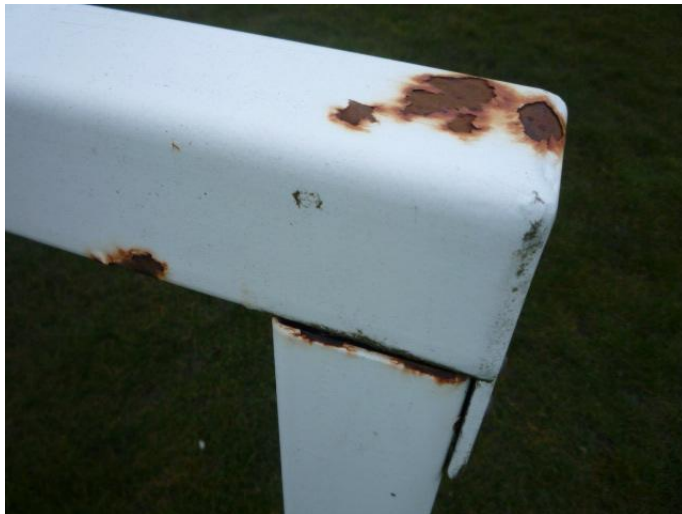
Paintwork is in poor condition. Recommend De-scale and coat with lead free paint, using appropriate precautions.

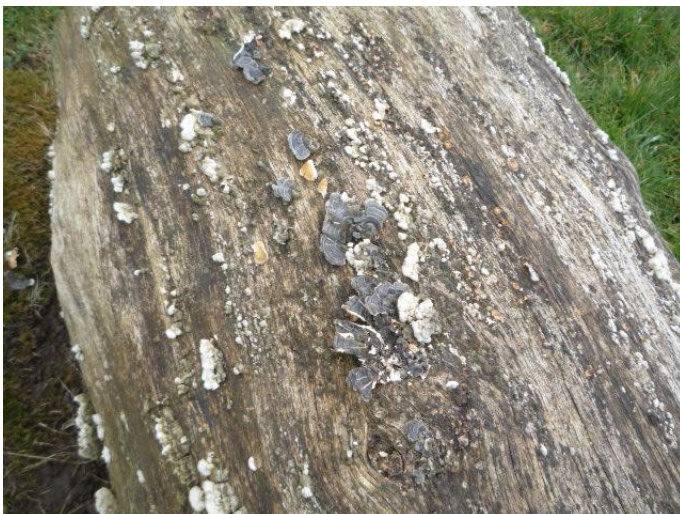
Recommend clean off fungi - Low to Medium risk.

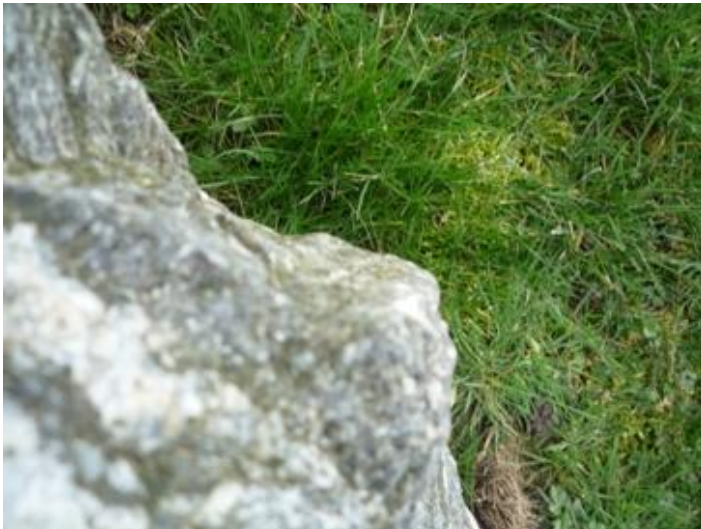
Edges not radiused or chamfered. Recommend Monitor only – Low Risk.

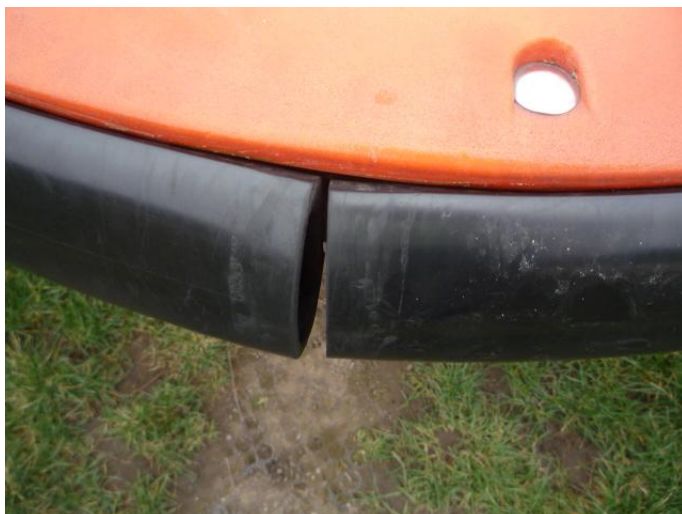
Recommend replace two missing fixings that cover the gaps in the outer rubber 'rim' –Low risk.

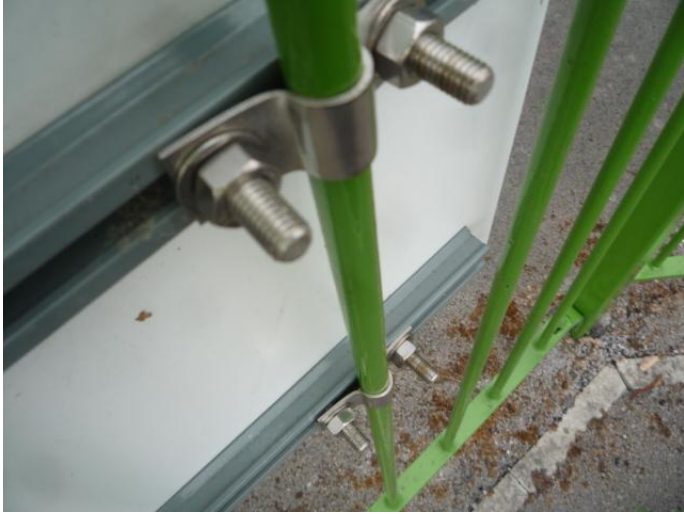
Signs – Recommend cut back bolt threads x 8 and file –Low to Medium risk.

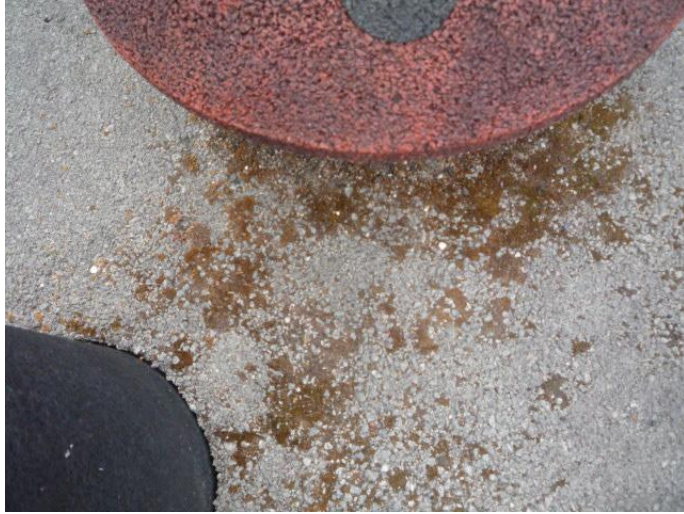
Recommend remove algae –slippery when wet –Low Risk.

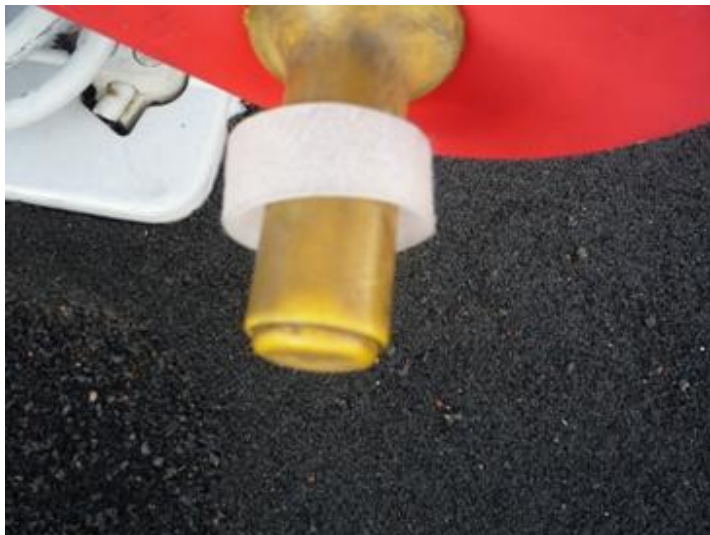
Protruding handles/foot rests not conforming to the requirements of EN1176 – Recommend Monitor only– Low risk.

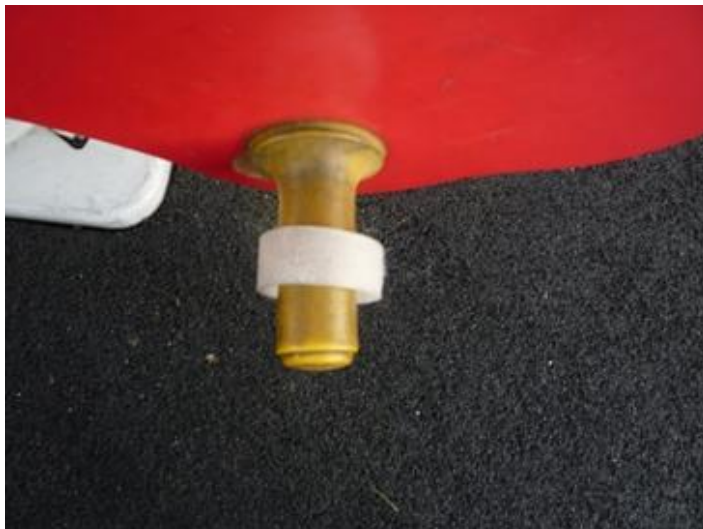
Protruding handles/foot rests not conforming to the requirements of EN1176 – Recommend Monitor only– Low risk.

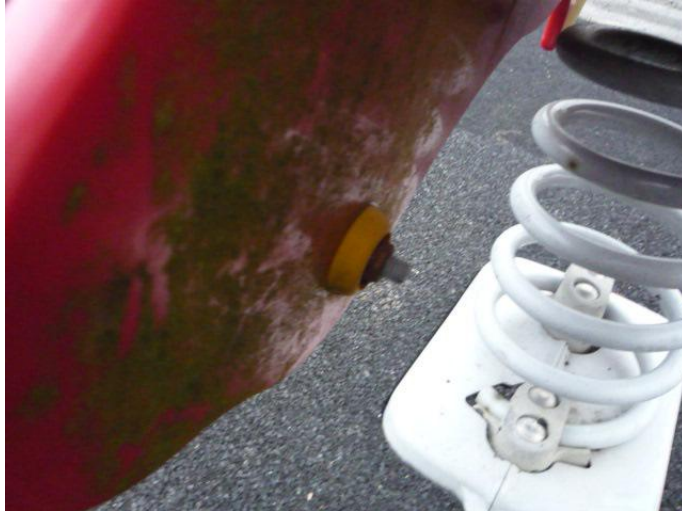
Recommend replace missing cap x 1 –Low risk.

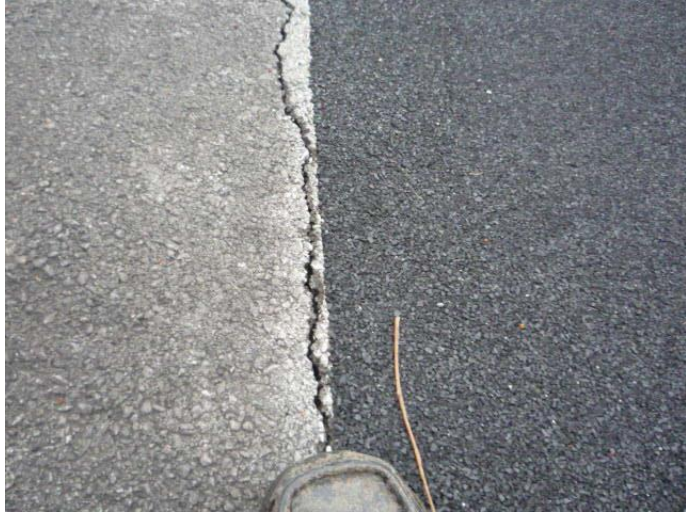
Recommend infill cracks in bitmac –Low risk

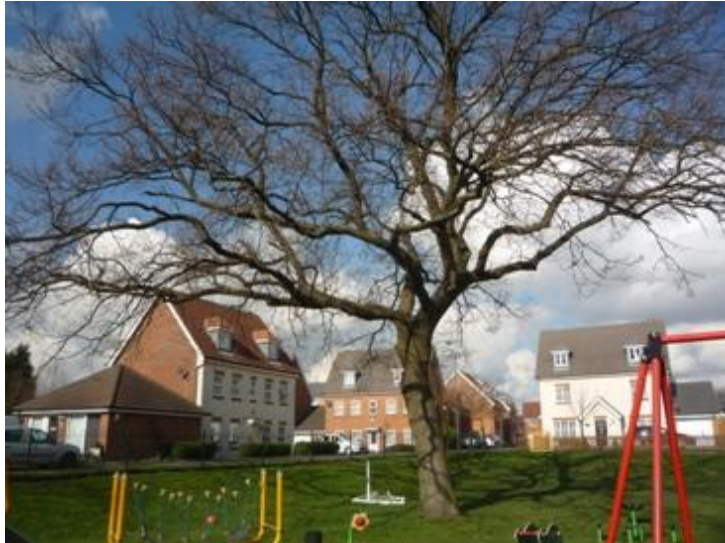
Mature tree in play area – Recommend to inspect annually by qualified arboriculturist and to remove any dead, diseased and damaged wood.

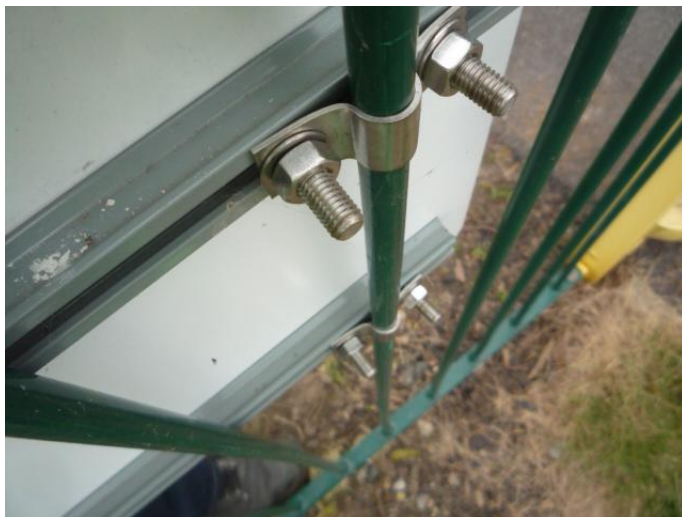
Sign –Recommend cut back bolt threads x 8 and file down –Low to Medium risk.

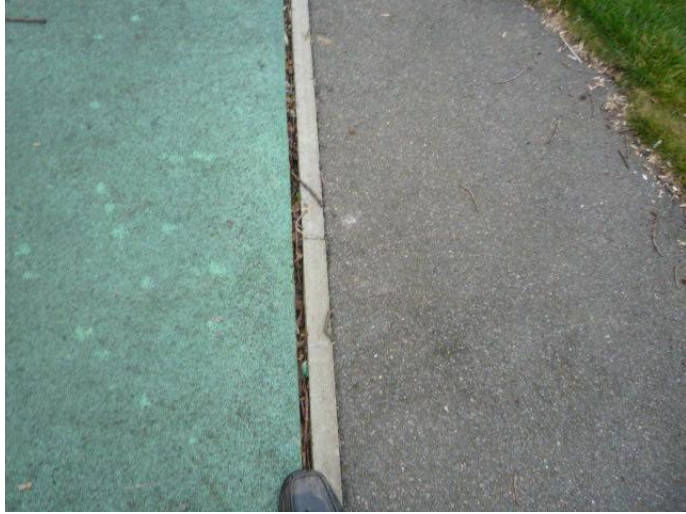
Surface is lifting. Recommend re-glue and fill gaps and joints as necessary
– Low risk.

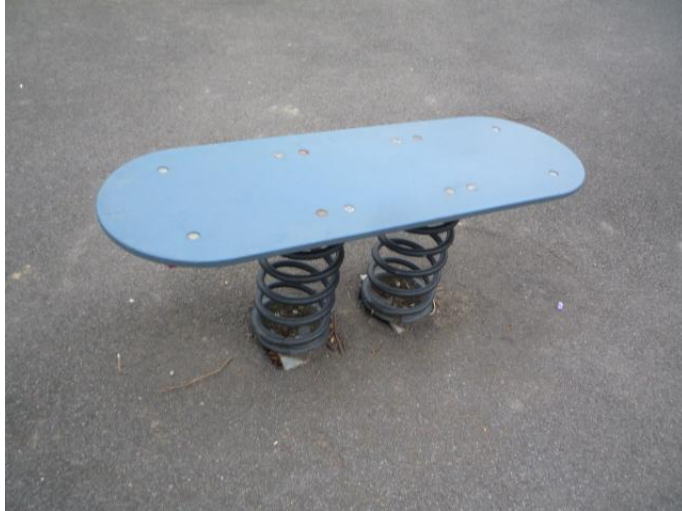
A protective surface is recommended for this item due to forced movement. EN1176 (4.2.8.5.2) states that 'Beneath all playground equipment with a free height of fall of more than 600mm and/or equipment causing a forced movement on the body of the user(e.g. swings, slides, rocking equipment, cableways,carousals etc.), there shall be impact attenuating surfacing over the entire impact area - Recommend Monitor – Low Risk

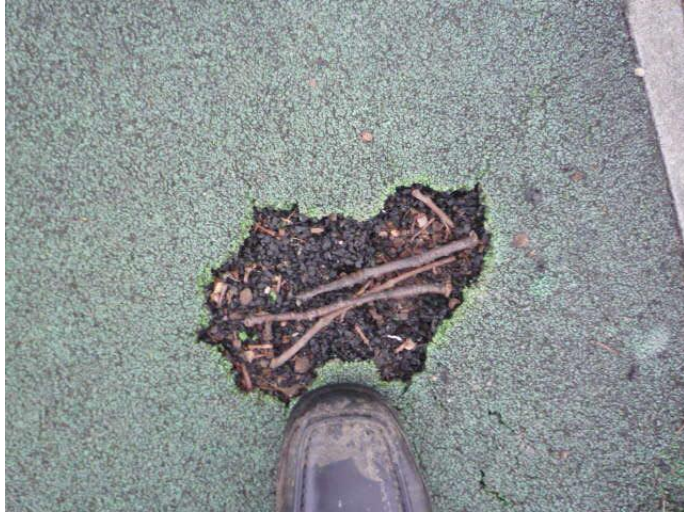
Recommend repair hole in surface –Low risk.

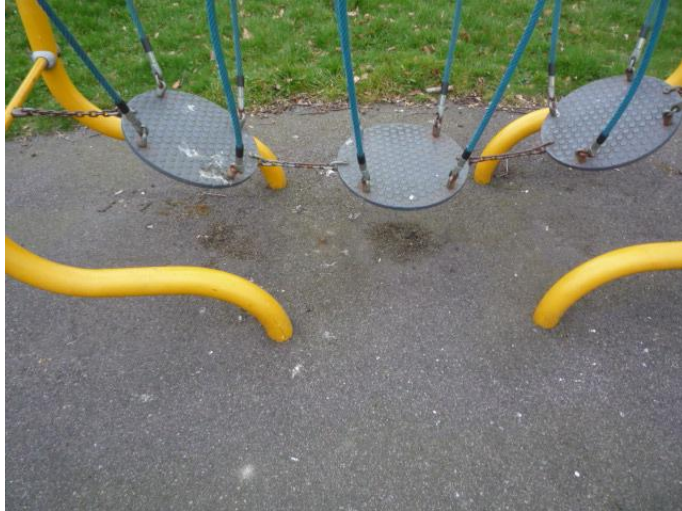
A protective surface is recommended for this item due to forced movement. EN1176)4.2.8.5.2) states that Beneath all playground equipment with a free height of fall of more than 600mm and/or equipment causing a forced movement on the body of the user(e.g. swings, slides, rocking equipment, cableways,carousals etc.), there shall be impact attenuating surfacing over the entire impact area.- Recommend Monitor – Low Risk.
