# **Annual Inspection**

Whitley Parish Council

Lee View

Inspection Ref: 918610 Site Ref: 46097 Customer Order: N/A

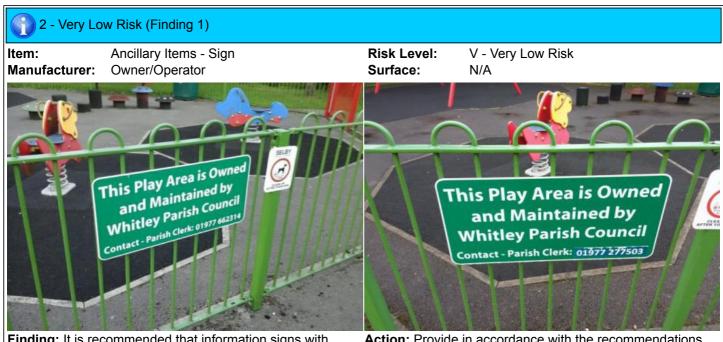
**Finding:** It is recommended that information signs with action: Provide in accordance with the recommendations emergency contact details are installed at each entrance/exit set out in BS EN 1176 point to the playground

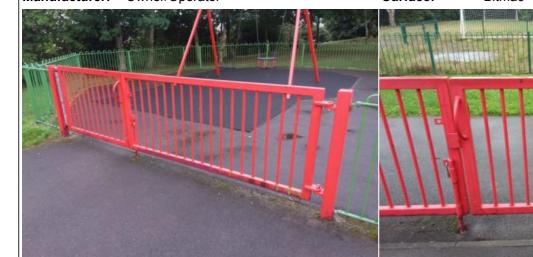
Item:Ancillary Items - Gate - CombinationRisk Level:L - Low RiskManufacturer:Owner/OperatorSurface:Bitmac

**Finding:** The gate is closing too quickly (less than 4 seconds)

**Action:** Take corrective action to ensure that the gate closes in 4-8 seconds

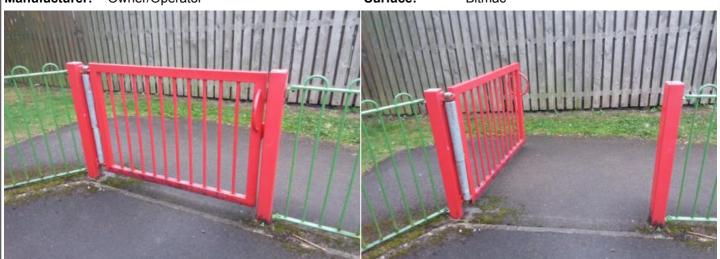
Item: Ancillary Items - Gate - Self Closing Risk Level: V - Very Low Risk

Finding: The gate is not operating correctly

**Action:** Take effective action to ensure the gate closes between 4 and 8 seconds

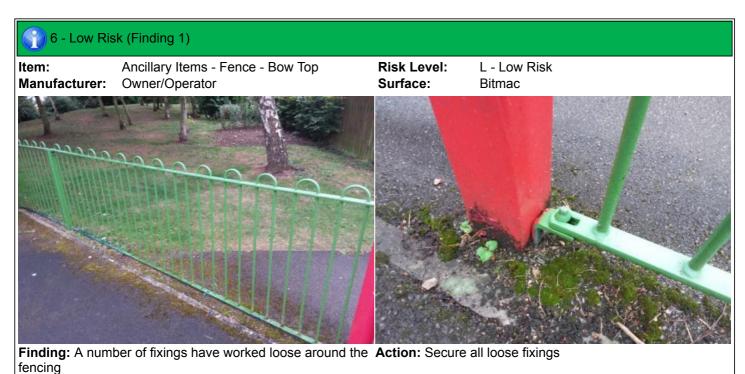
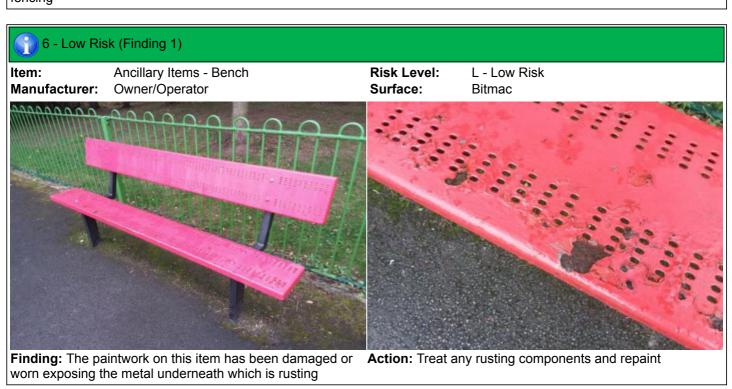
Ancillary Items - Bench Risk Level: L - Low Risk Item: Manufacturer: Owner/Operator Surface: Bitmac

**Finding:** There is algae or moss growth on the surface resulting in slippery conditions

Action: Clean and treat appropriately

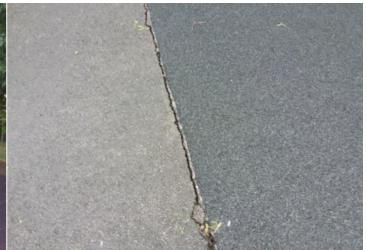
Item:Swings - 1 Bay 2 Seat SwingRisk Level:L - Low RiskManufacturer:Not IdentifiedSurface:Wet Pour

**Finding:** There are gaps opening between the surfacing and **Action:** Monitor for any further deterioration and repair as the edging surround or between the joints in the surfacing required

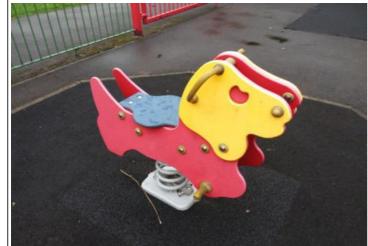
Item:Rocking Equipment - Spring LionRisk Level:L - Low RiskManufacturer:Not IdentifiedSurface:Wet Pour

**Finding:** The end of handgrips and/or footrests have a cross **Action:** Monitor - No remedial work recommended section of less than 15cm2 and fail to meet the requirements of BS EN 1176 Part 6; this is however, a relatively low risk failure and no remedial action is recommended
