## Annual Inspection

Whitley Parish Council

## Blackthorn Close

Inspection Ref: 1703917

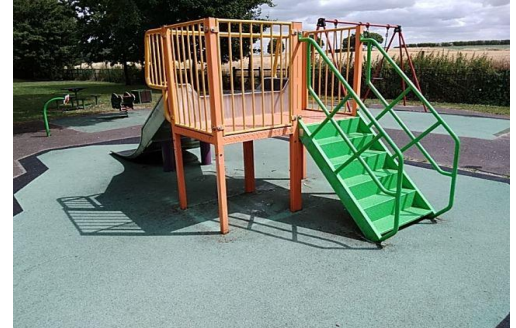
**Item:** Multi Play (Senior)  
**Manufacturer:** Wicksteed Playgrounds  
**Surface Type:** Wet Pour  
**Item Quantity:** 1  
**Equipment Compliance:** N/A  
**Surface Area Compliance:** N/A

There are gaps opening between the surfacing and the edging surround or between the joints in the surfacing - Monitor for any further deterioration and repair as required

There are a number of dents in the slide surface - Monitor for any further deterioration and repair as required

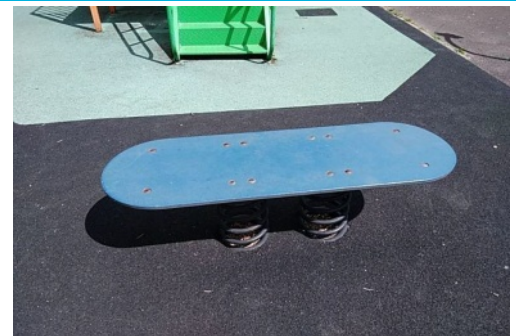
**Item:** Spring Board  
**Manufacturer:** Wicksteed Playgrounds  
**Surface Type:** Wet Pour  
**Item Quantity:** 1  
**Equipment Compliance:** Yes  
**Surface Area Compliance:** Yes

**Total Findings:** 1

**Finding 1**

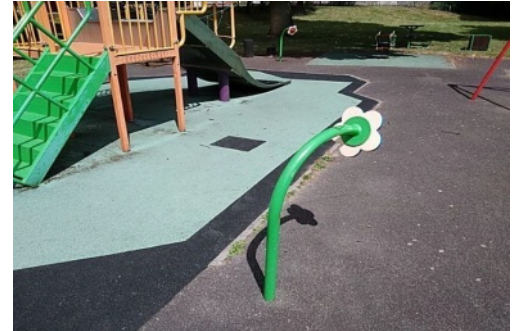
**Item:** Talk Tubes  
**Manufacturer:** Wicksteed Playgrounds  
**Surface Type:** Tarmac  
**Item Quantity:** 2  
**Equipment Compliance:** Yes  
**Surface Area Compliance:** N/A

**Total Findings:** 1

**Finding 1**

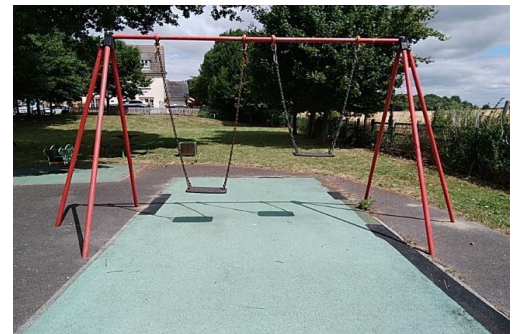
**Item:** 1 Bay 2 Seat (Flat)  
**Manufacturer:** Wicksteed Playgrounds  
**Surface Type:** Wet Pour  
**Item Part Number:** 2.4m. 2004/5  
**Item Quantity:** 1  
**Equipment Compliance:** Yes  
**Surface Area Compliance:** Yes  
**Total Findings:** 2

There are gaps opening between the surfacing and the edging surround or between the joints in the surfacing - Monitor for any further deterioration and repair as required

Bird faeces - Remove as required

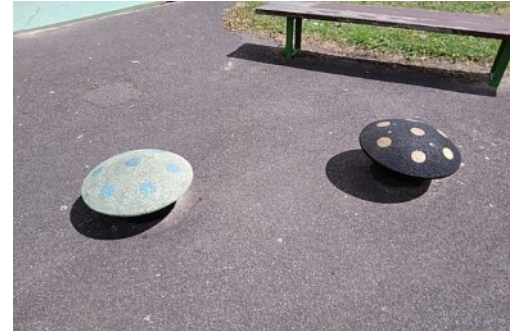
**Item:** Toadstools  
**Manufacturer:** Wicksteed Playgrounds  
**Surface Type:** Tarmac  
**Item Quantity:** 2  
**Equipment Compliance:** N/A  
**Surface Area Compliance:** N/A

**Total Findings:** 1

**Finding 1**

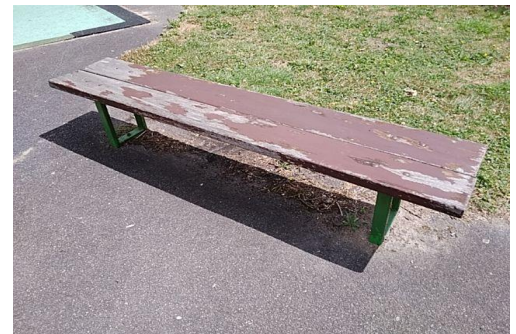
**Item:** Bench  
**Manufacturer:** Wicksteed Playgrounds  
**Surface Type:** Tarmac  
**Item Quantity:** 1  
**Equipment Compliance:** N/A  
**Surface Area Compliance:** N/A

Flaking coating may create splinter / abrasion hazards - Rub down and treat as required

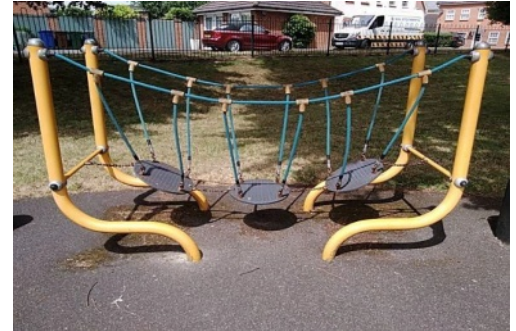
**Item:** Bridge  
**Manufacturer:** Wicksteed Playgrounds  
**Surface Type:** Tarmac  
**Item Quantity:** 1  
**Equipment Compliance:** Yes  
**Surface Area Compliance:** Yes

**Total Findings:** 1

**Finding 1**

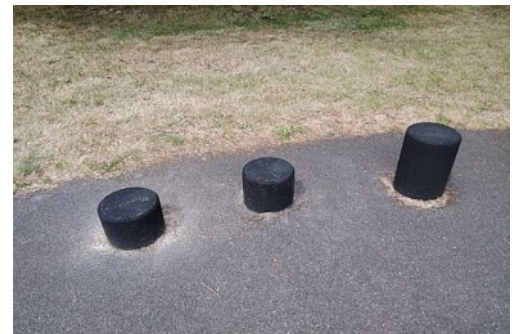
**Item:** Stepping Posts Rubber  
**Manufacturer:** Wicksteed Playgrounds  
**Surface Type:** Tarmac  
**Item Quantity:** 5  
**Equipment Compliance:** Yes  
**Surface Area Compliance:** Yes

**Total Findings:** 1

**Finding 1**

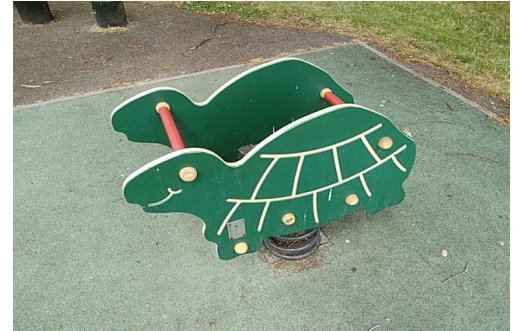
**Item:** Spring Snail  
**Manufacturer:** Wicksteed Playgrounds  
**Surface Type:** Wet Pour  
**Item Part Number:** 2006/7  
**Item Quantity:** 1  
**Equipment Compliance:** N/A  
**Surface Area Compliance:** N/A  
**Total Findings:** 1

There is/are bolt cap covers missing or damaged on the item - Replace missing or damaged bolt cap covers

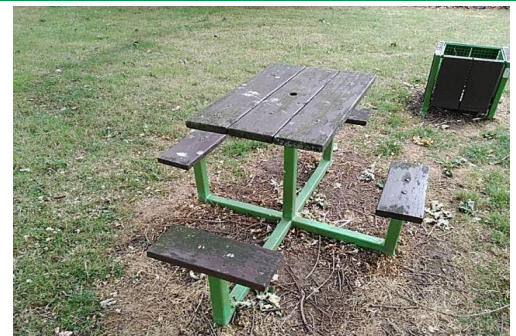
**Item:** Table  
**Manufacturer:** Wicksteed Playgrounds  
**Surface Type:** Grass  
**Item Quantity:** 1  
**Equipment Compliance:** N/A  
**Surface Area Compliance:** N/A  
**Total Findings:** 2

Bird faeces - Clean as required

Flaking coating - Rub down and treat as required

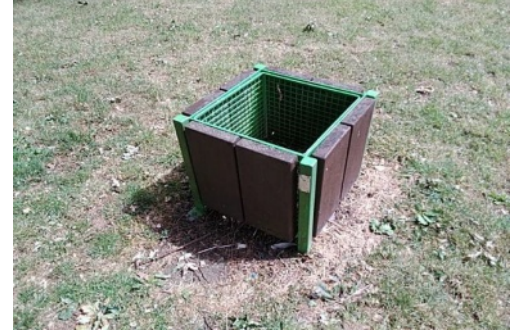
**Item:** Litter Bin  
**Manufacturer:** Wicksteed Playgrounds  
**Surface Type:** Grass  
**Item Quantity:** 2  
**Equipment Compliance:** N/A  
**Surface Area Compliance:** N/A

**Total Findings:** 1

**Finding 1**

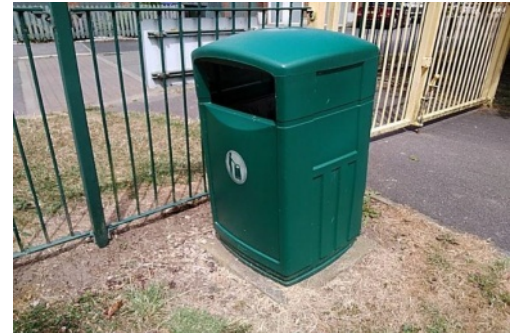
**Item:** Litter Bin  
**Manufacturer:** Unknown  
**Surface Type:** Grass  
**Item Quantity:** 1  
**Equipment Compliance:** N/A  
**Surface Area Compliance:** N/A

**Total Findings:** 1

**Finding 1**

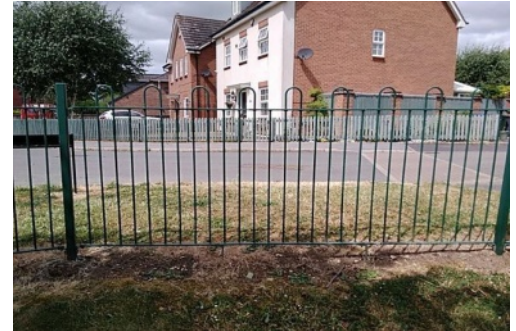
**Item:** Fence - Bow Top  
**Manufacturer:** Unknown  
**Surface Type:** Grass  
**Item Quantity:** 1  
**Equipment Compliance:** Yes  
**Surface Area Compliance:** N/A

**Total Findings:** 1

**Finding 1**

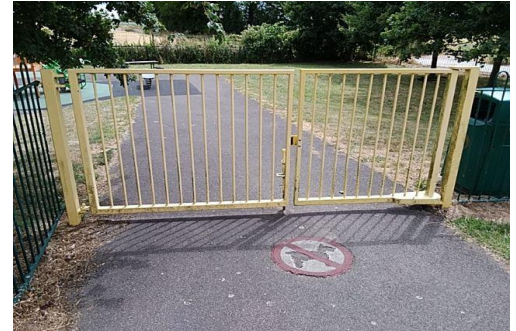
**Item:** Gate - Combination  
**Manufacturer:** Wicksteed Playgrounds  
**Surface Type:** Tarmac  
**Item Quantity:** 1  
**Equipment Compliance:** Yes  
**Surface Area Compliance:** N/A

Generally satisfactory, but recommend the unsprung gate is kept locked when not in use to ensure correct operation of the gates - Keep locked

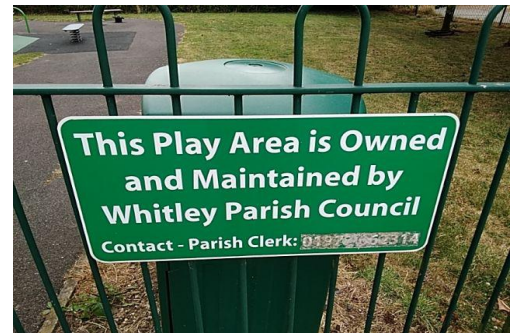
**Item:** Playground Sign  
**Manufacturer:** Unknown  
**Surface Type:** N/A  
**Item Quantity:** 1  
**Equipment Compliance:** N/A  
**Surface Area Compliance:** N/A

BS EN 1176 Part 7 recommends that signage shall include the site name / address - Provide additional information

BS EN 1176 Part 7 recommends that signage shall include emergency contact details and contact details of owner / operator for reporting maintenance issues - Provide additional information

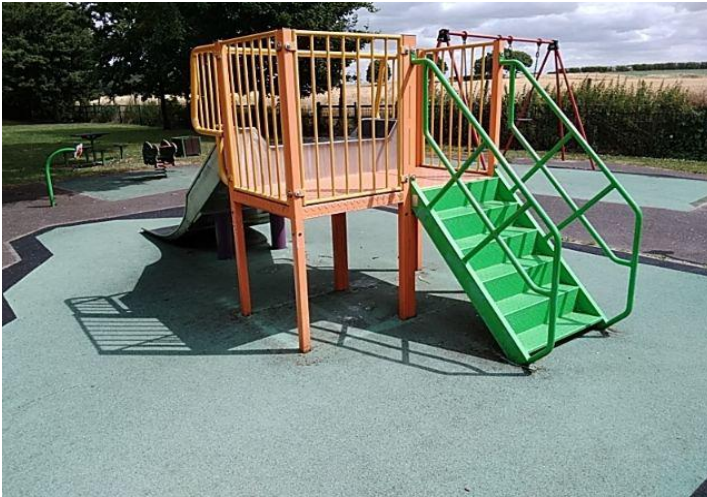
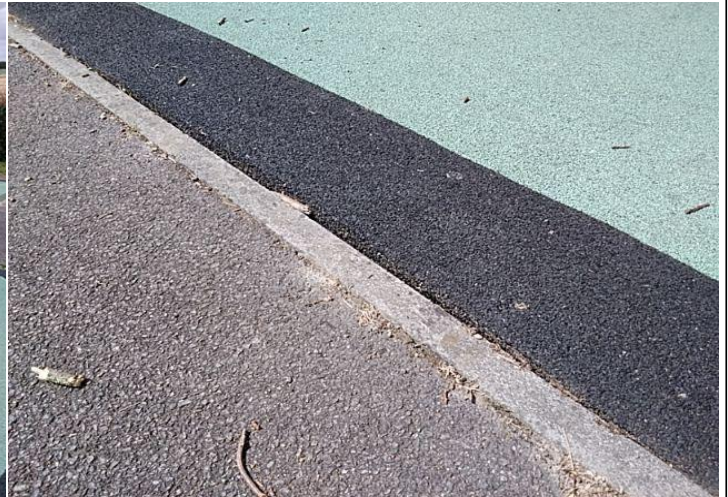
**Item:** Activity Equipment - Multi Play (Senior)  
**Manufacturer:** Wicksteed Playgrounds

**Finding:** There are gaps opening between the surfacing and the edging surround or between the joints in the surfacing  
**Action:** Monitor for any further deterioration and repair as required

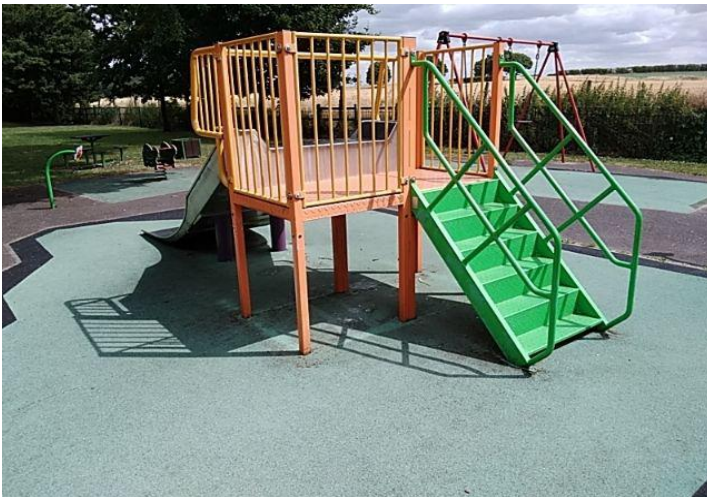
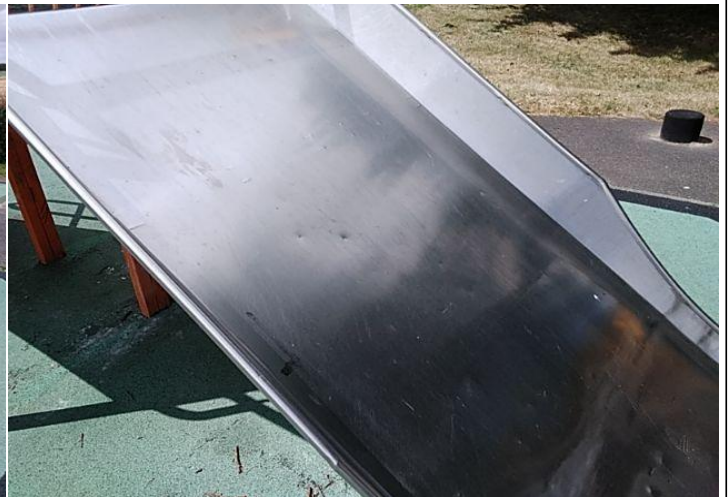
**Item:** Activity Equipment - Multi Play (Senior)  
**Manufacturer:** Wicksteed Playgrounds

**Finding:** There are a number of dents in the slide surface  
**Action:** Monitor for any further deterioration and repair as required

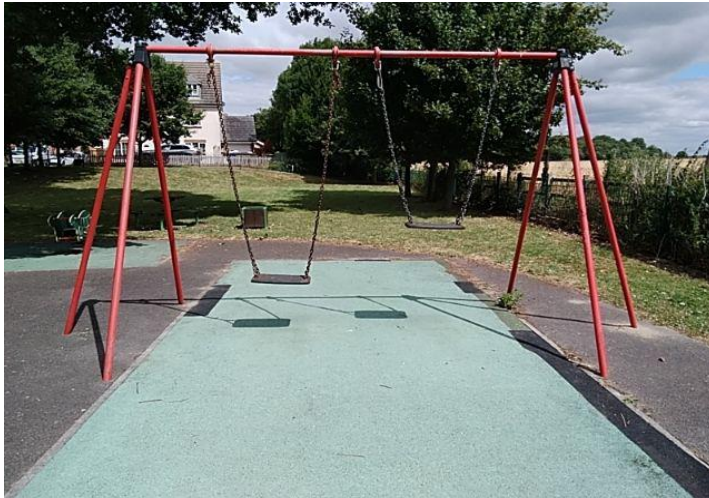
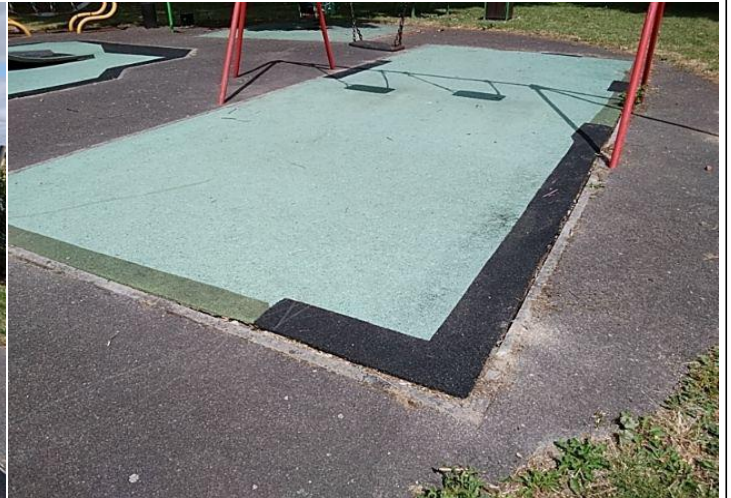
**Item:** Swings - 1 Bay 2 Seat (Flat)  
**Manufacturer:** Wicksteed Playgrounds

**Finding:** There are gaps opening between the surfacing and the edging surround or between the joints in the surfacing **Action:** Monitor for any further deterioration and repair as required

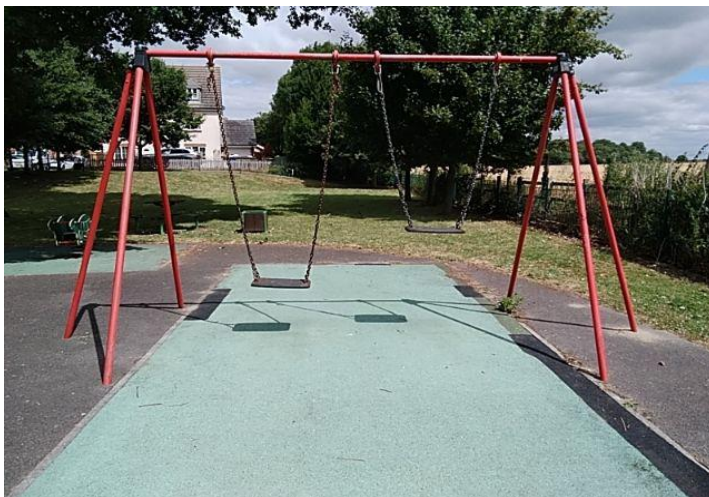
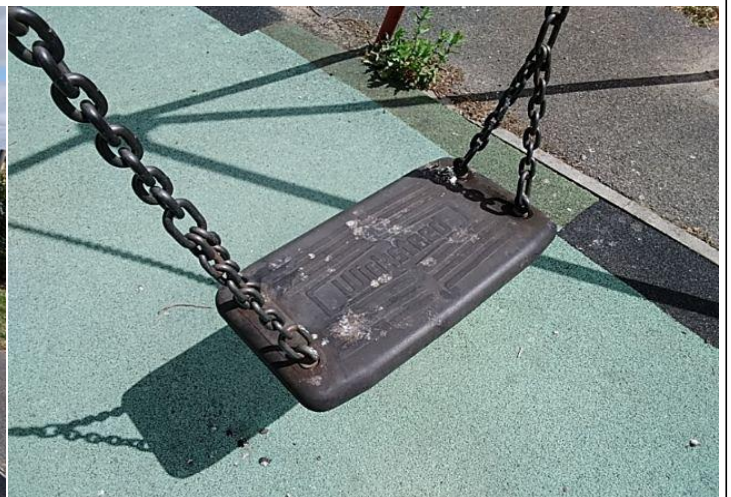
**Item:** Swings - 1 Bay 2 Seat (Flat)  
**Manufacturer:** Wicksteed Playgrounds

**Finding:** Bird faeces **Action:** Remove as required

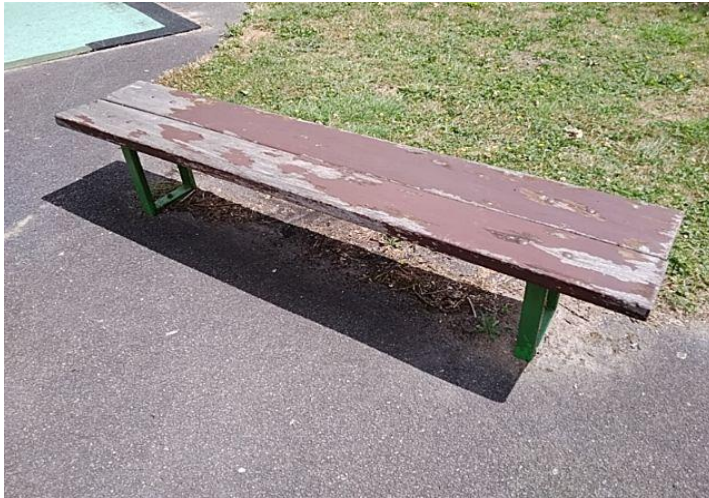
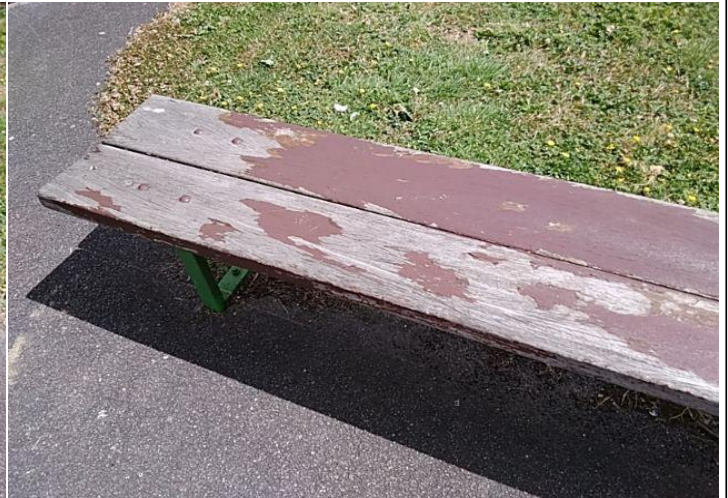
**Item:** Ancillary Items - Bench  
**Manufacturer:** Wicksteed Playgrounds

**Finding:** Flaking coating may create splinter / abrasion hazards

**Action:** Rub down and treat as required

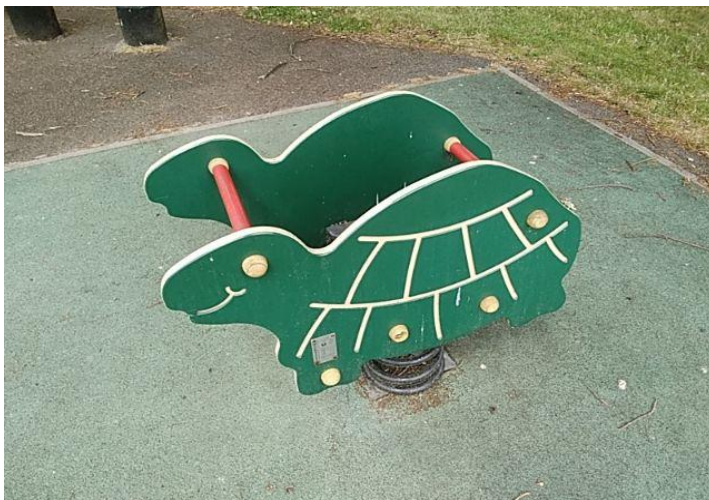
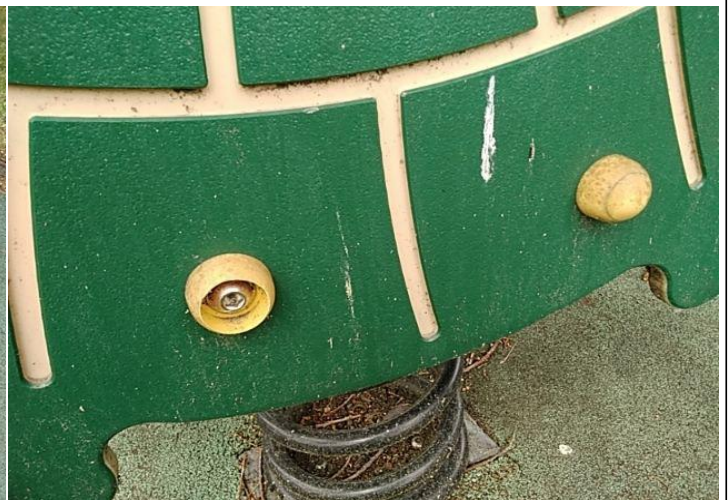
**Item:** Rocking Equipment - Spring Snail  
**Manufacturer:** Wicksteed Playgrounds

**Finding:** There is/are bolt cap covers missing or damaged on the item

**Action:** Replace missing or damaged bolt cap covers

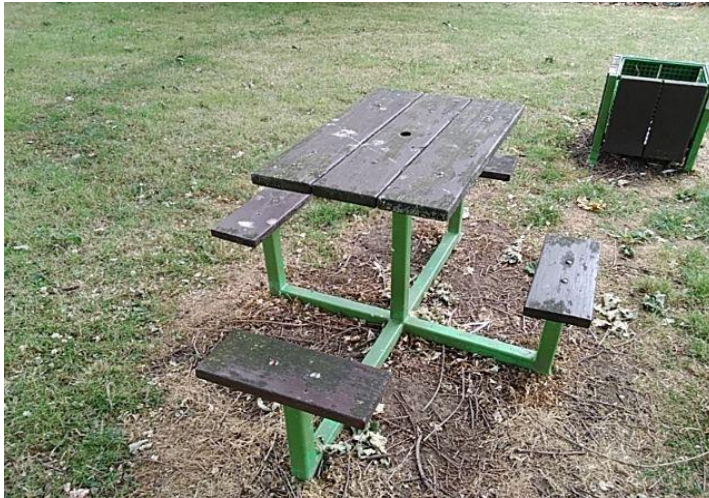
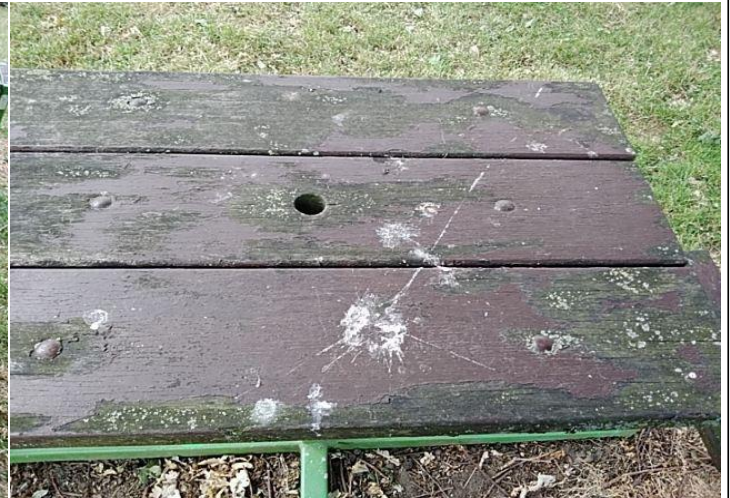
**Item:** Ancillary Items - Table  
**Manufacturer:** Wicksteed Playgrounds

**Finding:** Bird faeces

**Action:** Clean as required

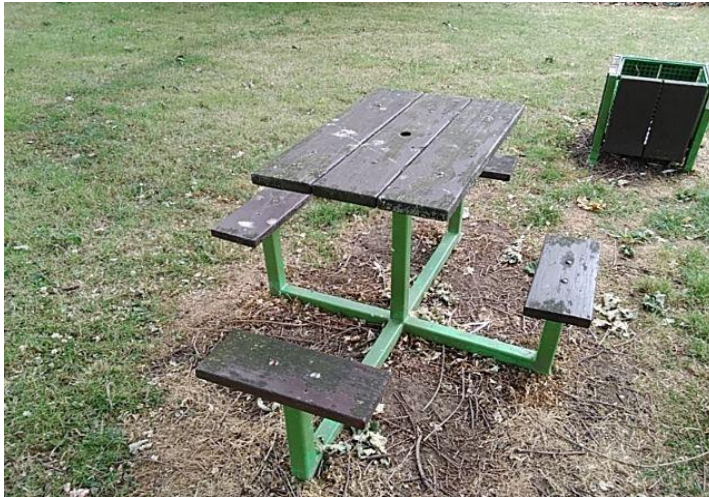
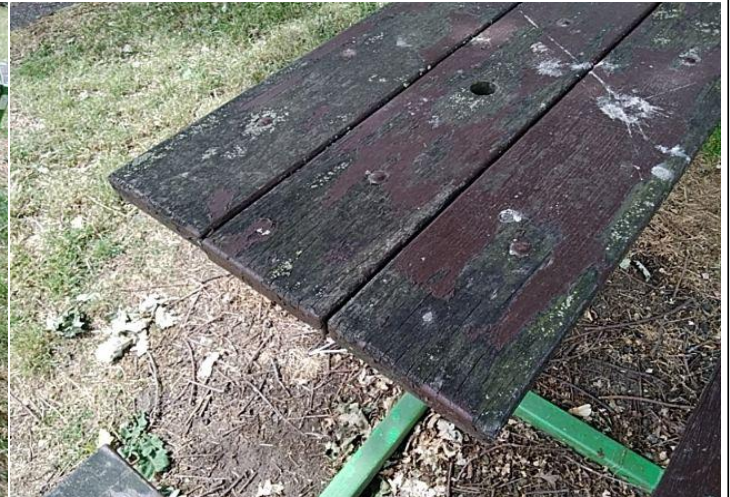
**Item:** Ancillary Items - Table  
**Manufacturer:** Wicksteed Playgrounds

**Finding:** Flaking coating

**Action:** Rub down and treat as required

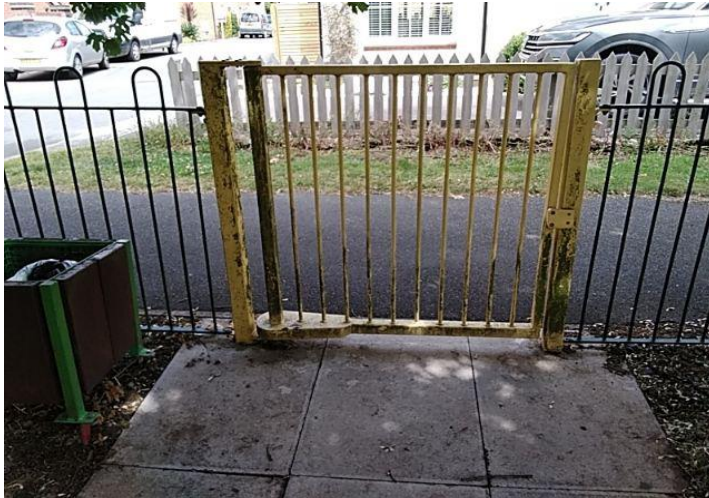
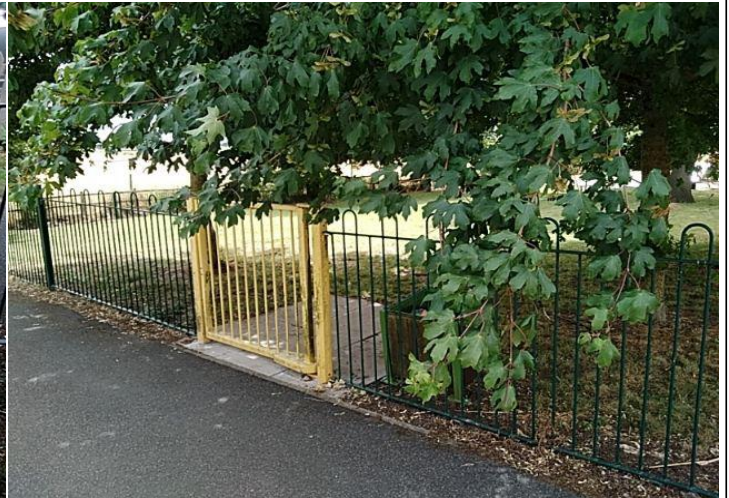
**Item:** Gates - Gate - Self Closing  
**Manufacturer:** Wicksteed Playgrounds

**Finding:** The adjacent foliage is overhanging

**Action:** Cut back and maintain

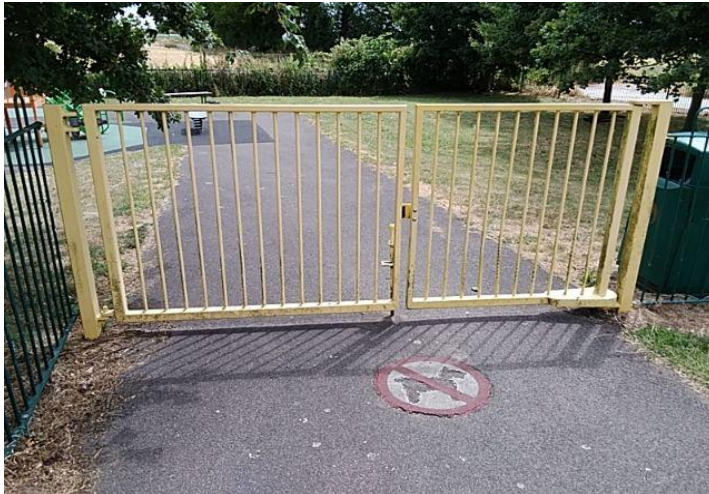
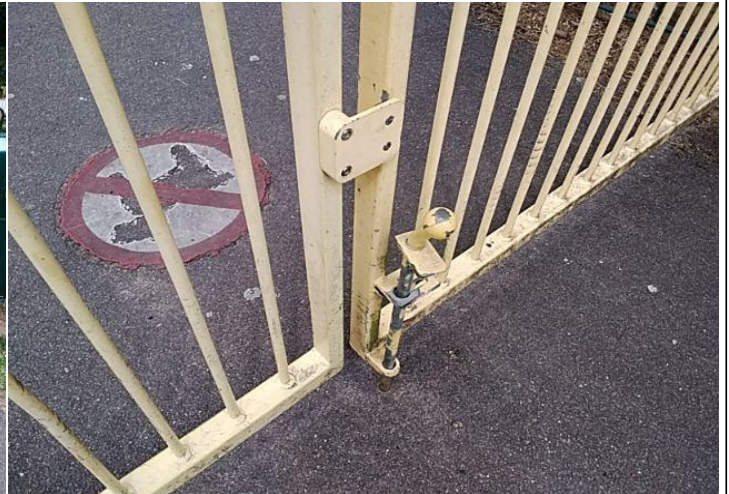
**Item:** Gates - Gate - Combination  
**Manufacturer:** Wicksteed Playgrounds

**Finding:** Generally satisfactory, but recommend the unsprung gate is kept locked when not in use to ensure correct operation of the gates

**Action:** Keep locked

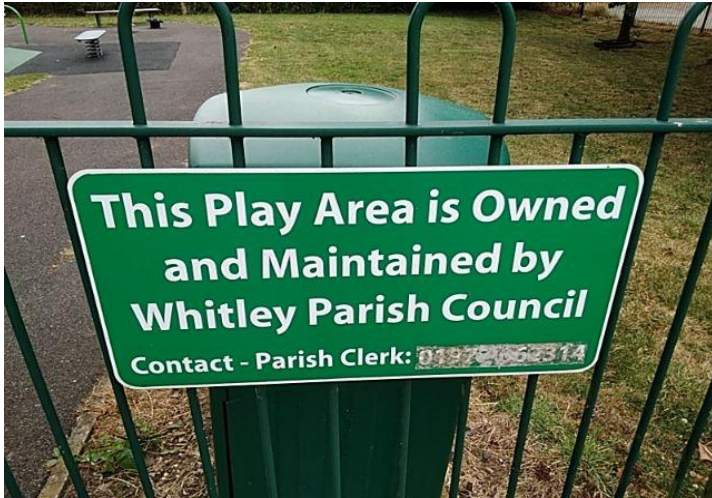
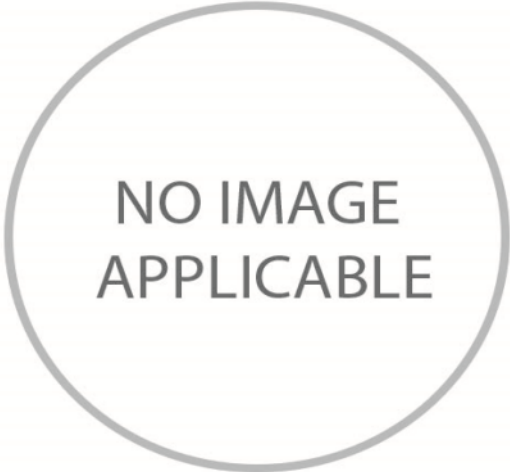
<b>Item:</b>	Signs - Playground Sign	<b>Risk Level:</b>	V - Very Low Risk
<b>Manufacturer:</b>	Unknown	<b>Surface:</b>	N/A

**Finding:** BS EN 1176 Part 7 recommends that signage shall include the site name / address **Action:** Provide additional information

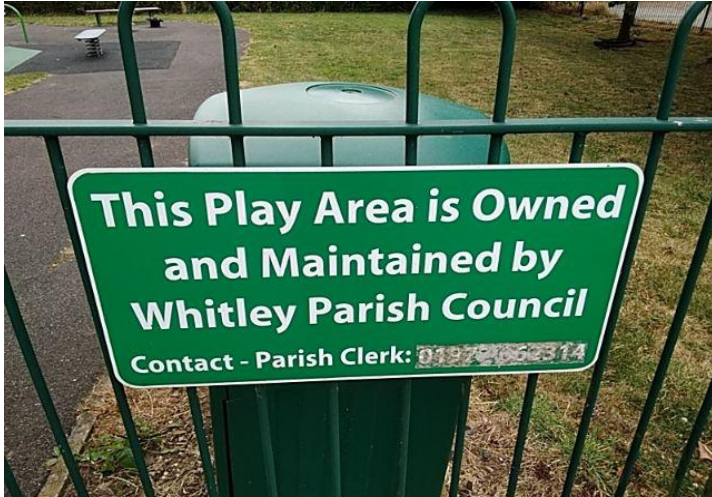
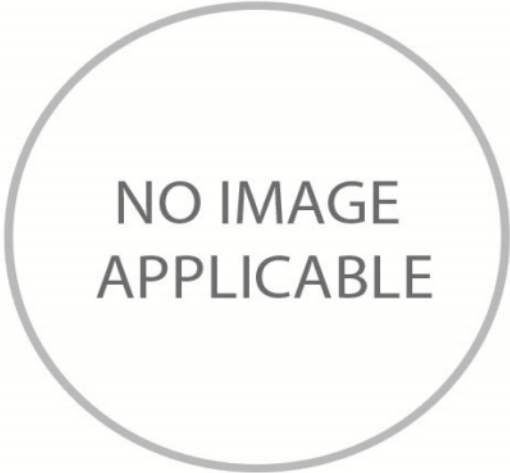
<b>Item:</b>	Signs - Playground Sign	<b>Risk Level:</b>	V - Very Low Risk
<b>Manufacturer:</b>	Unknown	<b>Surface:</b>	N/A

**Finding:** BS EN 1176 Part 7 recommends that signage shall include emergency contact details and contact details of owner / operator for reporting maintenance issues **Action:** Provide additional information
