Annual Inspection

Whitley Parish Council

Lee View

Inspection Ref: 1703916

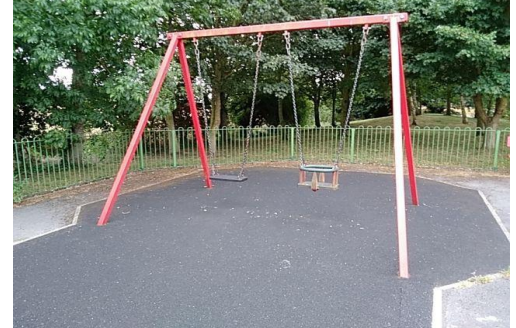
Item: 1 Bay 2 Seat Swing
Manufacturer: Unknown
Surface Type: Wet Pour
Item Quantity: 1
Equipment Compliance: Yes
Surface Area Compliance: Yes

There is no identification label affixed to the equipment -
 Provide an identification label

There are gaps opening between the surfacing and the
 edging surround or between the joints in the surfacing -
 Monitor for any further deterioration and repair as required

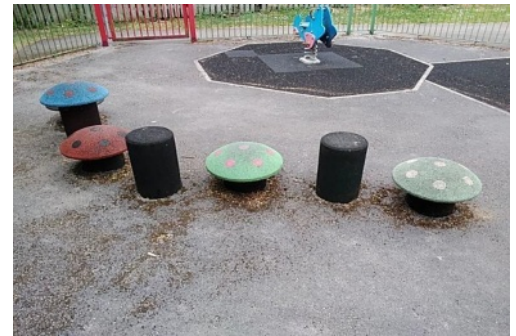
Item: Activity Trail
Manufacturer: Unknown
Surface Type: Tarmac
Item Quantity: 1
Equipment Compliance: N/A
Surface Area Compliance: N/A

This item is satisfactory - no work required -

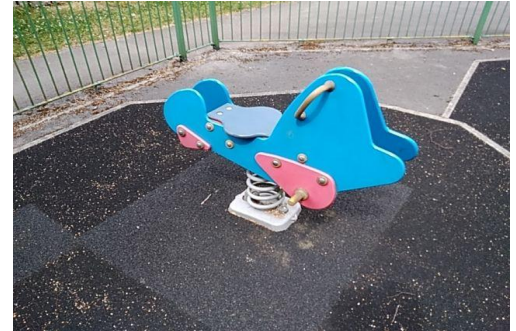
Item: Spring Aeroplane
Manufacturer: Ledon
Surface Type: Wet Pour
Item Quantity: 1
Equipment Compliance: No
Surface Area Compliance: Yes

The end of footrests have a cross section of less than 15cm² and fail to meet the requirements of BS EN 1176 Part 6 - Monitor - No remedial work recommended

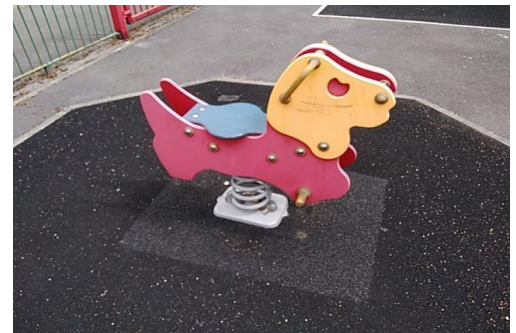
Item: Spring Dog
Manufacturer: Ledon
Surface Type: Wet Pour
Item Quantity: 1
Equipment Compliance: No
Surface Area Compliance: Yes

The end of footrests have a cross section of less than 15cm² and fail to meet the requirements of BS EN 1176 Part 6 - Monitor - No remedial work recommended

The item has been damaged - Monitor for any further deterioration and replace as required

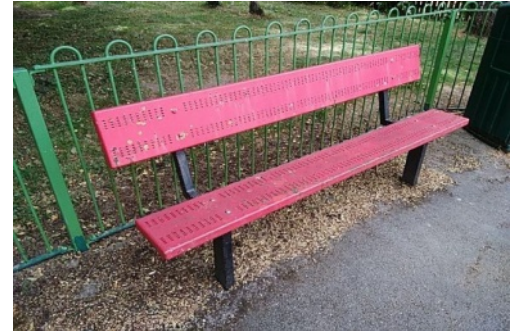
Item: Seat
Manufacturer: Record RSS
Surface Type: Tarmac
Item Quantity: 1
Equipment Compliance: N/A
Surface Area Compliance: N/A

This item is satisfactory - no work required -

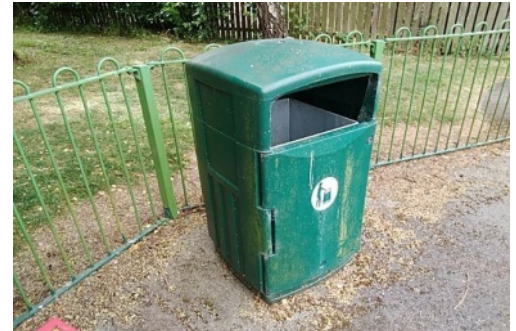
Item: Litter Bin
Manufacturer: Glasdon
Surface Type: Tarmac
Item Quantity: 1
Equipment Compliance: N/A
Surface Area Compliance: N/A

This item is satisfactory - no work required -

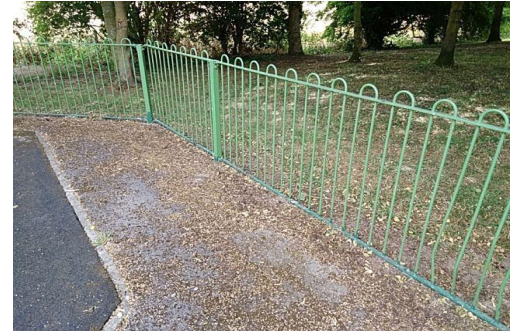
Item: Fence - Bow Top
Manufacturer: Unknown
Surface Type: Tarmac
Item Quantity: 1
Equipment Compliance: Yes
Surface Area Compliance: N/A

The item has been damaged - Monitor for any further deterioration and replace as required

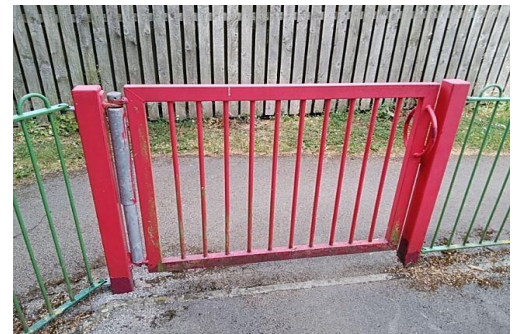
Item: Gate - Pedestrian
Manufacturer: Unknown
Surface Type: Tarmac
Item Quantity: 1
Equipment Compliance: N/A
Surface Area Compliance: N/A

The gate is not self closing - Adjust if possible

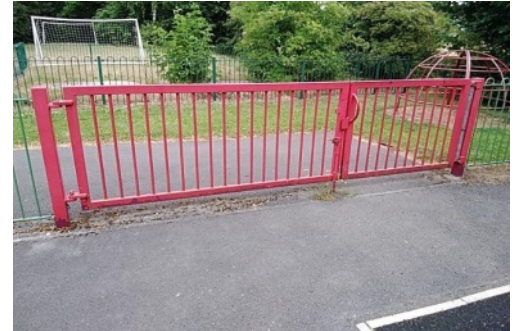
Item: Gate - Combination
Manufacturer: Unknown
Surface Type: Tarmac
Item Quantity: 1
Equipment Compliance: Yes
Surface Area Compliance: N/A

This item is satisfactory - no work required -

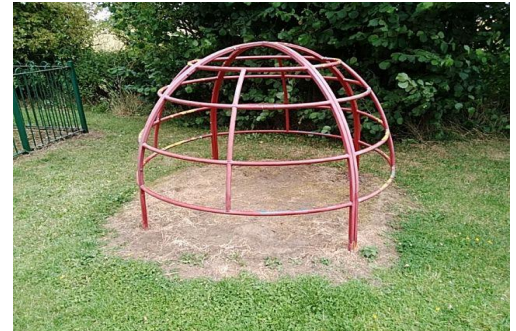
Item: Climbing Frame
Manufacturer: Unknown
Surface Type: Grass Matrix Tiles
Item Quantity: 1
Equipment Compliance: Yes
Surface Area Compliance: Yes

There is no identification label affixed to the equipment - Provide an identification label

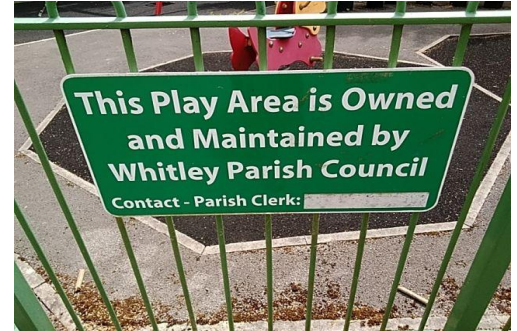
Item: Sign
Manufacturer: Unknown
Surface Type: N/A
Item Quantity: 1
Equipment Compliance: No
Surface Area Compliance: N/A

BS EN 1176 Part 7 recommends that signage shall include the site name / address - Provide additional information

BS EN 1176 Part 7 recommends that signage shall include emergency contact details and contact details of owner / operator for reporting maintenance issues - Provide additional information

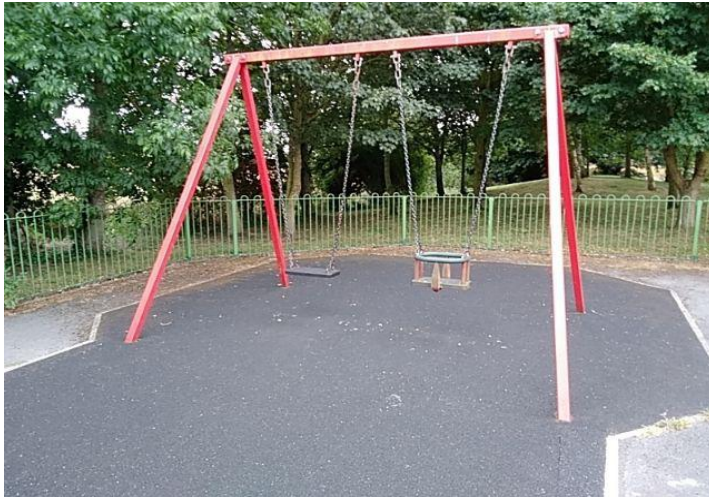
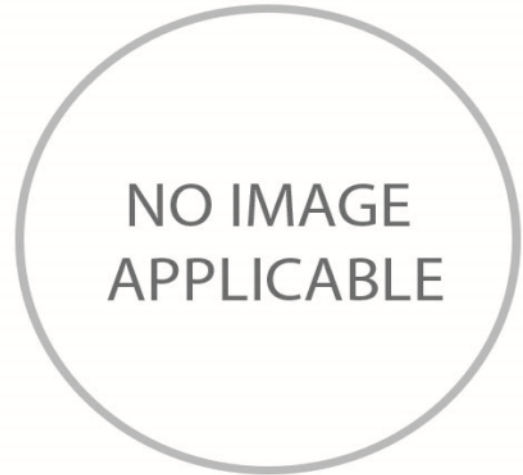
Item: Swings - 1 Bay 2 Seat Swing
Manufacturer: Unknown

Finding: There is no identification label affixed to the equipment

Action: Provide an identification label

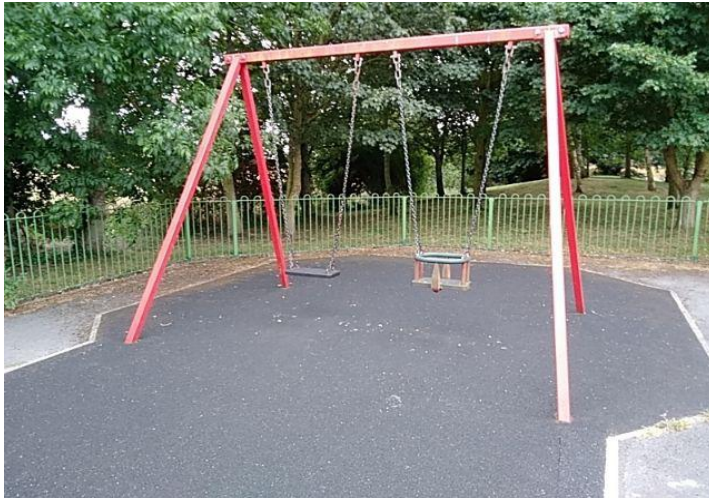
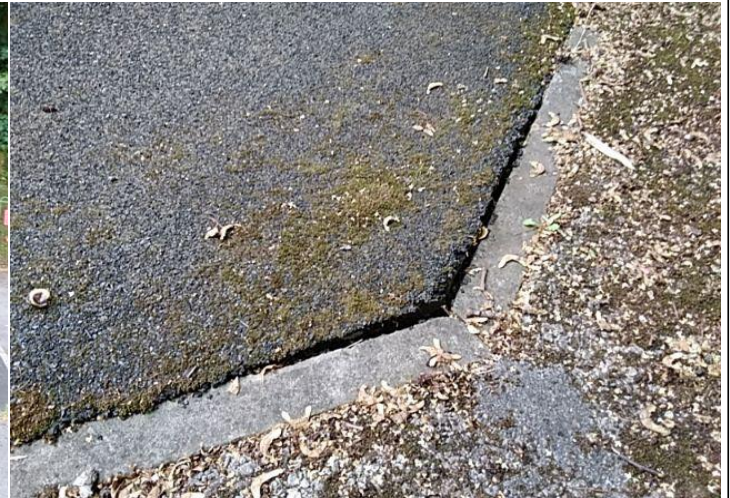
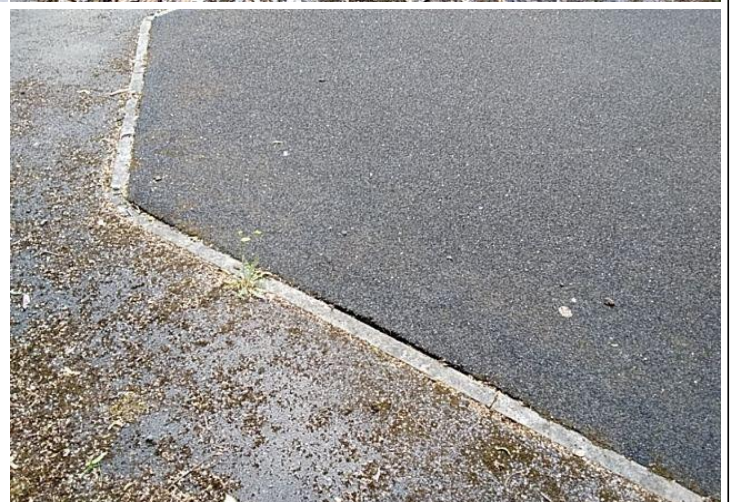
Item: Swings - 1 Bay 2 Seat Swing
Manufacturer: Unknown

Finding: There are gaps opening between the surfacing and the edging surround or between the joints in the surfacing
Action: Monitor for any further deterioration and repair as required

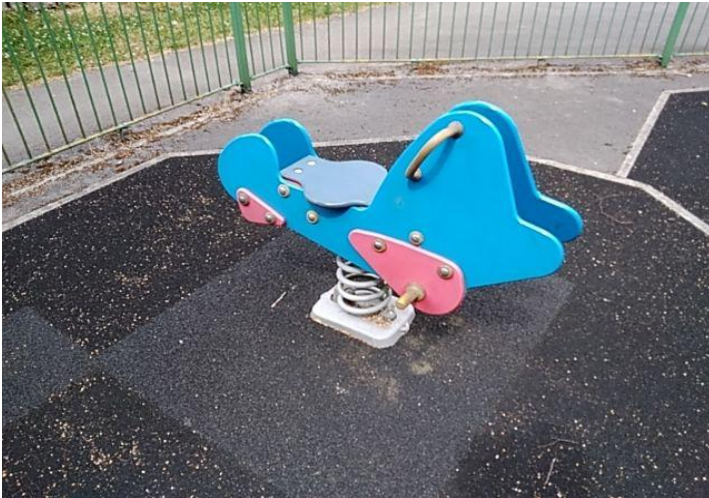
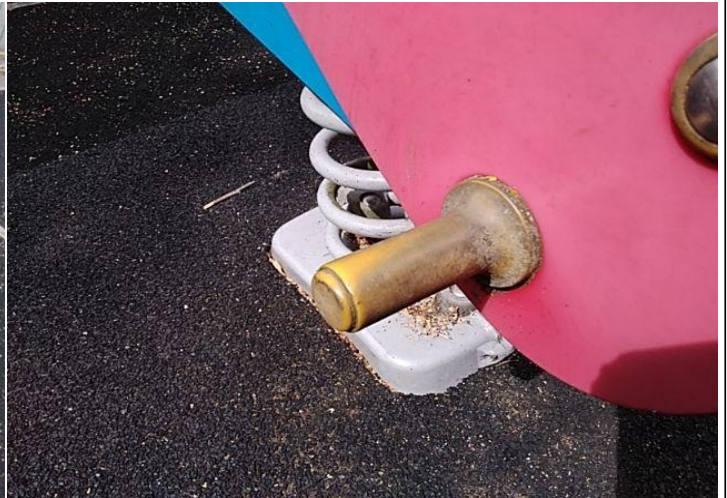
Item: Rocking Equipment - Spring Aeroplane
Manufacturer: Ledon

Finding: The end of footrests have a cross section of less than 15cm² and fail to meet the requirements of BS EN 1176 Part 6

Action: Monitor - No remedial work recommended

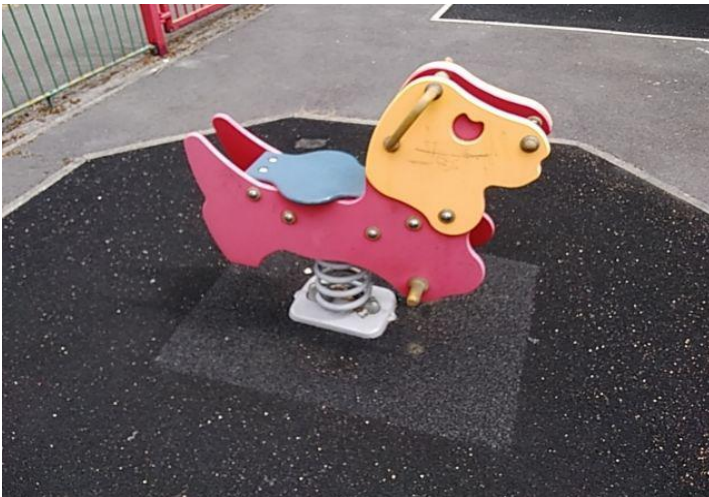
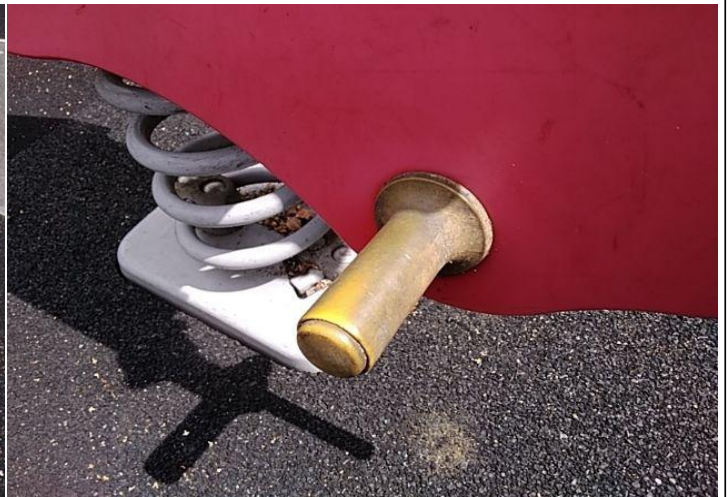
Item: Rocking Equipment - Spring Dog
Manufacturer: Ledon

Finding: The end of footrests have a cross section of less than 15cm² and fail to meet the requirements of BS EN 1176 Part 6

Action: Monitor - No remedial work recommended

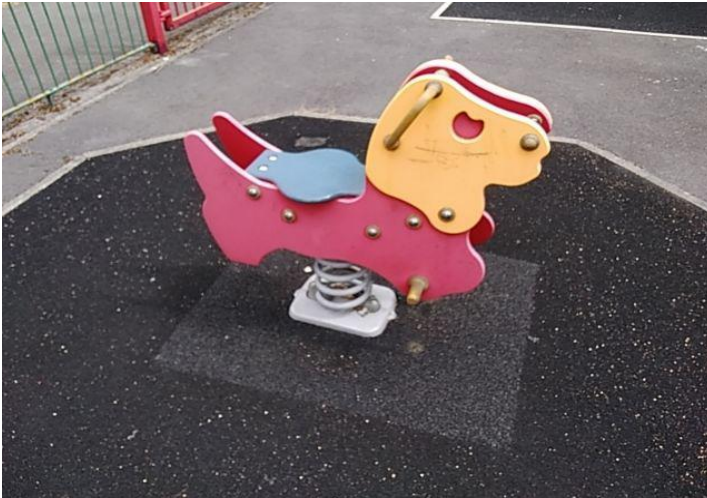
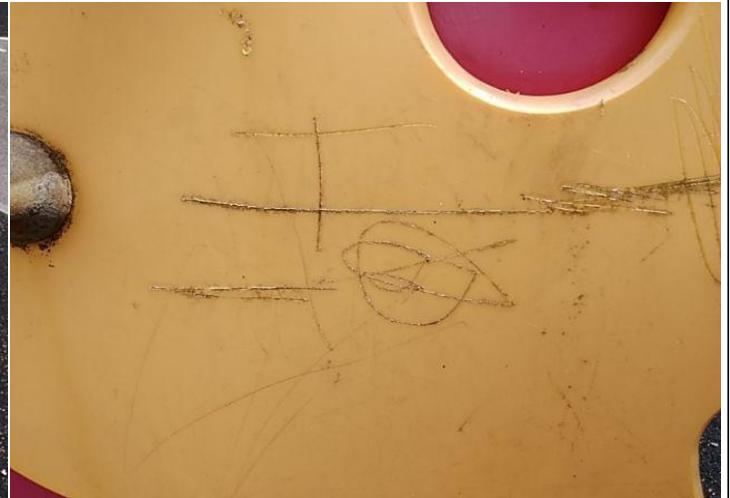
Item: Rocking Equipment - Spring Dog
Manufacturer: Ledon

Finding: The item has been damaged

Action: Monitor for any further deterioration and replace as required

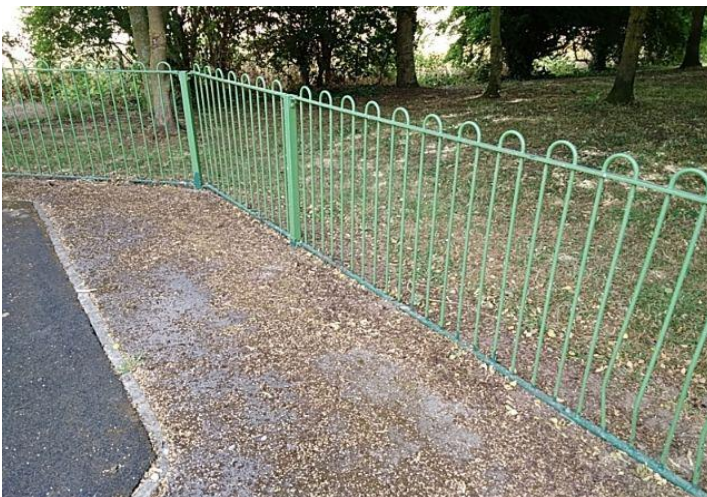
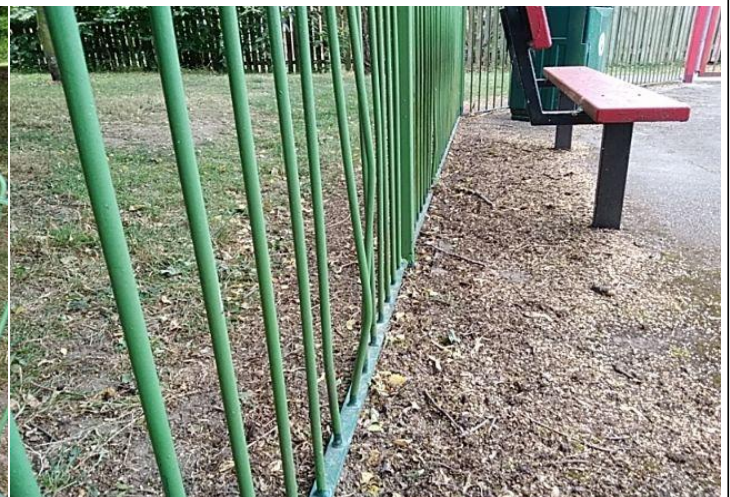
Item: Fences - Fence - Bow Top
Manufacturer: Unknown

Finding: The item has been damaged

Action: Monitor for any further deterioration and replace as required

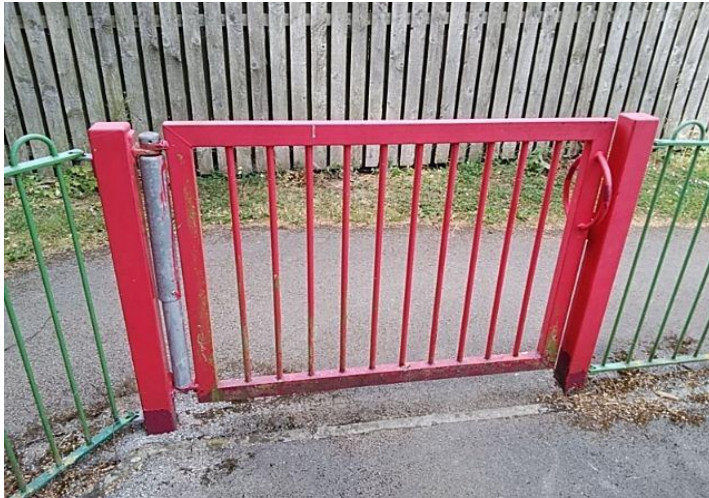
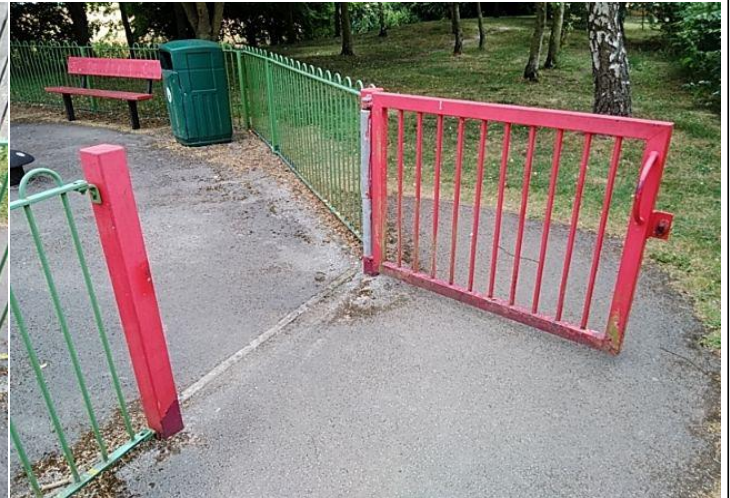
Item: Gates - Gate - Pedestrian
Manufacturer: Unknown

Finding: The gate is not self closing

Action: Adjust if possible

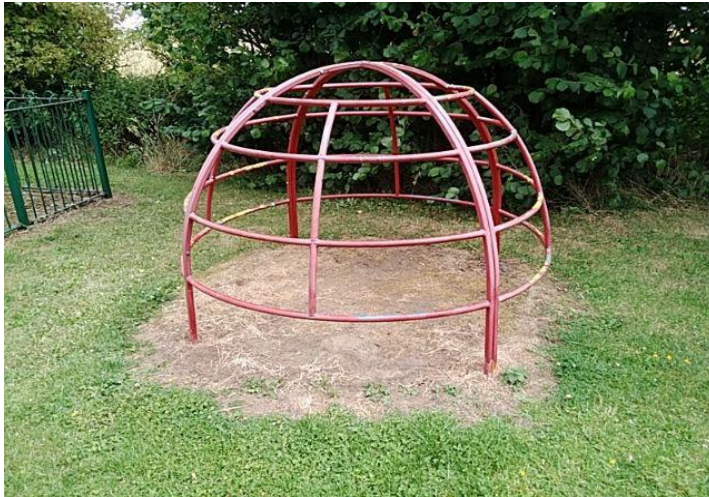
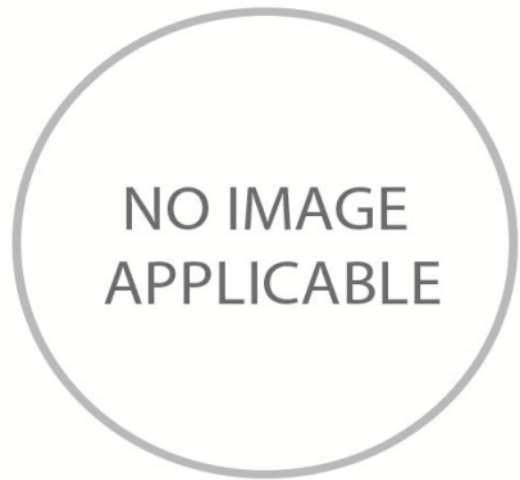
Item: Activity Equipment - Climbing Frame
Manufacturer: Unknown

Finding: There is no identification label affixed to the equipment

Action: Provide an identification label

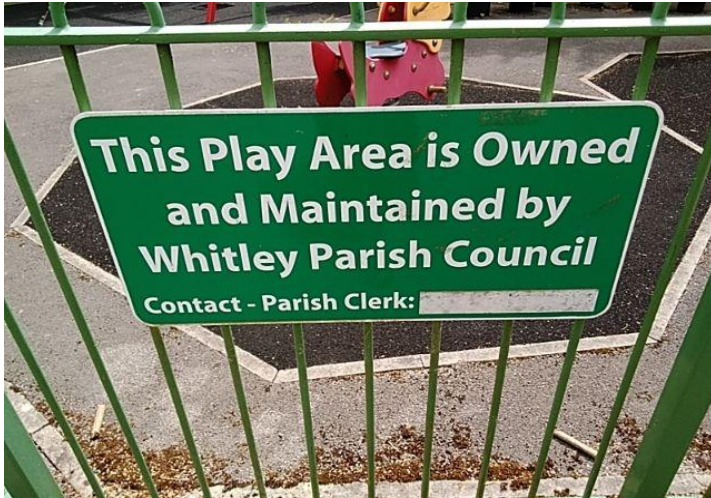
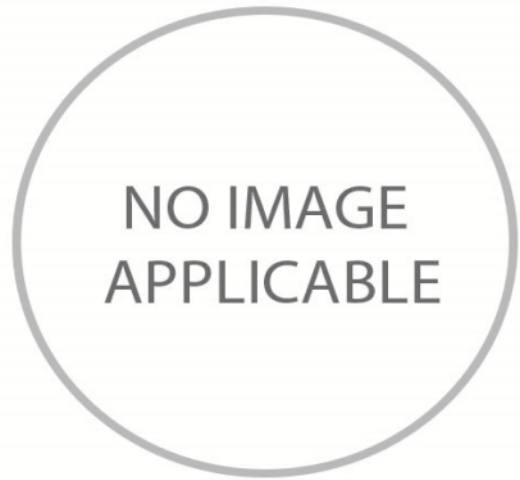
Item: Ancillary Items - Sign
Manufacturer: Unknown

Finding: BS EN 1176 Part 7 recommends that signage shall include the site name / address **Action:** Provide additional information

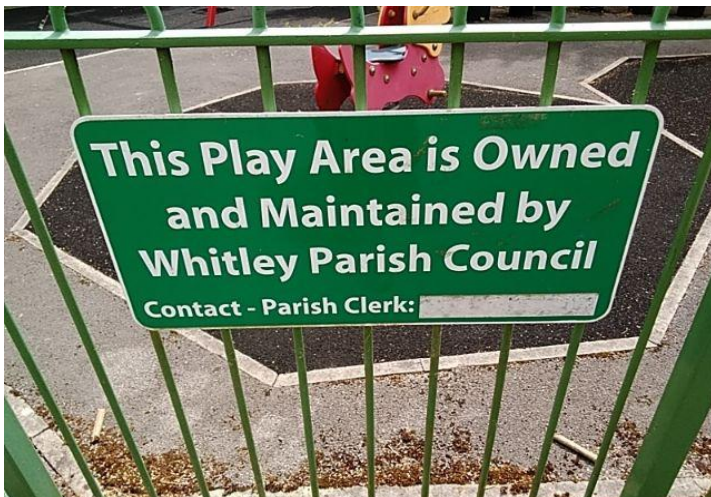
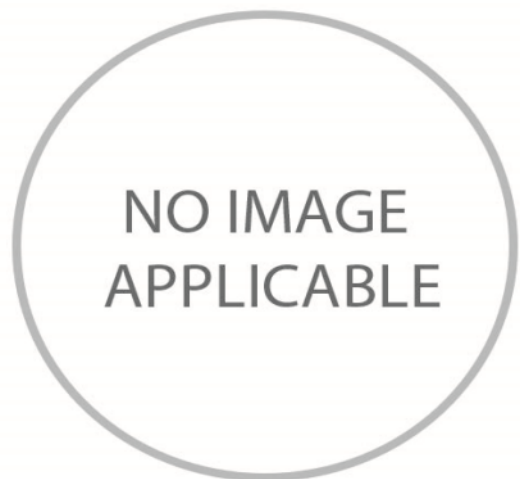
Item: Ancillary Items - Sign
Manufacturer: Unknown

Finding: BS EN 1176 Part 7 recommends that signage shall include emergency contact details and contact details of owner / operator for reporting maintenance issues **Action:** Provide additional information
