Annual Inspection

Whitley Parish Council

Blackthorn Close

Inspection Ref: 2236753

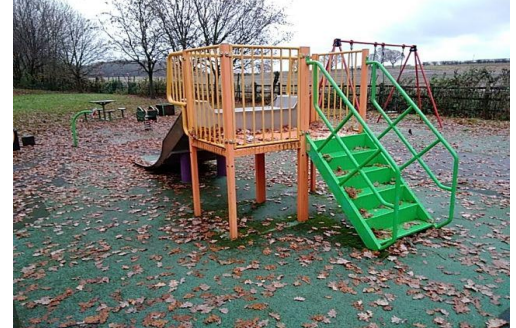
Item: Multi Play (Senior)
Manufacturer: Wicksteed Playgrounds
Surface Type: Wet Pour
Item Quantity: 1
Equipment Compliance: N/A
Surface Area Compliance: N/A

Total Findings: 2

There are gaps opening between the surfacing and the edging surround or between the joints in the surfacing - Monitor for any further deterioration and repair as required

There are a number of dents in the slide surface - Monitor for any further deterioration and repair as required

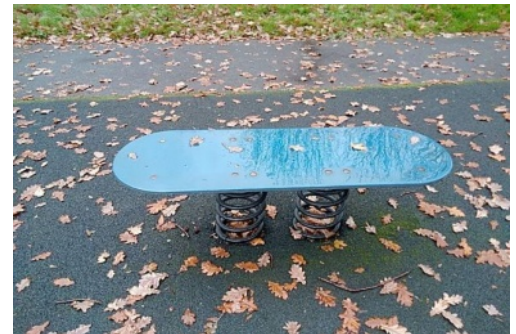
Item: Spring Board
Manufacturer: Wicksteed Playgrounds
Surface Type: Wet Pour
Item Quantity: 1
Equipment Compliance: Yes
Surface Area Compliance: Yes

This item is satisfactory - no work required -

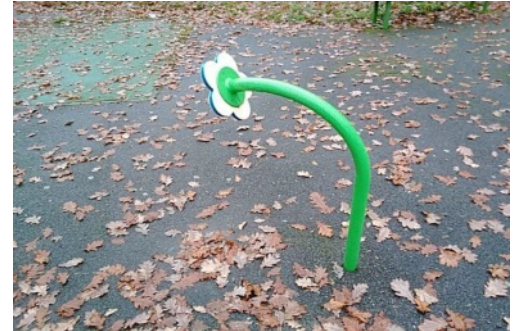
Item: Talk Tubes
Manufacturer: Wicksteed Playgrounds
Surface Type: Tarmac
Item Quantity: 2
Equipment Compliance: Yes
Surface Area Compliance: N/A

This item is satisfactory - no work required -

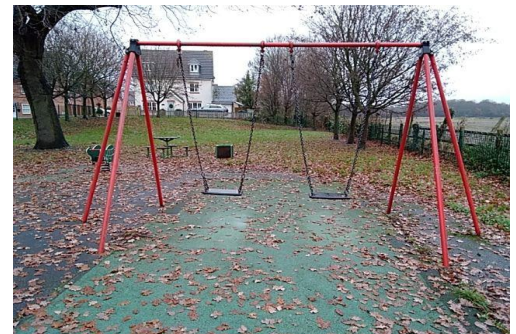
Item: 1 Bay 2 Seat (Flat)
Manufacturer: Wicksteed Playgrounds
Surface Type: Wet Pour
Item Part Number: 2.4m. 2004/5
Item Quantity: 1
Equipment Compliance: Yes
Surface Area Compliance: Yes
Total Findings: 2

There are gaps opening between the surfacing and the edging surround or between the joints in the surfacing - Monitor for any further deterioration and repair as required

There are weeds/vegetation growth between or around the edges of the surfacing - Remove weeds/vegetation growth

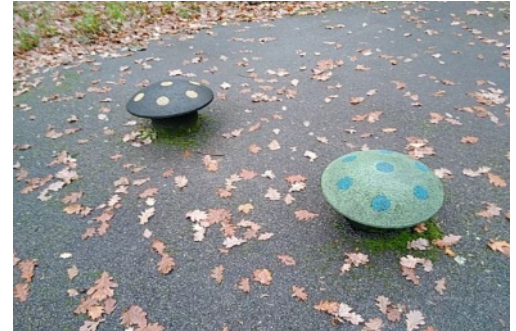
Item: Toadstools
Manufacturer: Wicksteed Playgrounds
Surface Type: Tarmac
Item Quantity: 2
Equipment Compliance: N/A
Surface Area Compliance: N/A

This item is satisfactory - no work required -

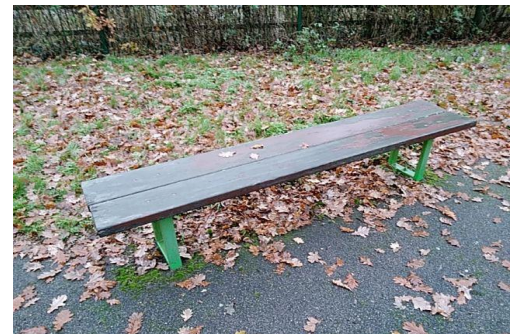
Item: Bench
Manufacturer: Wicksteed Playgrounds
Surface Type: Tarmac
Item Quantity: 1
Equipment Compliance: N/A
Surface Area Compliance: N/A

Flaking coating may create splinter / abrasion hazards - Rub down and treat as required

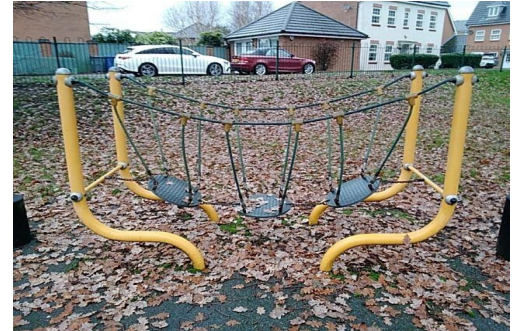
Item: Bridge
Manufacturer: Wicksteed Playgrounds
Surface Type: Tarmac
Item Quantity: 1
Equipment Compliance: Yes
Surface Area Compliance: Yes

There is algae or moss growth on the surface resulting in slippery conditions - Clean and treat appropriately

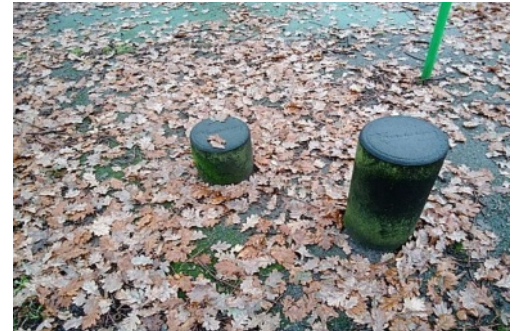
Item: Stepping Posts Rubber
Manufacturer: Wicksteed Playgrounds
Surface Type: Tarmac
Item Quantity: 5
Equipment Compliance: Yes
Surface Area Compliance: Yes

This item is satisfactory - no work required -

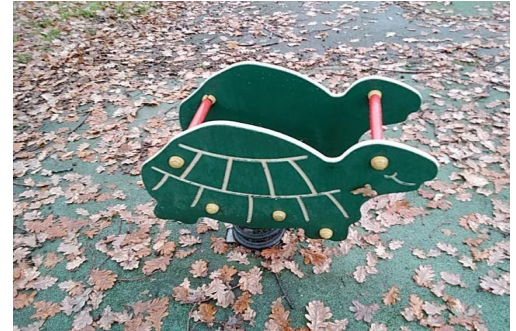
Item: Spring Snail
Manufacturer: Wicksteed Playgrounds
Surface Type: Wet Pour
Item Part Number: 2006/7
Item Quantity: 1
Equipment Compliance: N/A
Surface Area Compliance: N/A
Total Findings: 1

There is/are bolt cap covers missing or damaged on the item - Replace missing or damaged bolt cap covers

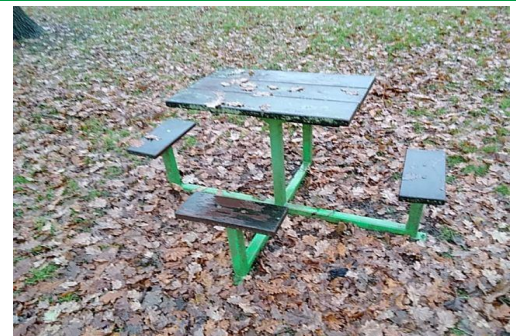
Item: Table
Manufacturer: Wicksteed Playgrounds
Surface Type: Grass
Item Quantity: 1
Equipment Compliance: N/A
Surface Area Compliance: N/A
Total Findings: 1

Flaking coating - Rub down and treat as required

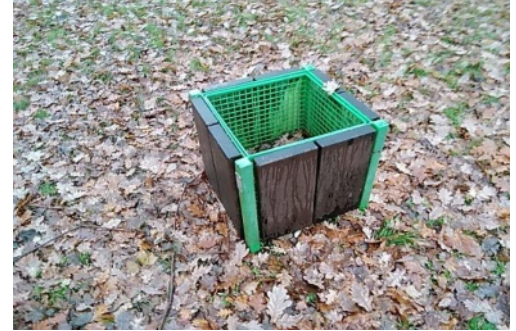
Item: Litter Bin
Manufacturer: Wicksteed Playgrounds
Surface Type: Grass
Item Quantity: 2
Equipment Compliance: N/A
Surface Area Compliance: N/A

This item is satisfactory - no work required -

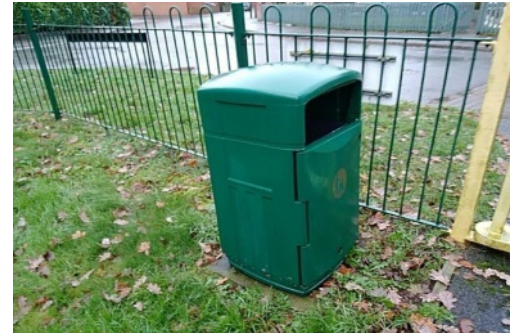
Item: Litter Bin
Manufacturer: Unknown
Surface Type: Grass
Item Quantity: 1
Equipment Compliance: N/A
Surface Area Compliance: N/A

This item is satisfactory - no work required -

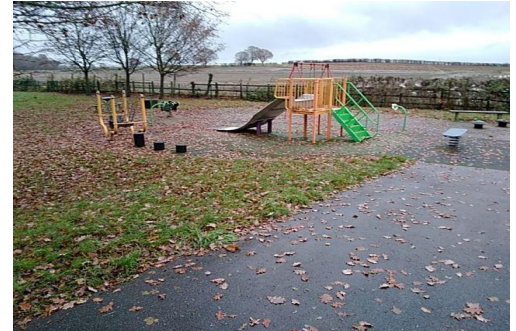
Item: Site General
Manufacturer: Unknown
Surface Type: Mixed Surface
Item Quantity: 1
Equipment Compliance: N/A
Surface Area Compliance: N/A

Leaves on the playing surface and the equipment - Clean as required

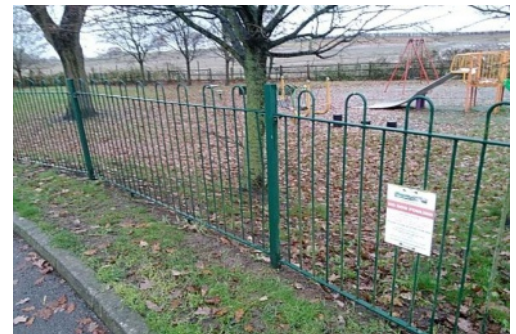
Item: Fence - Bow Top
Manufacturer: Unknown
Surface Type: Grass
Item Quantity: 1
Equipment Compliance: Yes
Surface Area Compliance: N/A

This item is satisfactory - no work required -

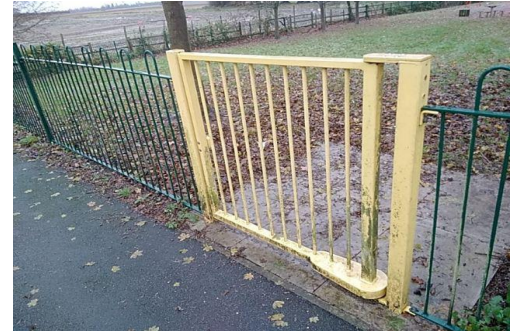
Item: Gate - Self Closing
Manufacturer: Wicksteed Playgrounds
Surface Type: Tarmac
Item Quantity: 1
Equipment Compliance: N/A
Surface Area Compliance: N/A

The adjacent foliage is overhanging - Cut back and maintain

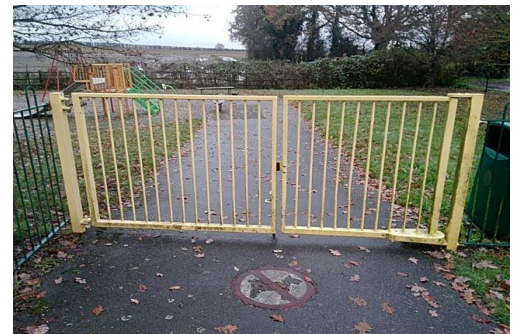
Item: Gate - Combination
Manufacturer: Wicksteed Playgrounds
Surface Type: Tarmac
Item Quantity: 1
Equipment Compliance: Yes
Surface Area Compliance: N/A

Generally satisfactory, but recommend the unsprung gate is kept locked when not in use to ensure correct operation of the gates - Keep locked

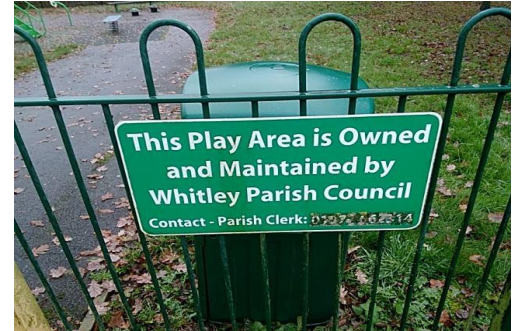
Item: Playground Sign
Manufacturer: Unknown
Surface Type: N/A
Item Quantity: 1
Equipment Compliance: N/A
Surface Area Compliance: N/A

BS EN 1176 Part 7 recommends that signage shall include emergency contact details and contact details of owner / operator for reporting maintenance issues - Provide additional information

BS EN 1176 Part 7 recommends that signage shall include the site name / address - Provide additional information

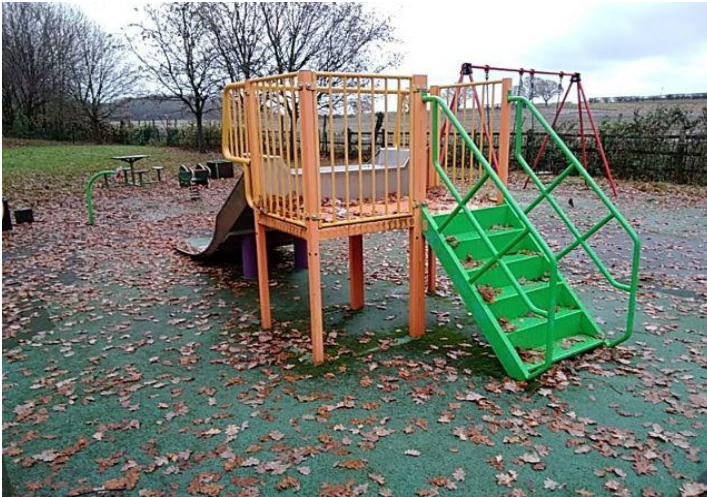
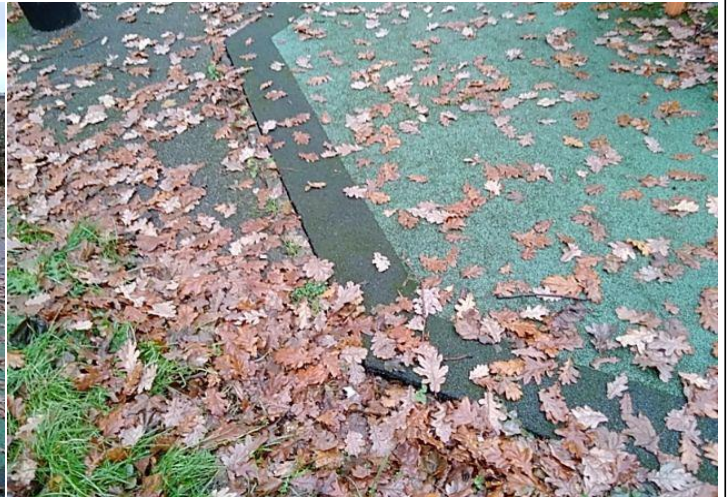
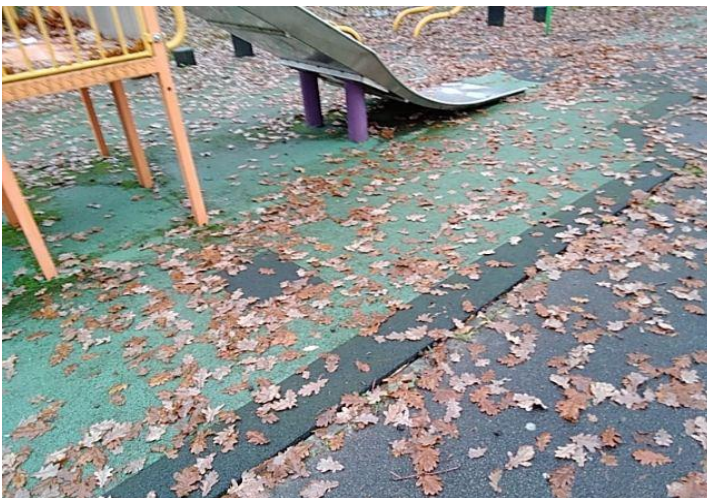
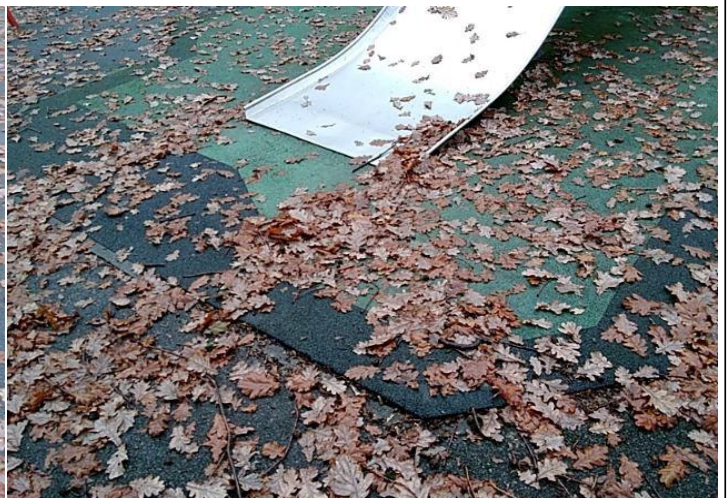
Item: Activity Equipment - Multi Play (Senior)
Manufacturer: Wicksteed Playgrounds

Finding: There are gaps opening between the surfacing and the edging surround or between the joints in the surfacing
Action: Monitor for any further deterioration and repair as required

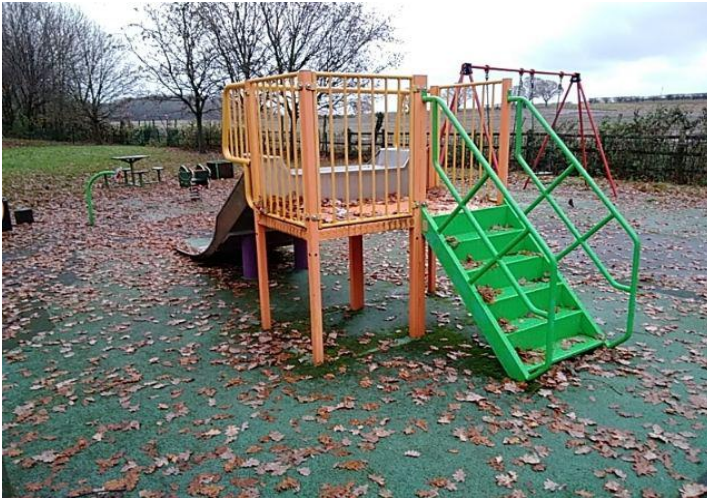
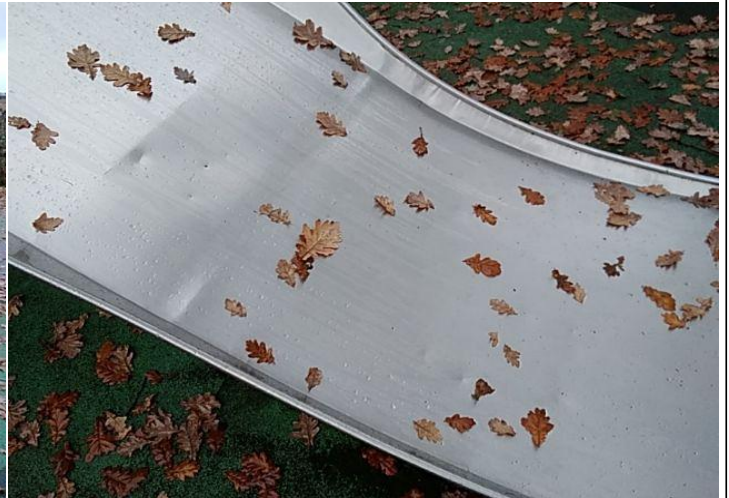
Item: Activity Equipment - Multi Play (Senior)
Manufacturer: Wicksteed Playgrounds

Finding: There are a number of dents in the slide surface

Action: Monitor for any further deterioration and repair as required

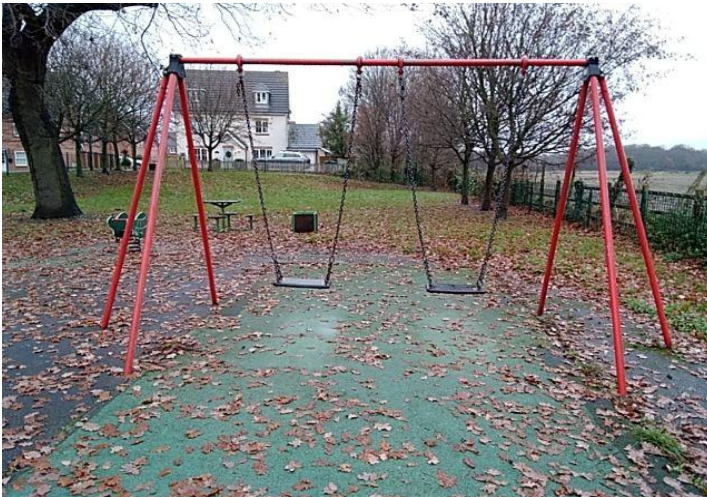
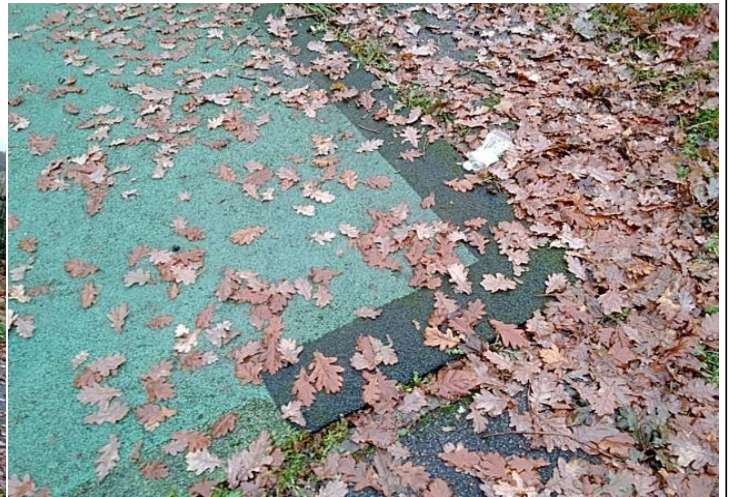
Item: Swings - 1 Bay 2 Seat (Flat)
Manufacturer: Wicksteed Playgrounds

Finding: There are gaps opening between the surfacing and the edging surround or between the joints in the surfacing

Action: Monitor for any further deterioration and repair as required

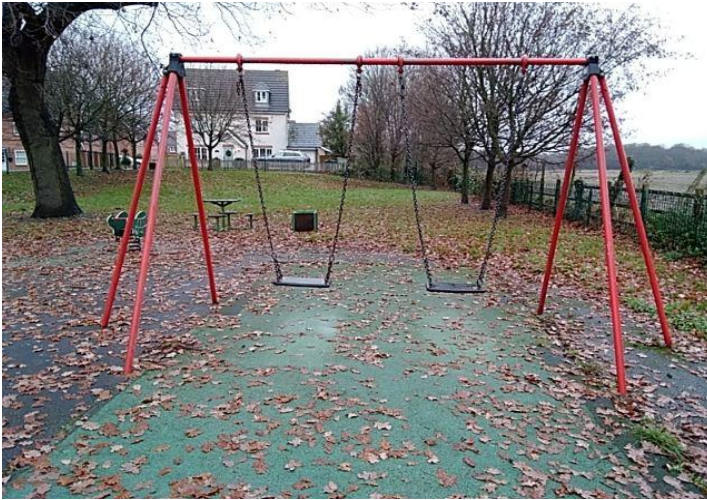
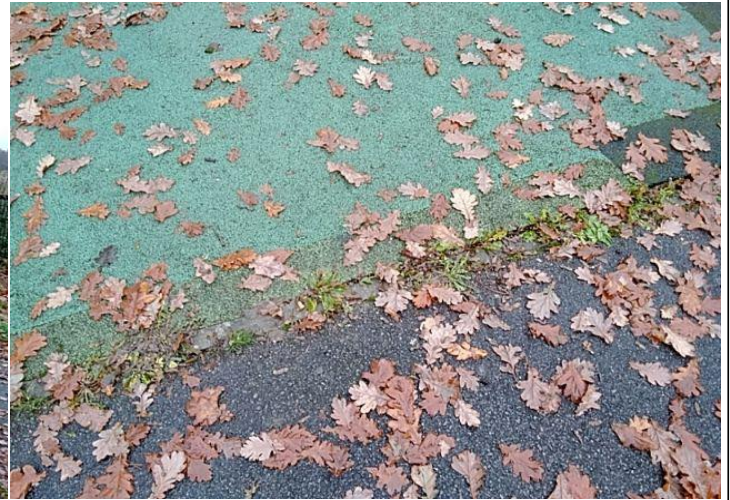
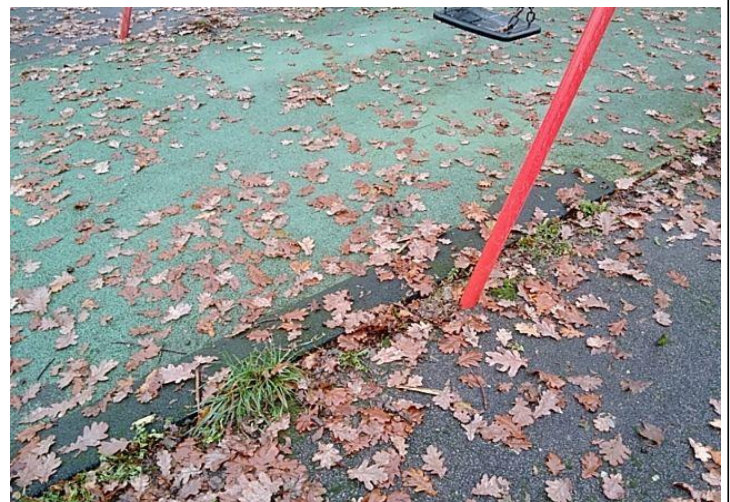
Item: Swings - 1 Bay 2 Seat (Flat)
Manufacturer: Wicksteed Playgrounds

Finding: There are weeds/vegetation growth between or around the edges of the surfacing

Action: Remove weeds/vegetation growth

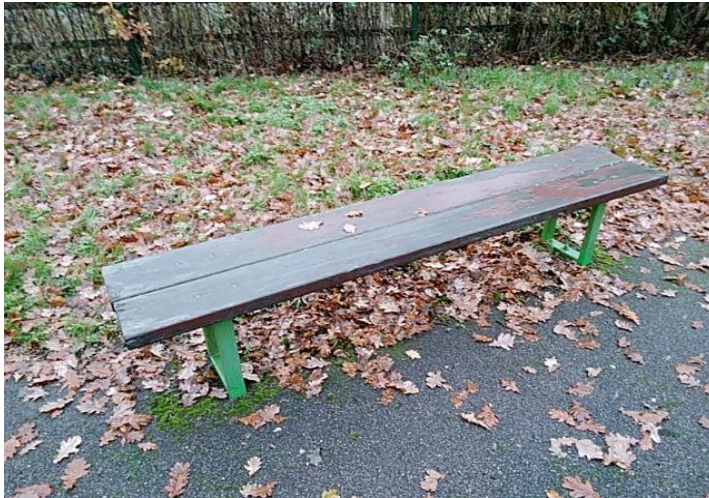
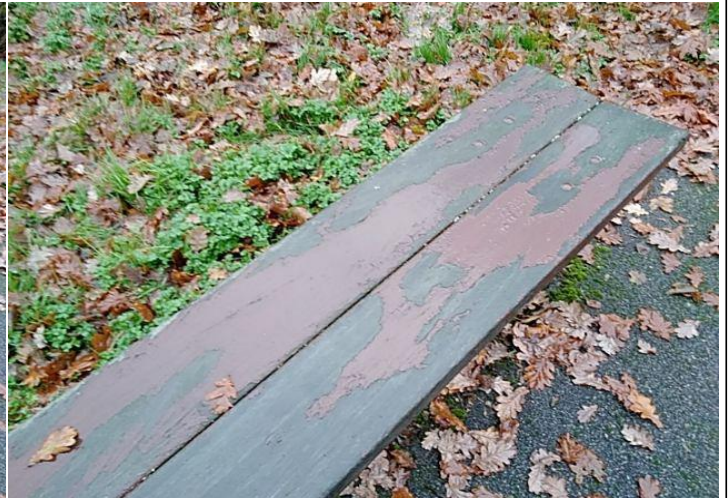
Item: Ancillary Items - Bench
Manufacturer: Wicksteed Playgrounds

Finding: Flaking coating may create splinter / abrasion hazards

Action: Rub down and treat as required

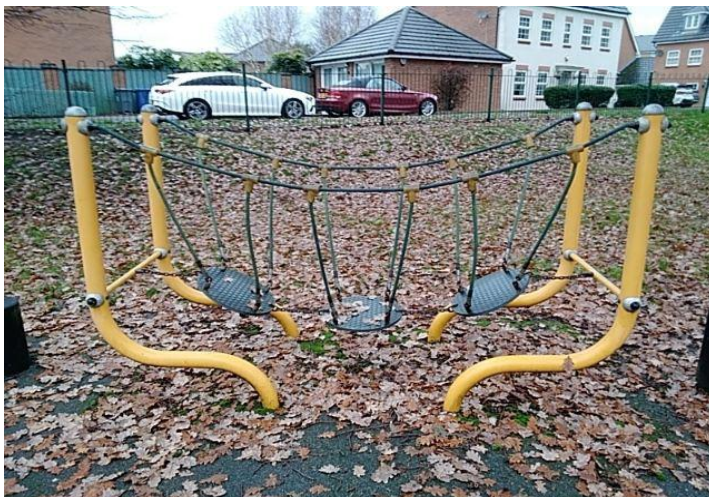
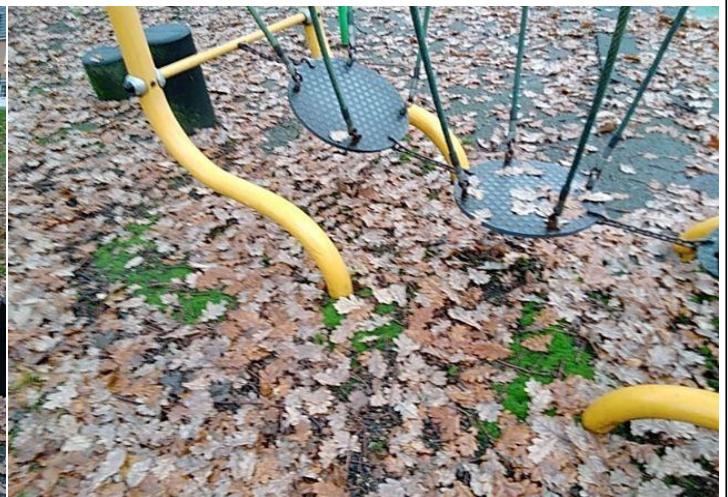
Item: Activity Equipment - Bridge
Manufacturer: Wicksteed Playgrounds

Finding: There is algae or moss growth on the surface resulting in slippery conditions

Action: Clean and treat appropriately

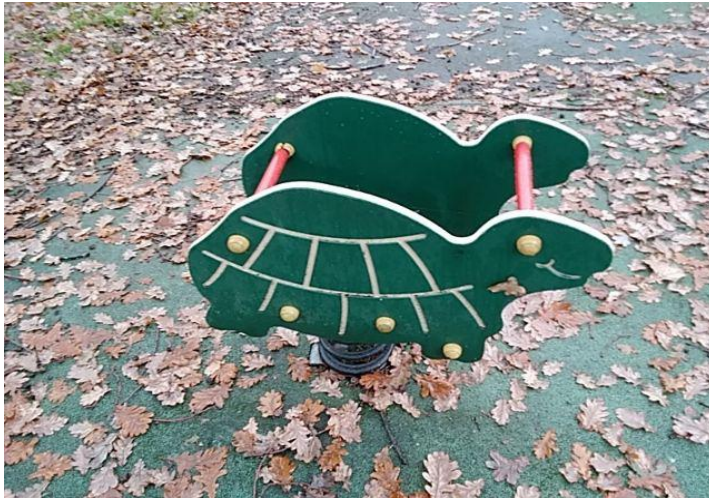
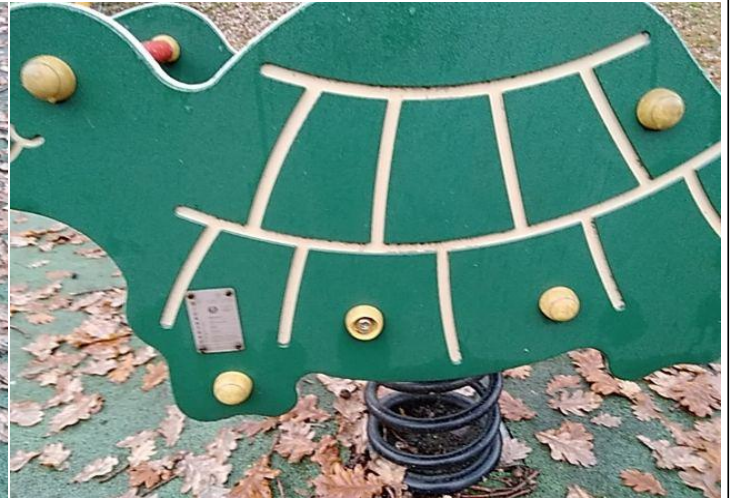
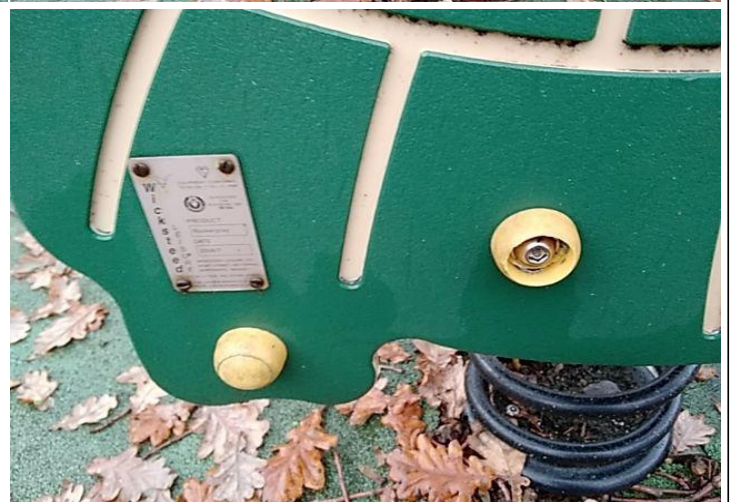
Item: Rocking Equipment - Spring Snail
Manufacturer: Wicksteed Playgrounds

Finding: There is/are bolt cap covers missing or damaged on the item

Action: Replace missing or damaged bolt cap covers

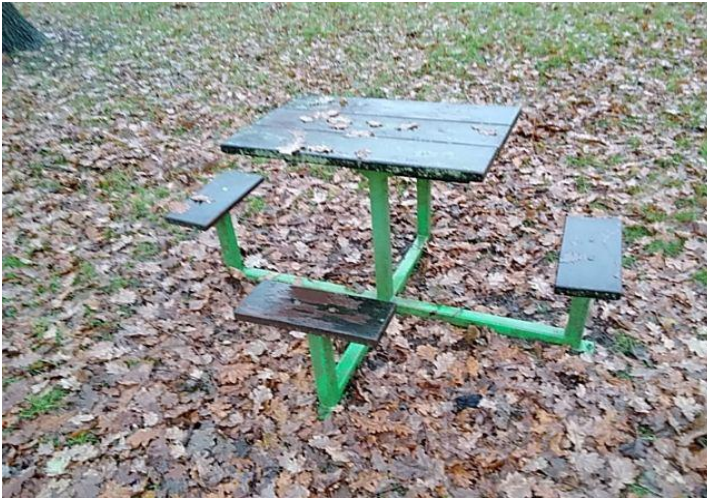
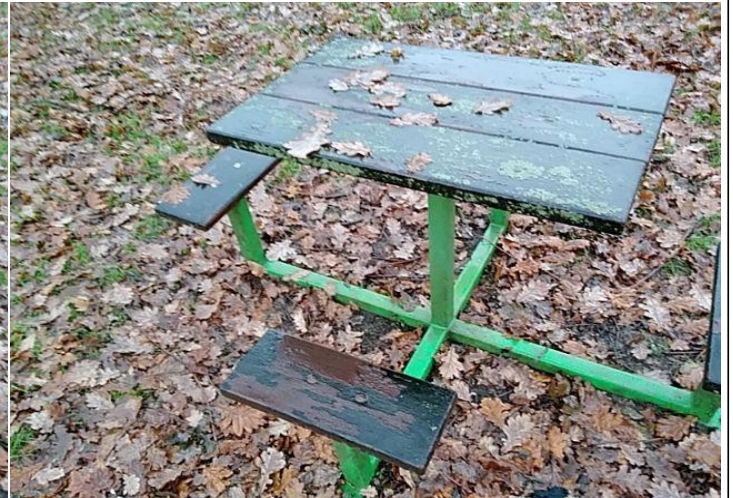
Item: Ancillary Items - Table
Manufacturer: Wicksteed Playgrounds

Finding: Flaking coating

Action: Rub down and treat as required

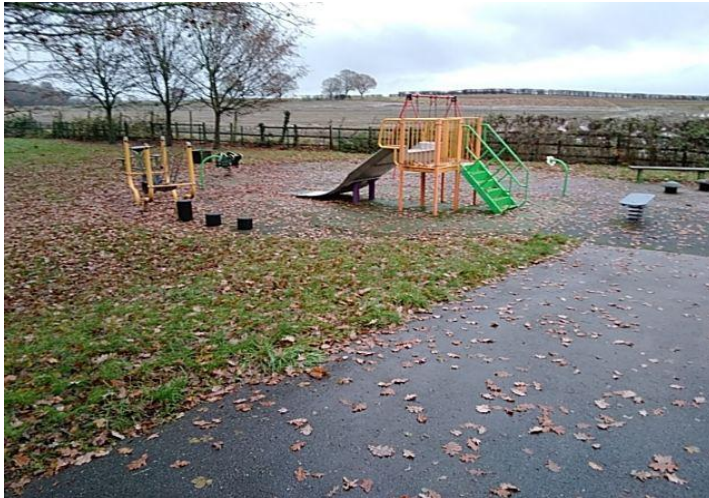
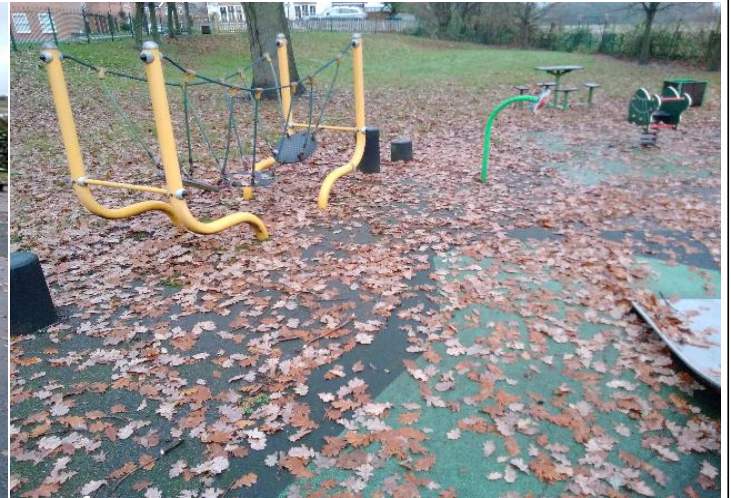
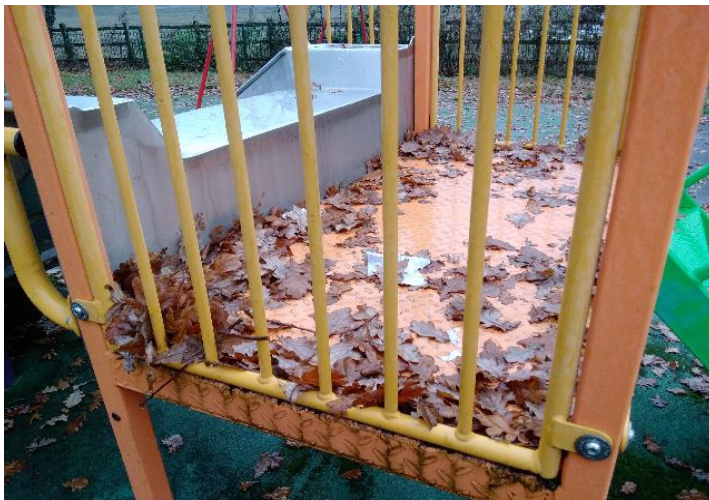
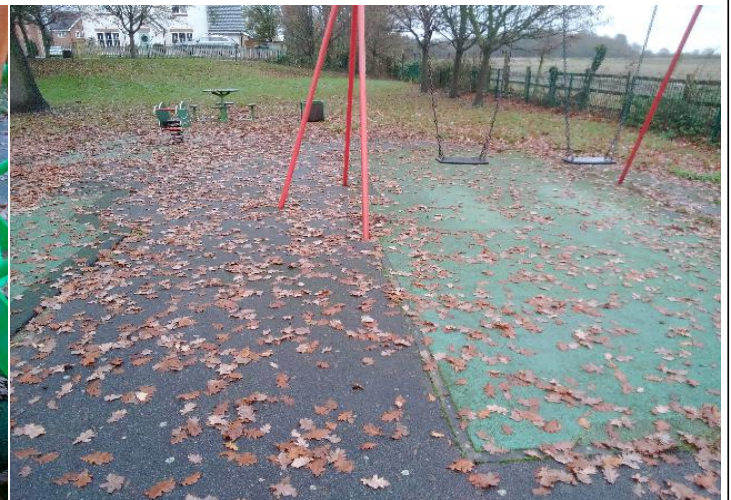
Item: Ancillary Items - Site General
Manufacturer: Unknown

Finding: Leaves on the playing surface and the equipment **Action:** Clean as required

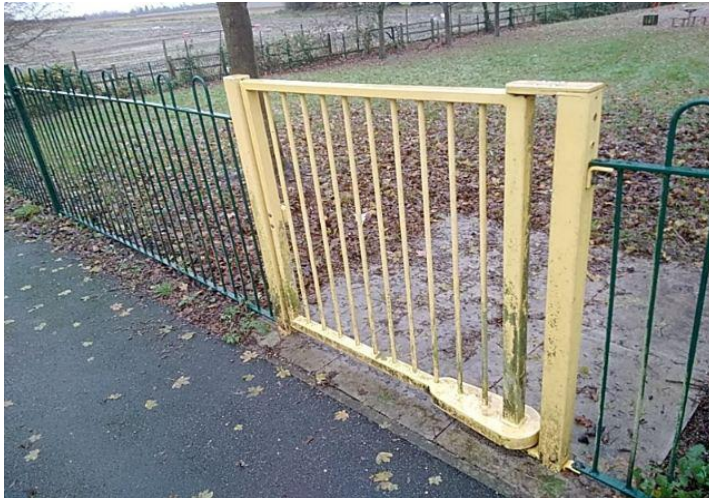
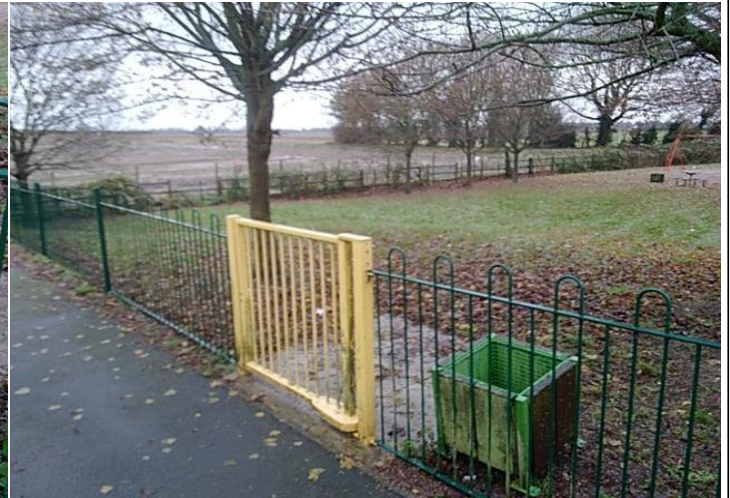
Item: Gates - Gate - Self Closing
Manufacturer: Wicksteed Playgrounds

Finding: The adjacent foliage is overhanging

Action: Cut back and maintain

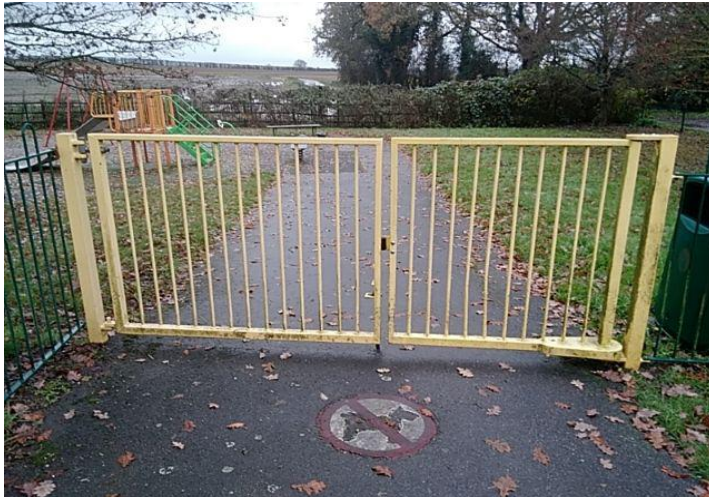
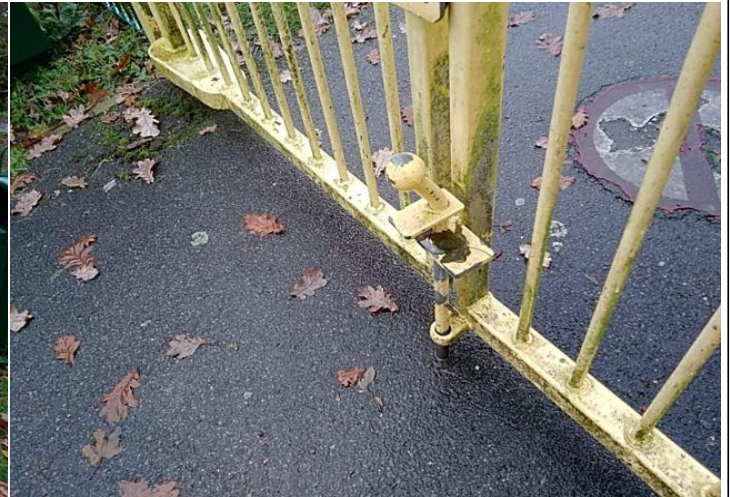
Item: Gates - Gate - Combination
Manufacturer: Wicksteed Playgrounds

Finding: Generally satisfactory, but recommend the unsprung gate is kept locked when not in use to ensure correct operation of the gates

Action: Keep locked

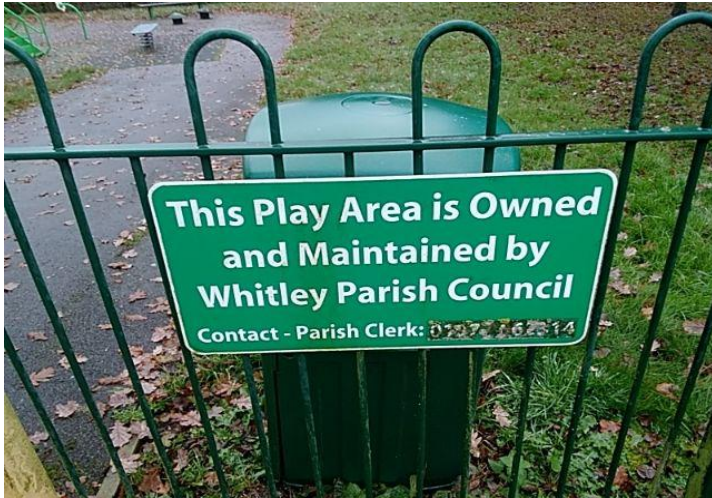
Item: Signs - Playground Sign
Manufacturer: Unknown
Risk Level: V - Very Low Risk
Surface: N/A

Finding: BS EN 1176 Part 7 recommends that signage shall include emergency contact details and contact details of owner / operator for reporting maintenance issues
Action: Provide additional information
