Annual Inspection

Whitley Parish Council

Daffodil Field

Whitley Farm Close , DN14 0GL

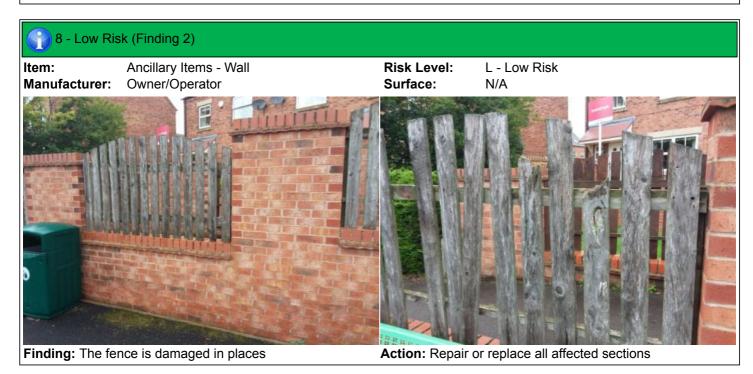
Finding: A number of fixings have worked loose around the **Action:** Secure all loose fixings fencing

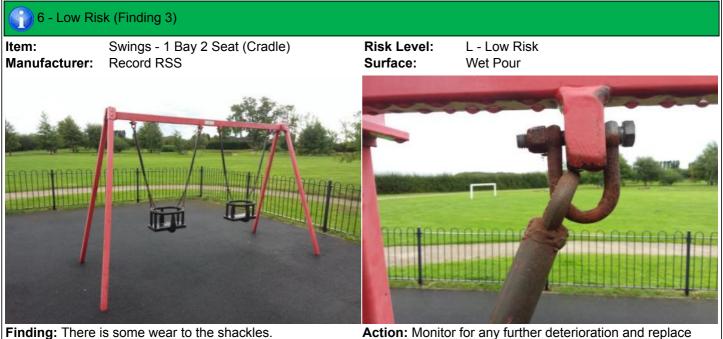
Finding: There is some notable evidence of chain wear

Action: Monitor for any further deterioration and replace when 40% worn

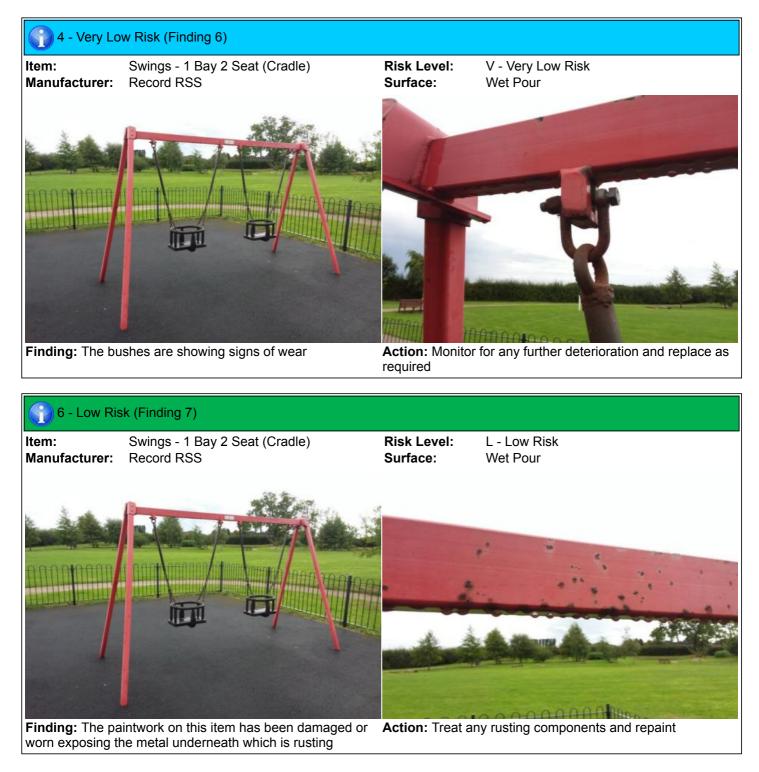
Finding: There is some notable evidence of wear to the anti Action: Monitor for any further deterioration and replace wrap bars when 40% worn

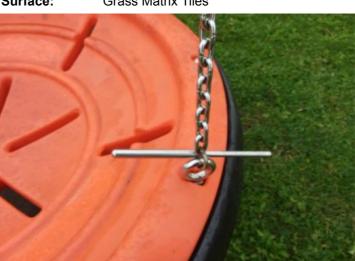
Finding: The connecting links are in excess of 8.6mm and less than 12mm and fail the requirements of BS EN 1176 Part 1; clause 4.2.13, Chains

Action: Monitor use and replace with compliant links at the next maintenance cycle
