PLAY AREA SAFETY ANNUAL INSPECTION REPORT

For Whitley Parish Council

On 18th March 2016

Play Area, Whitley Farm Close, Whitley, Yorkshire

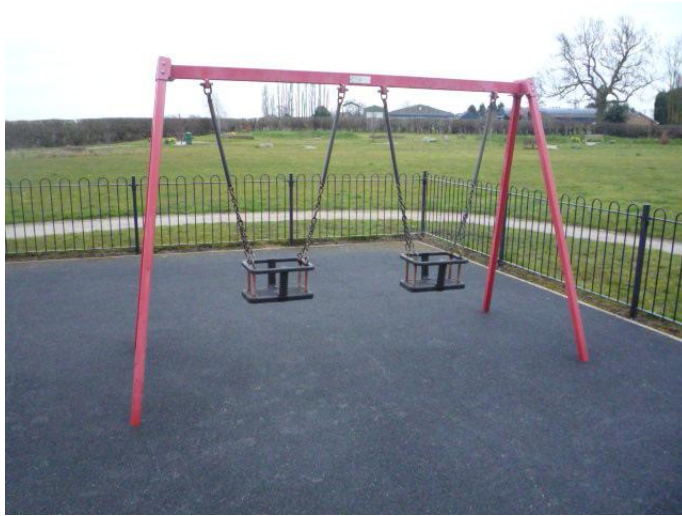
Item: 1 Bay 2 Cradle Seat 'Swingmaster' Swing (1850mm) -
Manufacturer : Record

The swing seat has been damaged but does not require immediate replacement. Monitor and replace when hard material is exposed.

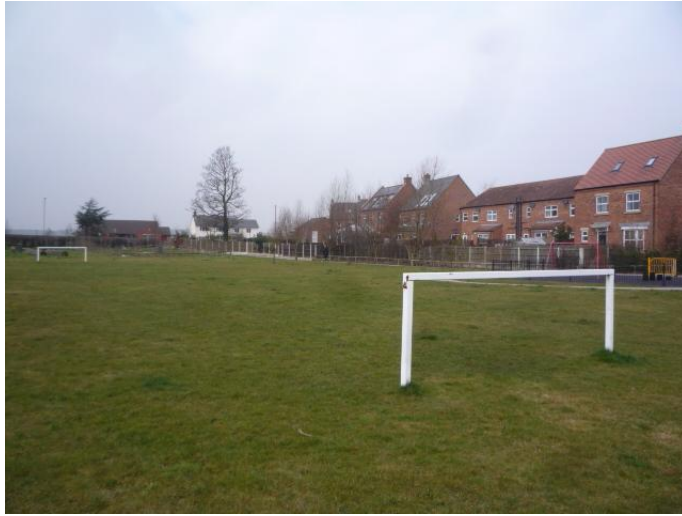
Item: Small Goals x2 - Manufacturer : Record

Paintwork is in poor condition. Recommend De-scale and coat with lead free paint, using appropriate precautions.

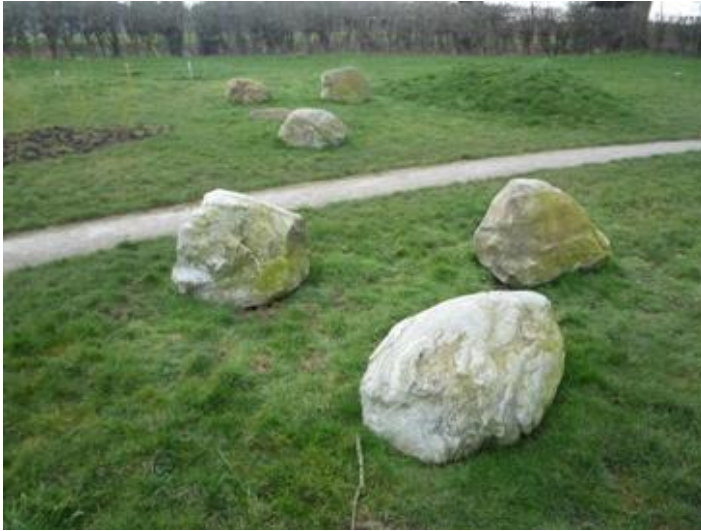
Item: Boulders x 12

The item fails to meet the requirements of EN1176 in the following respects:

Edges not radiused or chamfered. Recommend Monitor only – Low Risk.

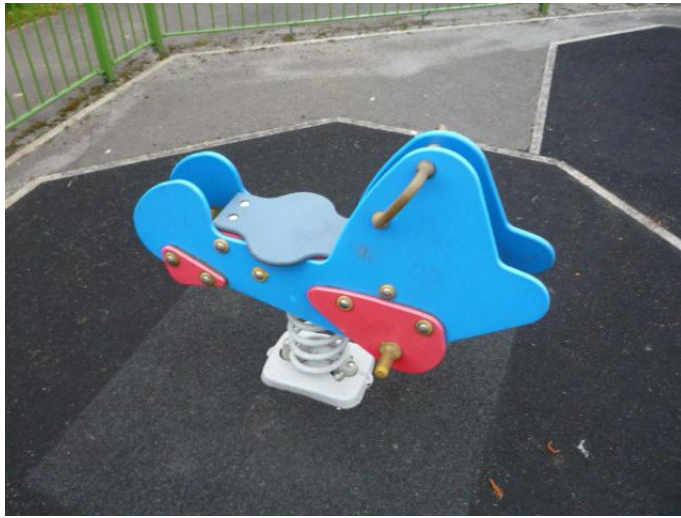
Item: Springy Aeroplane - Manufacturer : Record

The item fails to meet the requirements of EN1176 in the following respects:

Protruding handles/foot rests not conforming to the requirements of EN1176 – Recommend Monitor only– Low risk.

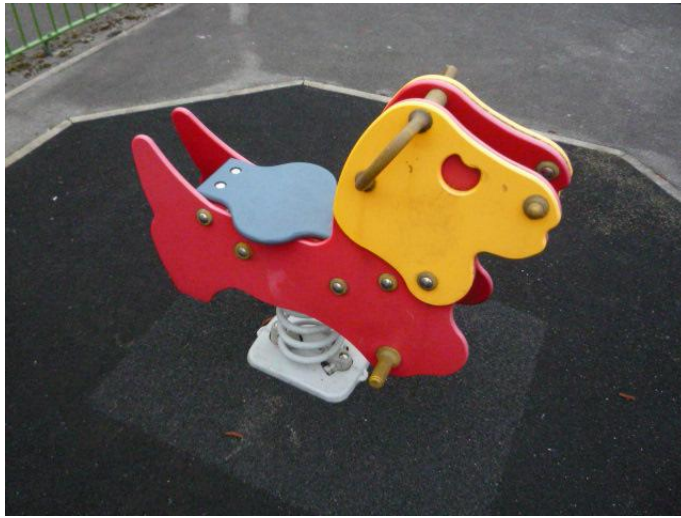
Item: Puppy Springy - Manufacturer : Record

The item fails to meet the requirements of EN1176 in the following respects:

Protruding handles/foot rests not conforming to the requirements of EN1176 – Recommend Monitor only– Low risk.
