the **play inspection** company

Annual Inspection

Whitley Parish Council

Inspected: 6-September-2019 - 09:24 by Ross Pringle RPII Annual Inspector

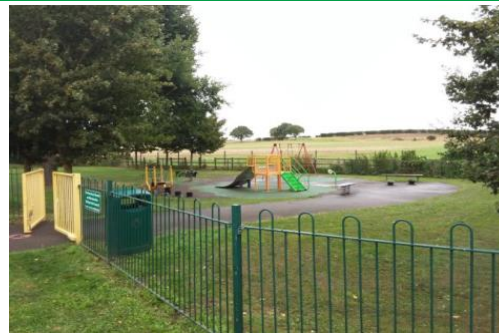
Finding 1

There are weeds/vegetation growth between or around the edges of the surfacing - Remove weeds/vegetation growth

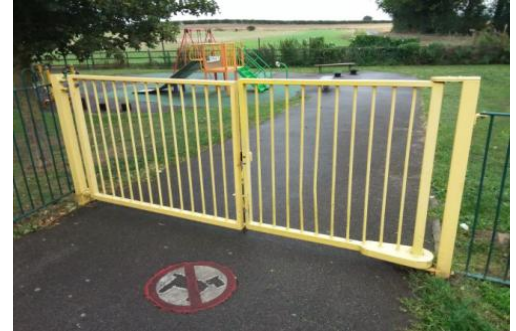
Finding 1

The padlock on the maintenance gate is not securing it from being opened - Secure the gate

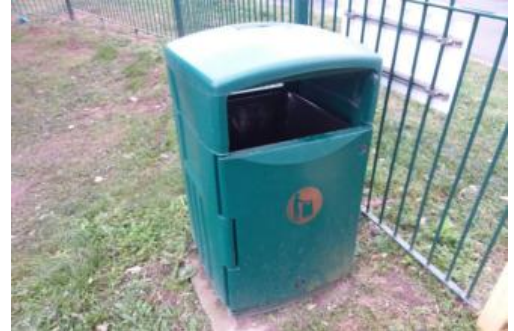
Finding 1

This item is satisfactory - no work required -

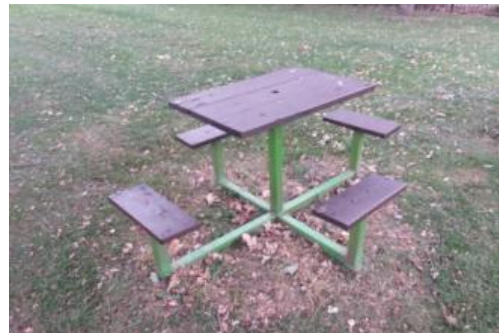
Finding 1

This item is satisfactory - no work required -

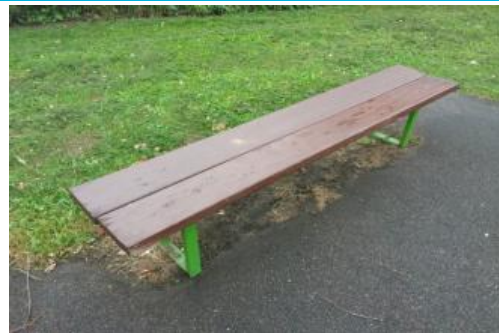
Finding 1

This item is satisfactory - no work required -

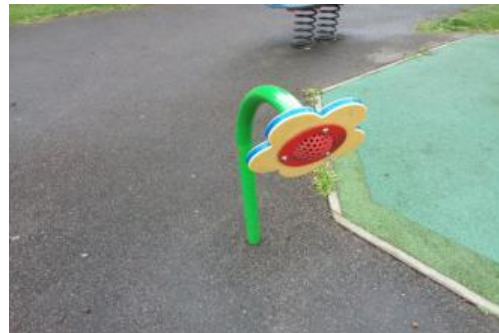
Finding 1

This item is satisfactory - no work required -

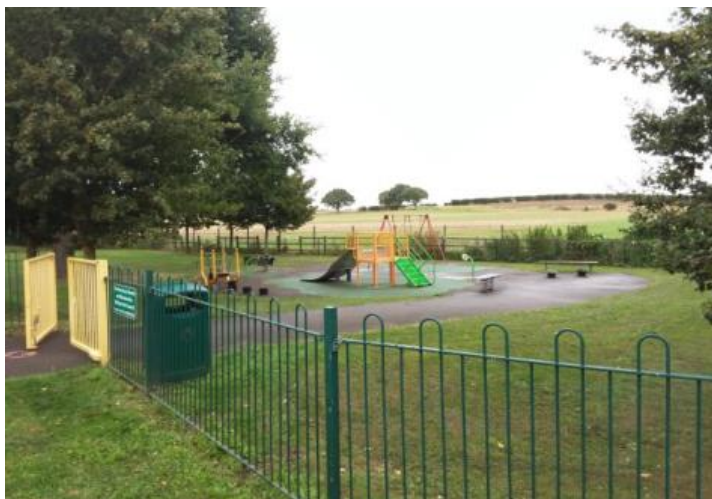
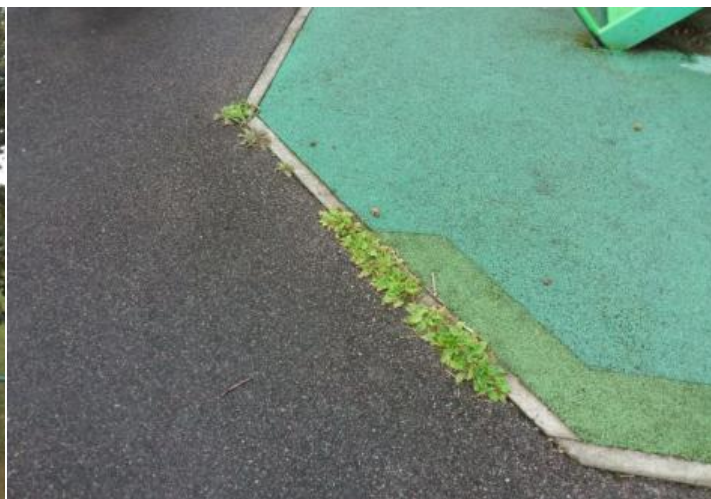
Item: Ancillary Items - Site General
Manufacturer: Owner/Operator

Finding: There are weeds/vegetation growth between or around the edges of the surfacing

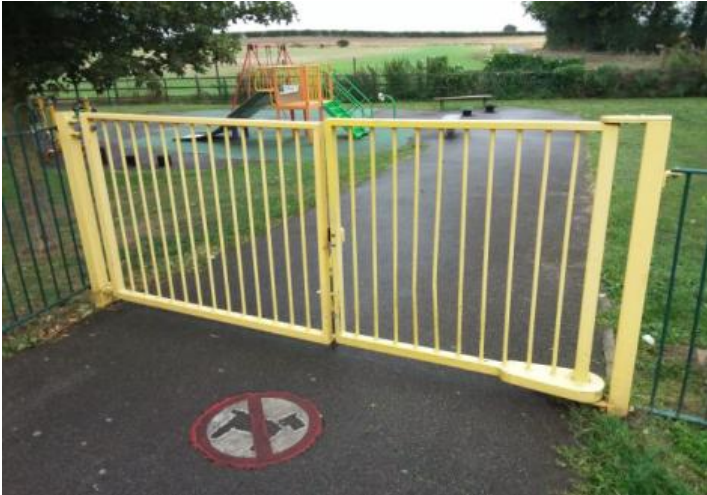
Item: Ancillary Items - Gate - Combination
Manufacturer: Owner/Operator

Finding: The padlock on the maintenance gate is not securing it from being opened

Action: Secure the gate

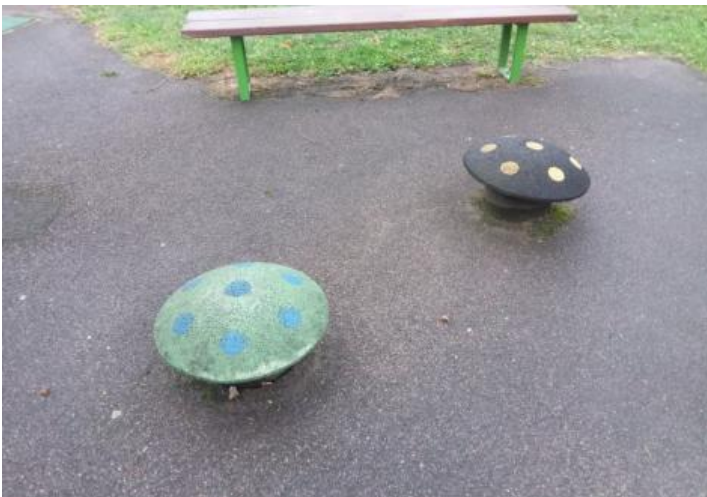
Item: Activity Equipment - Stepping Stones
Manufacturer: Not Identified

Finding: The bench forms a hard object within the falling space of the equipment in contravention of the requirements of BS EN 1176 Part 1
